Roads to Rivers Assessment Eleven Mile Canyon, Happy Meadows, and Sportsmen's Paradise Roads

September 2015

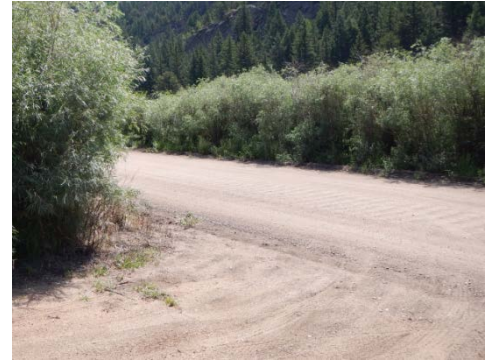
The AASHTO Guidelines for Very Low Volume Roads include a minimum sight distance of 90 feet. Numerous areas do not meet this minimum sight distance, primarily because of rock outcroppings that result in tight radii and minimal setback from the edge of the road to the obstruction. Limited sight distances occur around three curves because of large rock outcroppings. At a few intersections where a spur road meets the main road, vegetation along the side of the road causes reduced sight distance.

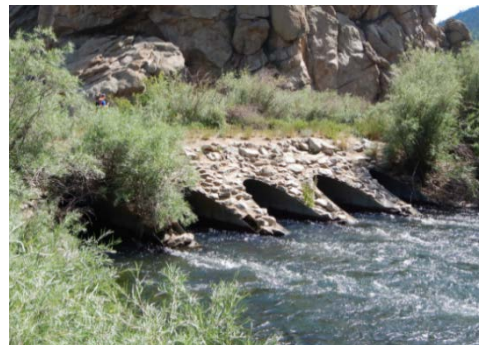
There are five bridges along the road where the river crosses under the roadway. There is one additional river crossing with four large culverts near station 38+00. Bridge inspection reports from 2012 were provided by USFS. The reports address the existing bridge conditions and associated costs to address reported issues, as summarized in **Table 2**. It should be noted that the mile posts designated in the table start at the Eleven Mile Canyon fee station.

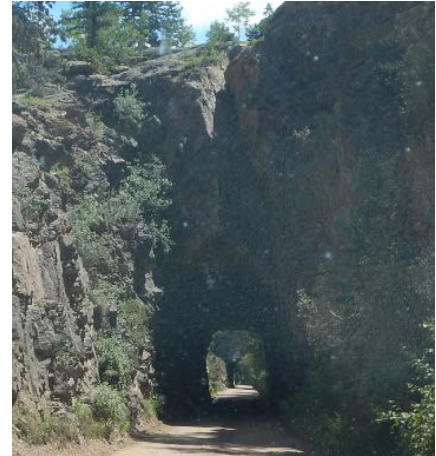
There are three tunnels that cut through large rock outcrops, a single tunnel at station 236+00, and a double tunnel at stations 103+00 and 107+00. The tunnels were built for the historical railroad and have a narrow width of 14 feet and a height of 17 feet. These tunnels do not provide enough width for two cars to pass, but they are on straight sections of the road, so they provide adequate sight distance. On either side of the tunnels, there are pullout areas for cars to park and wait for oncoming cars to clear the tunnel.

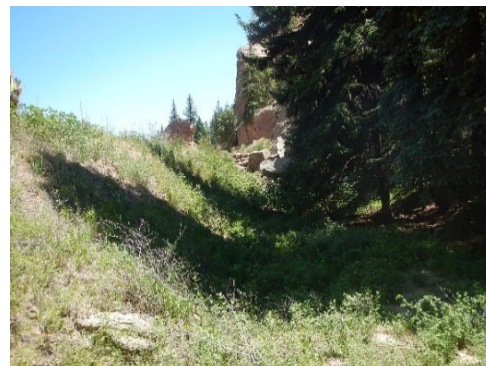
Multiple retention ponds, both natural and manmade, are located throughout the Eleven Mile Canyon reach. Natural retention ponds are localized depressions in the topography, and manmade retention ponds are locations where the road forms one edge of the retention pond. These retention ponds do not have formal outlet structures or pipes to the South Platte River. Water that enters the ponds infiltrates into the ground over time, which reduces the runoff and sediment load that directly enters the river.
