# Waldo Fire Recovery

## The Waldo Canyon Fire Master Plan for Watershed Restoration & Sediment Reduction

# Stream Segments

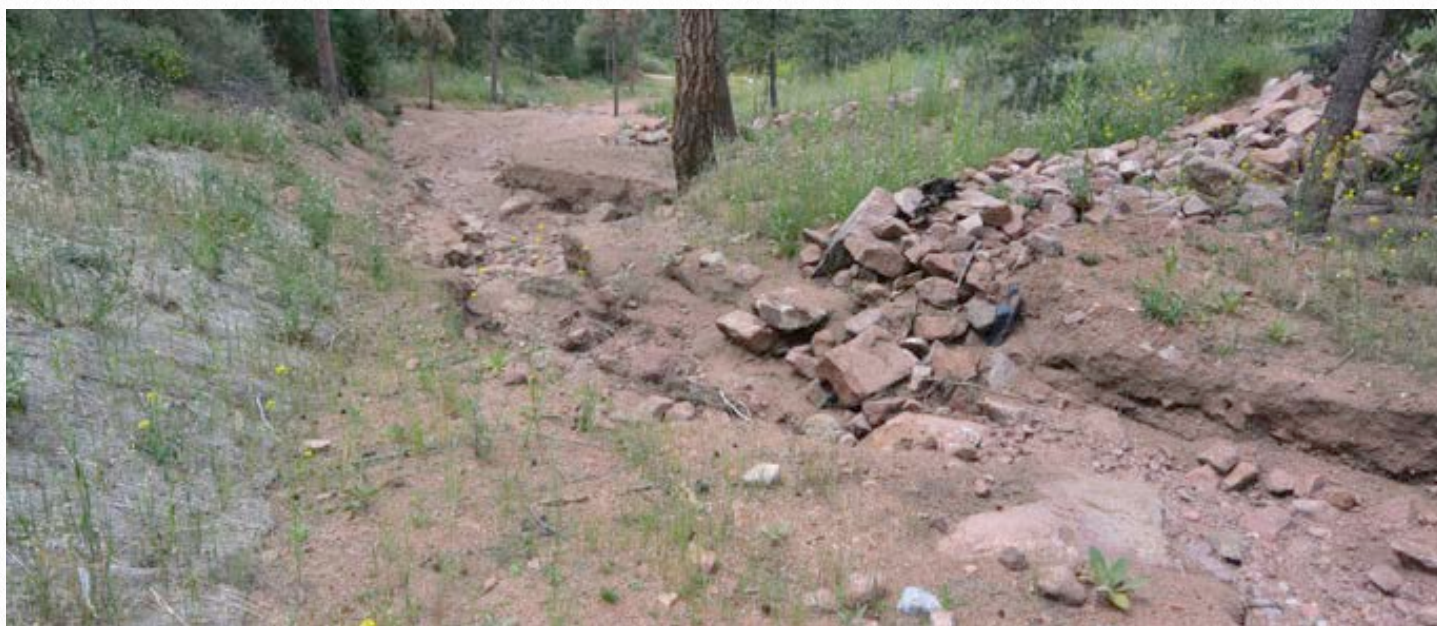
The hard-engineered structures were somewhat effective, with the exception of the bendway weirs, where we observed that 70 % of these treatments were at least partially failed. Bendway weirs likely are not a good choice in this particular channel, given the small substrates found and the mobility of the decomposed granite materials comprising the channel bottom. In every case, we observed channel down cutting at the channel end of these weirs, resulting in the bed eroding to a lower level and increasing the slope of the banks in the immediate vicinity of the weir.

Bendway Weir causing channel down cutting in Lower Cascade Creek.

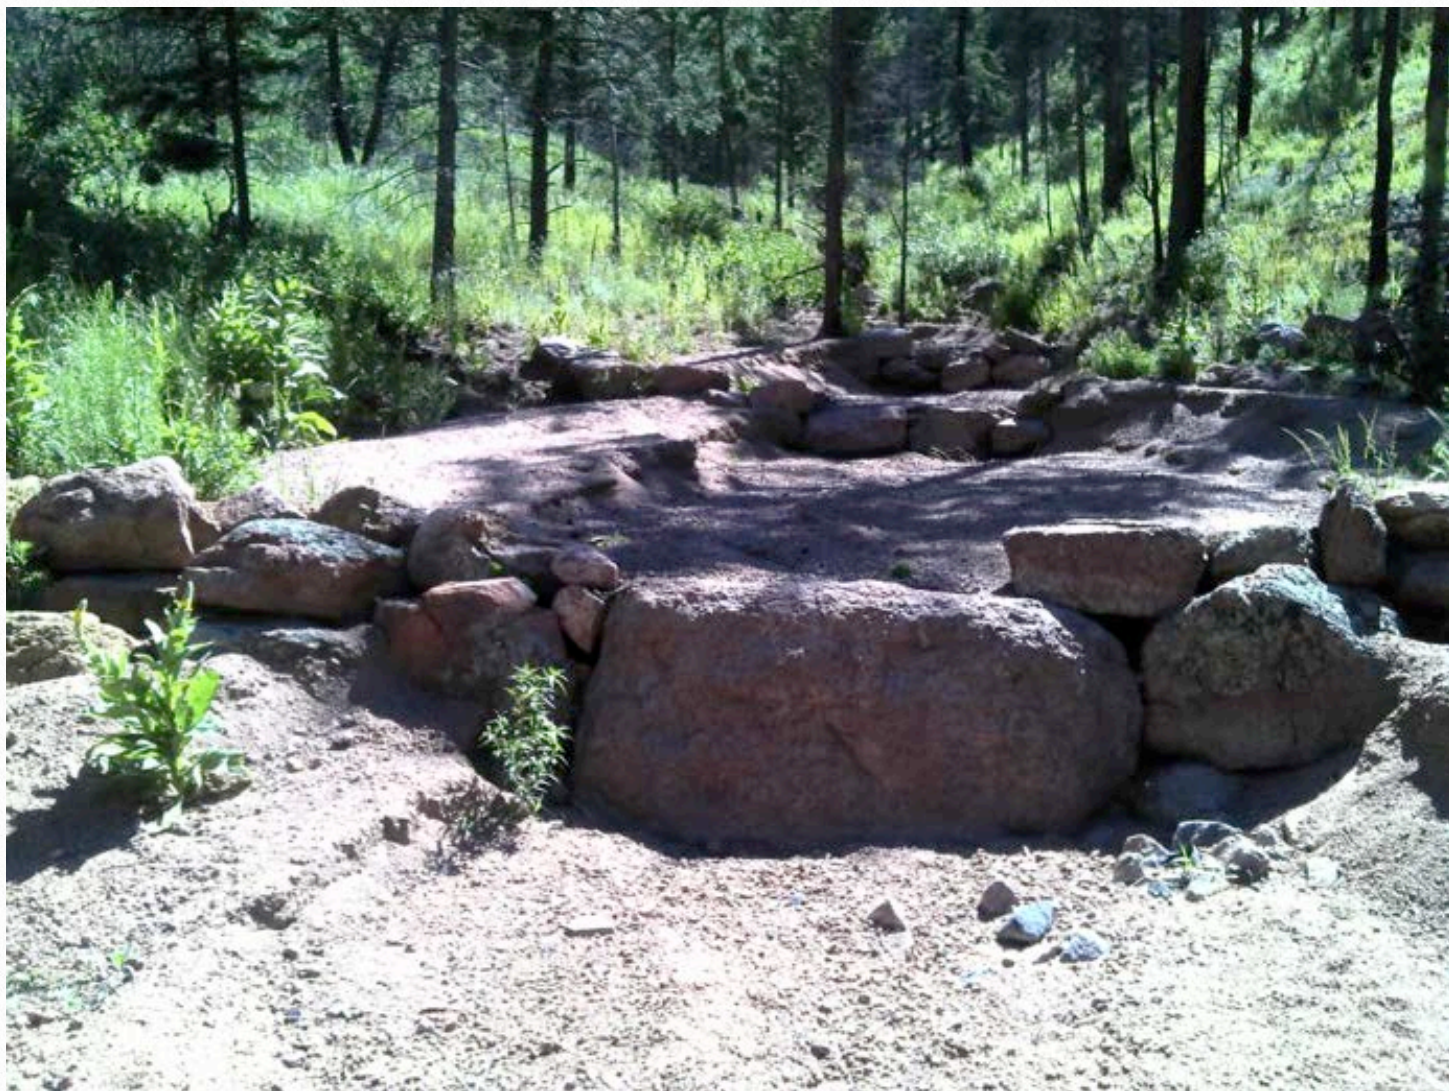
Boulder Drop Structures in Upper Cascade Creek

Both natural channel and engineered treatments have been effective in the upper Cascade Creek reach. Boulder drop structures and log sills were the most common treatments, which would be expected in this higher gradient transport reach. Failure rates of these structures were less than observed in other sub-basin. Sediment basins in the reach were still providing storage for flood debris and sediment, even though one crib wall was functioning at risk, and one basin sill had completely failed. We did observe that some of the hard treatments had not performed as well as expected, most notably a rip rapped bank that had partially failed due to collapse of the toe slope. Additionally, one of the two rip rapped channels observed in the lower segment of the reach appeared to be functioning at risk, and may not withstand a future significant flood event. Overall, 77% of the treatments

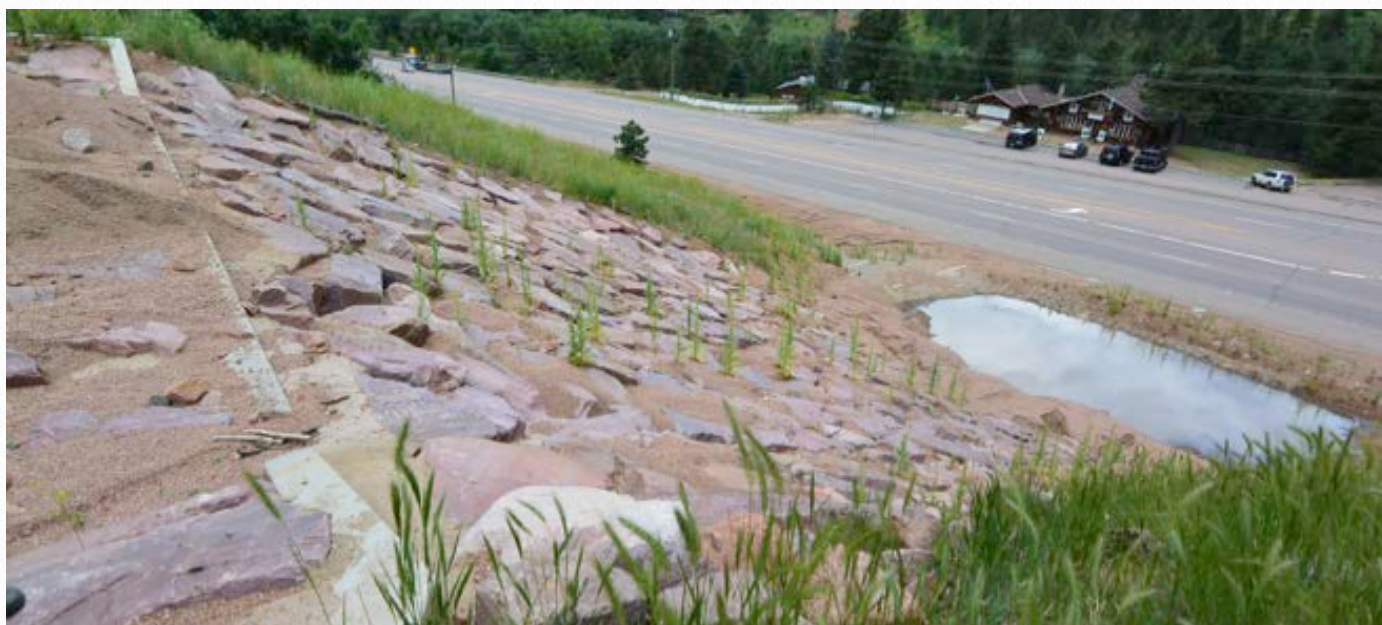
Massive Grouted Boulder Drop Structure & Basin at Spring Gulch.

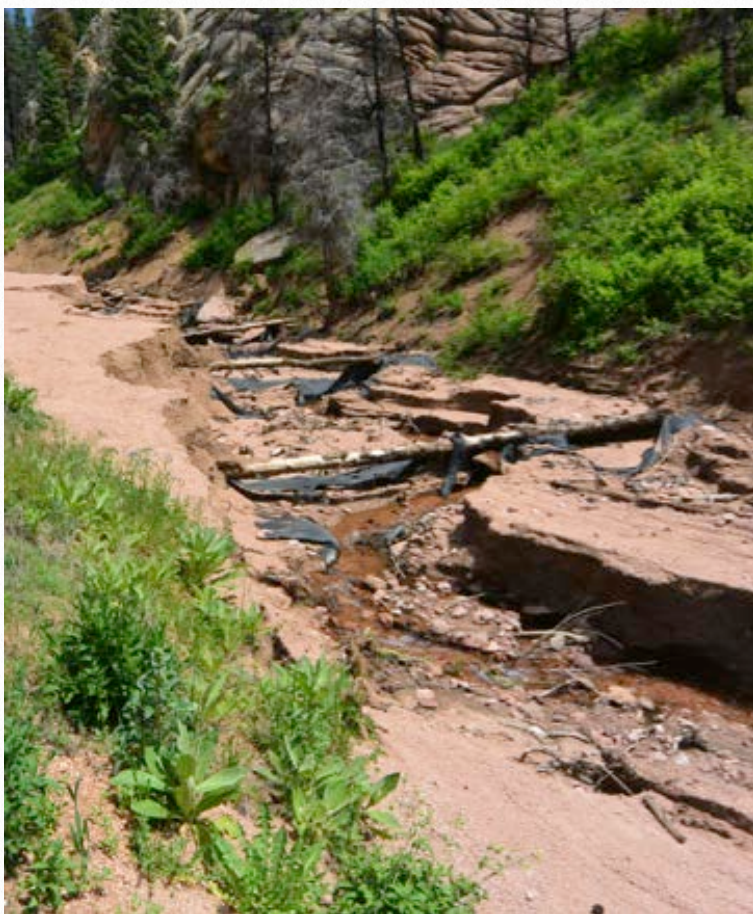
#### Failed sills in Middle Wellington

Log sills were the most common treatment in the upper reach. Failure rates of these structures were consistent with of those found in other basins. There appeared to be too much reliance on log sills in the reach, which likely lead to the overall failure of the project. Many of the log sill treatments were lacking geotextile fabric, which likely increased the risk of undermining. Two sediment basins in the reach were still providing storage for flood debris and sediment, but the basin crib walls and basin sills had failed or partially failed in all of these features, likely limiting their future function. Two earthen berms were constructed in the reach, but both of these features had completely failed.

Upper Wellington Gulch had the highest failure rate of all of the project reaches assessed in 2015. Overall, 22% of the treatments in the project reach were found to be fully functioning and 10% of the treatments were fully functioning but at risk. 58% of the work had failed completely, and 9% of the treatments were partially failed and not function at full potential. Critical grade control features such as boulder drop structures had a 100% failure rate in the reach. It was clear that the downstream most grade control had failed in the reach, and the resulting head cut had migrated up through the project reach, undermining the structures upstream

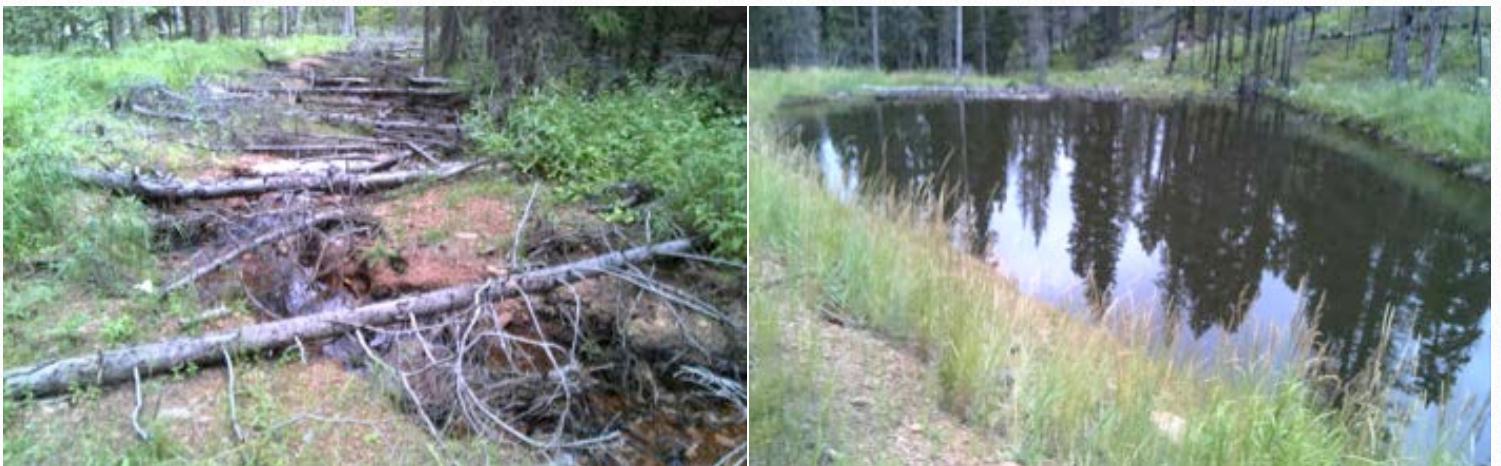
The two sediment basins in the project reach are still functioning to capture sediment and debris, despite the fact that the log crib walls and basin log sills on each feature have failed. The lower basin still has some storage capacity, but will likely fill up in the near future. A segment of the channel between the two basins was hardened by laying dozens of small diameter cut logs across the channel perpendicular to the flow (log corduroy). While this treatment may have helped add roughness to the surface, it failed in the first rain.

Log corduroy (left) and sediment basin (right)

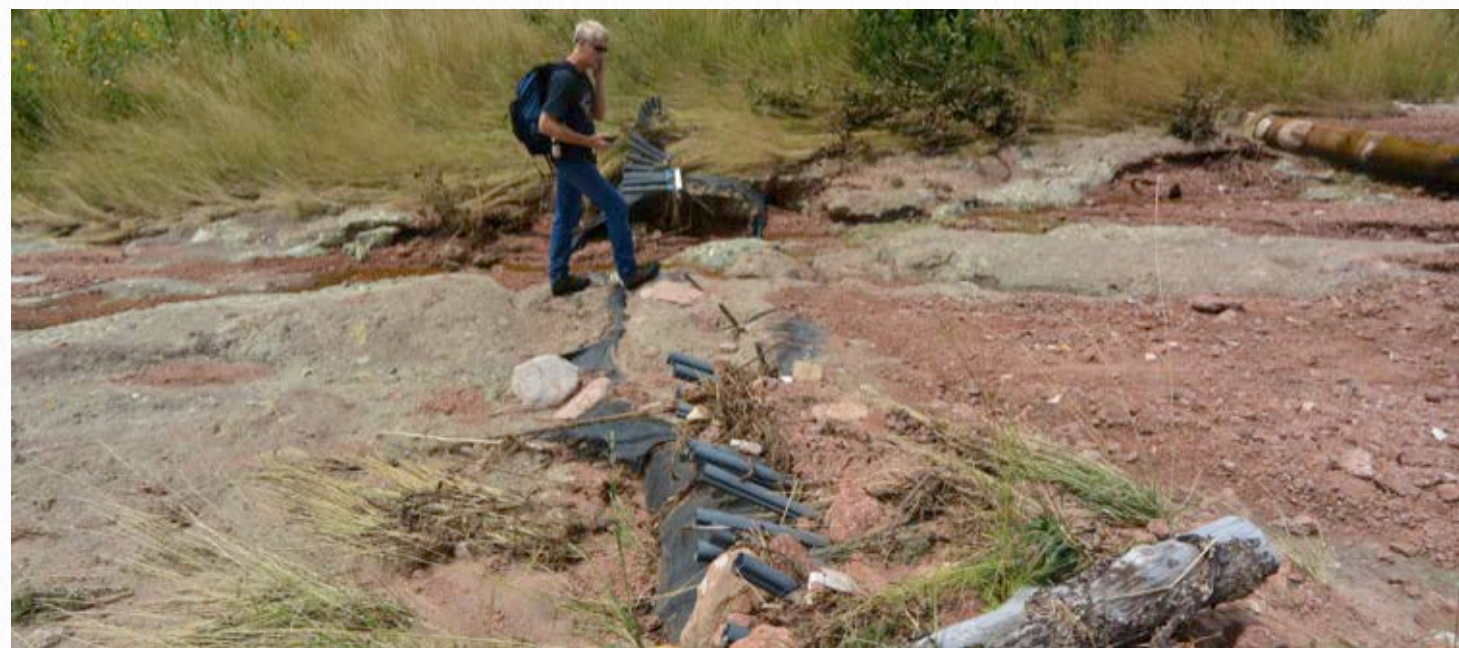
Damaged Whisker Sills: These were a new product recommended by a hydrologist, but they failed quickly.

The upper part of the reach sustained significant damage during the flood event. 40% of the log sills and 90% of the whisker sills sustained damage and were no longer fully functioning. Several of the whisker sills, which are constructed of PVC plastic pipe, had shattered, likely due to the large boulders and cobbles that were mobilized in the channel during the flood. The sediment basin, although damaged, was still functioning, and was being excavated by the City of Colorado Springs during the course of our survey. The trap bag walls surrounding the school were still fully intact, but flood was high enough to allow water to enter the building around these features.

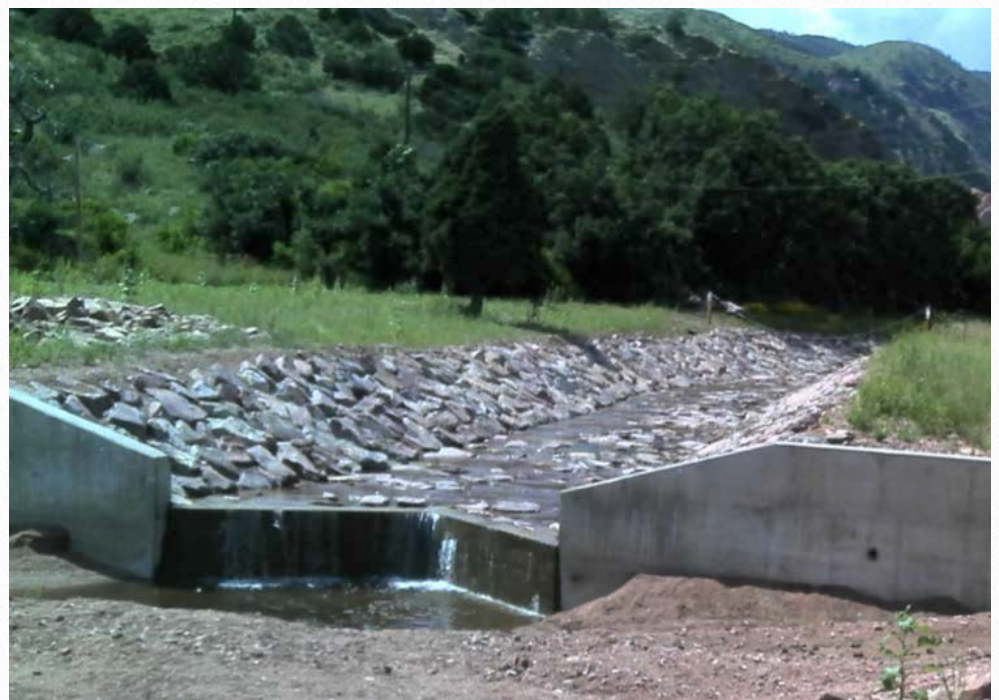
The hard engineered treatments through the Navigators compound appear to be very effective, although there was some evidence of sediment deposition and channel aggrading in some of the channel segments, which may indicate that the channel will lose capacity over time. The massive debris net at the upstream boundary has effectively captured larger debris coming into the reach from the watershed above.

Riprap channel through Navigators

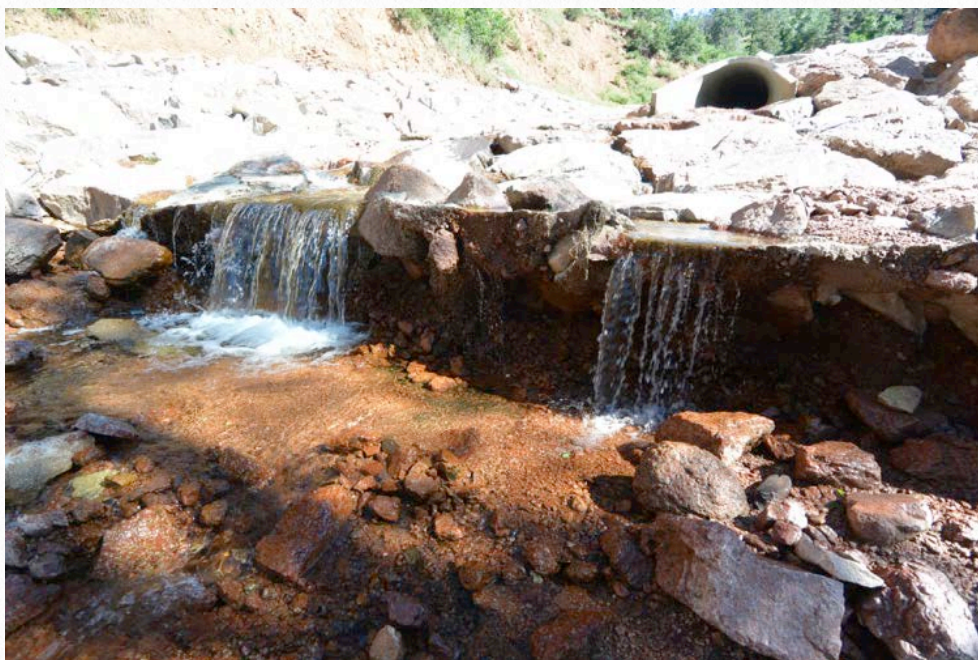
Grouted Rip Rap Channel functioning at risk as the toe begins to erode.

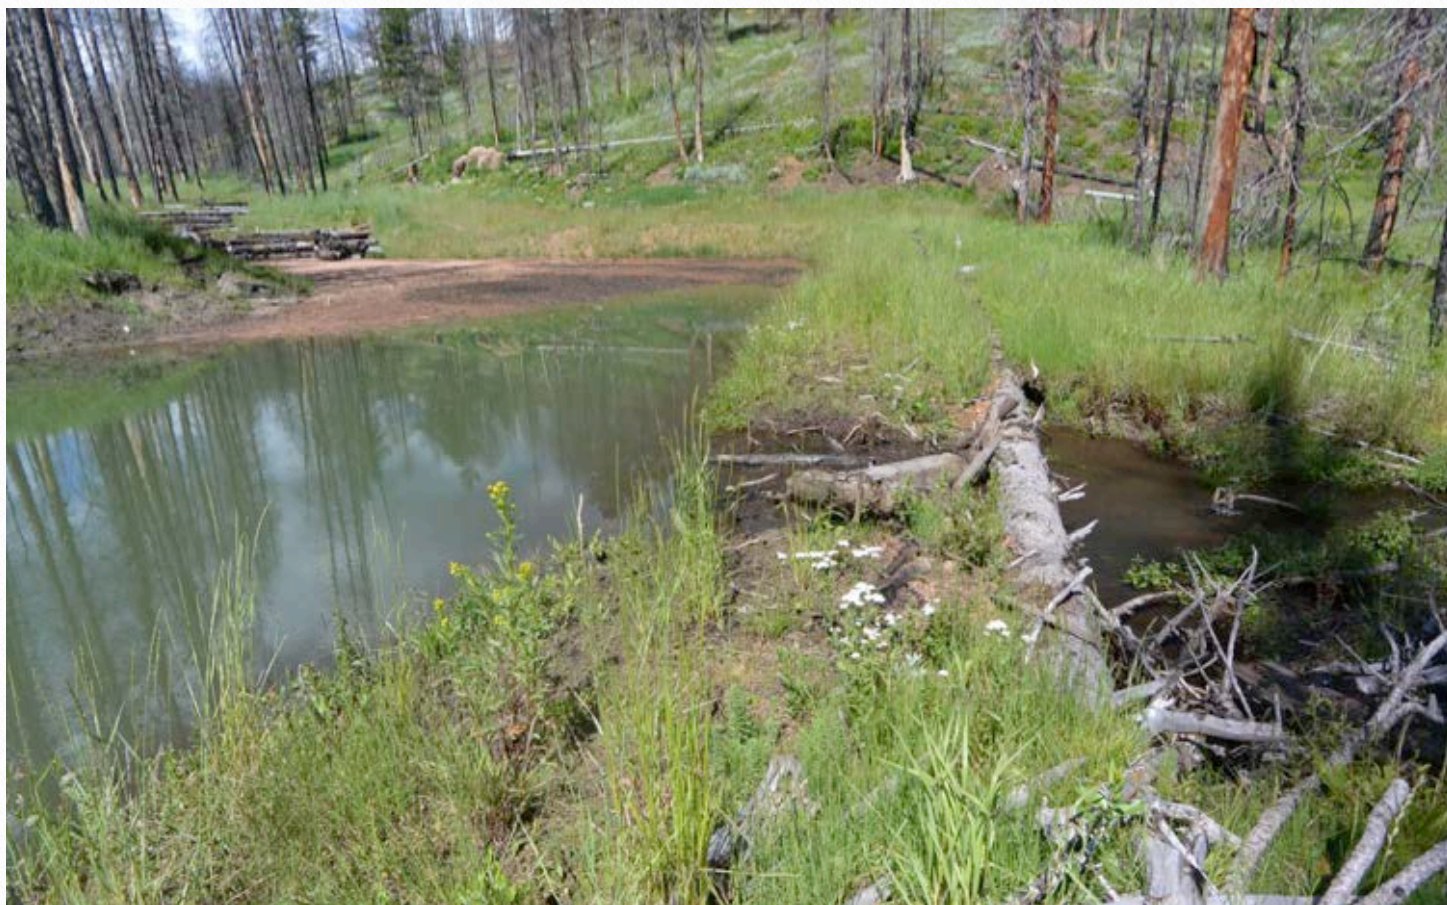
Functioning basin sills in Northfield

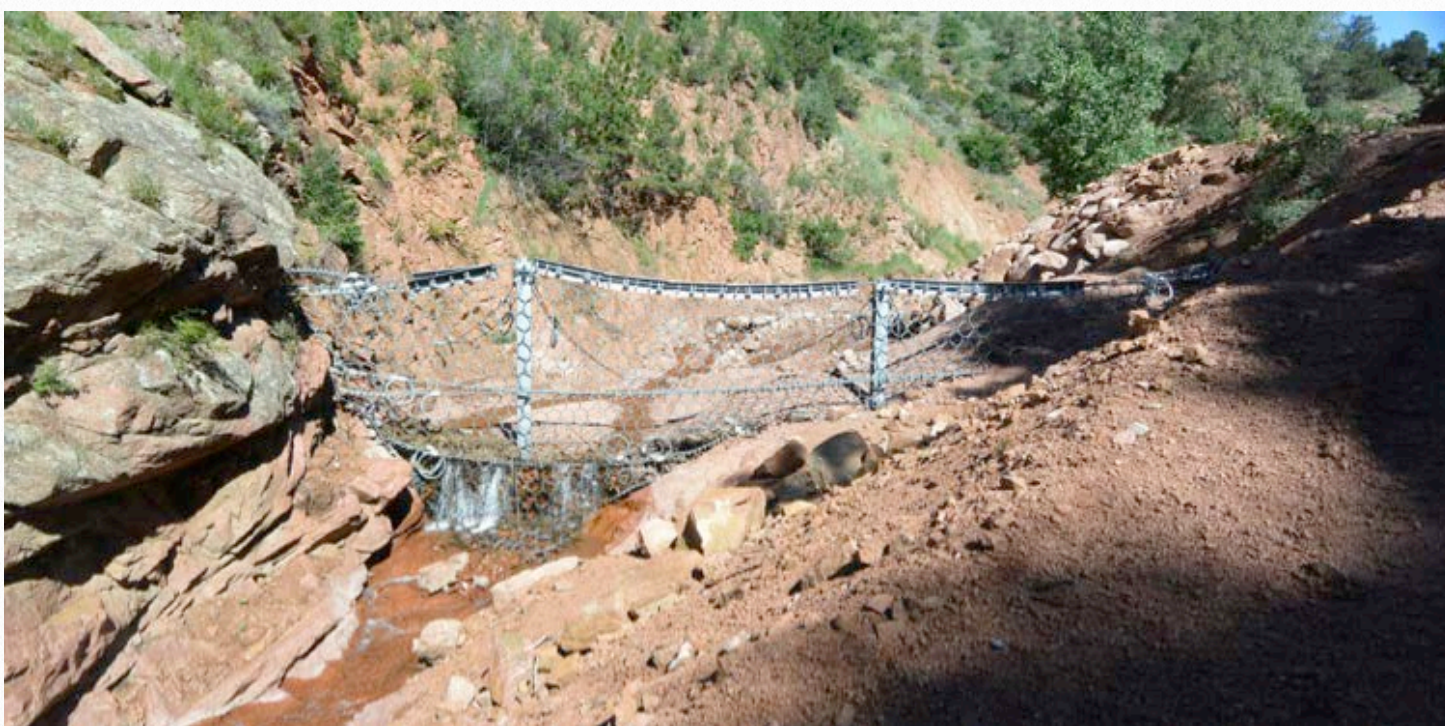
Five steel debris nets have been employed in Camp Creek, lower Williams Canyon and Waldo Canyon to capture larger cobble and boulders, as well as large wood and other organic matter. These structures range in size from the massive net above Glen Eyrie to much smaller detention structures in Waldo Canyon and Williams Canyon. These engineered structures have been very effective in capturing material before it can damage flood control infrastructure downstream, but are quite expensive to install and require frequent maintenance.

CDOT Debris Net in Waldo Canyon

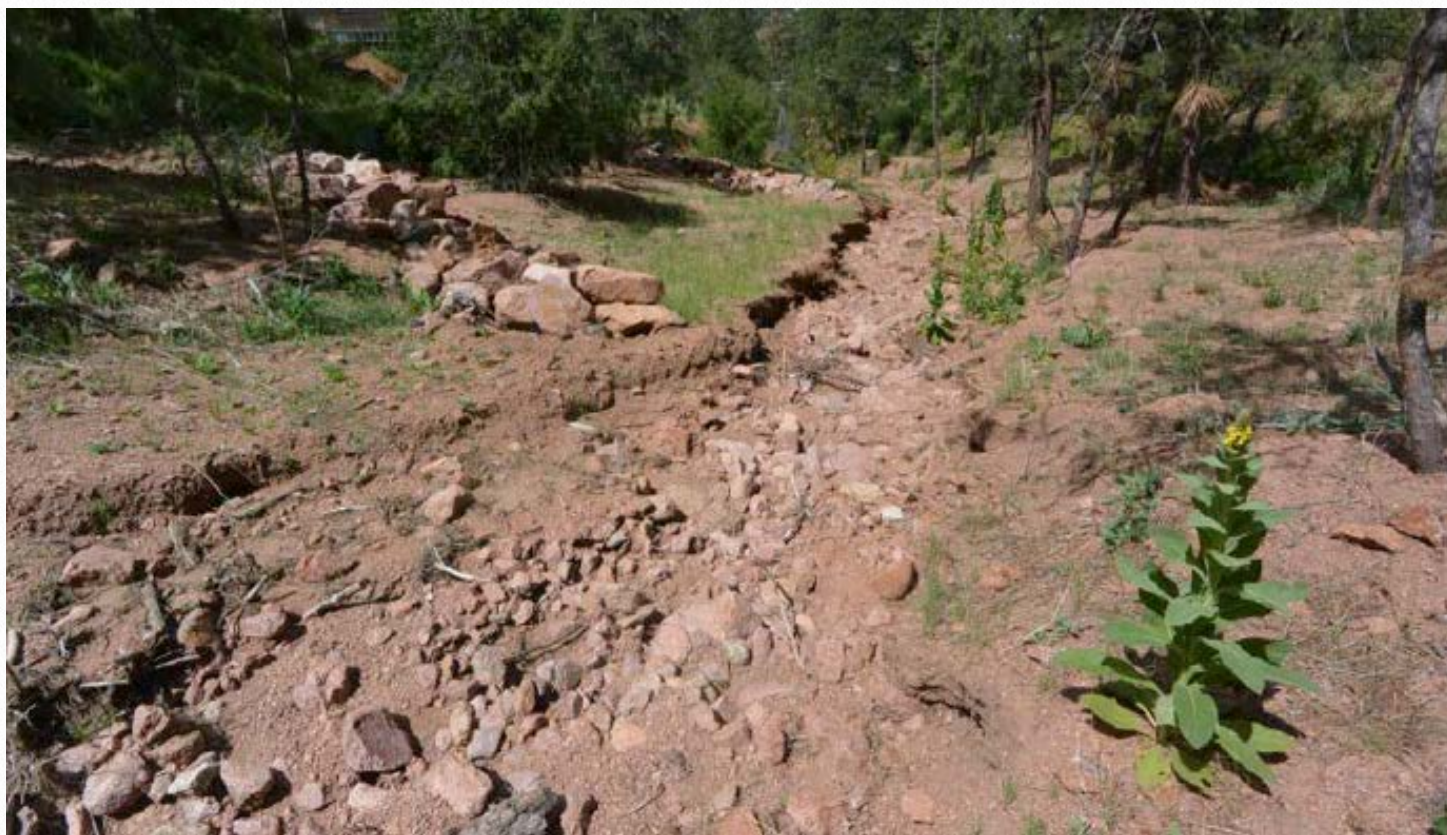
Bendway weirs are a common channel and bank stabilization technique employed throughout the US for flood control. Bendway weirs are typically installed perpendicular to the direction of flow, and extend across only a portion of the active channel. Bendway weirs were utilized in only one project reach in the Waldo Canyon burn, and were found to be ineffective in the highly erosive decomposed granite channels found in the burn area. We observed that the weirs actually accelerated erosion and down cutting of the channel bed surface, due to convergence of flow at the channel end of the structure, and 70% of these treatments had partially failed, or failed completely, and could threaten more functional treatments both upstream and downstream.

Failed, bendway weir

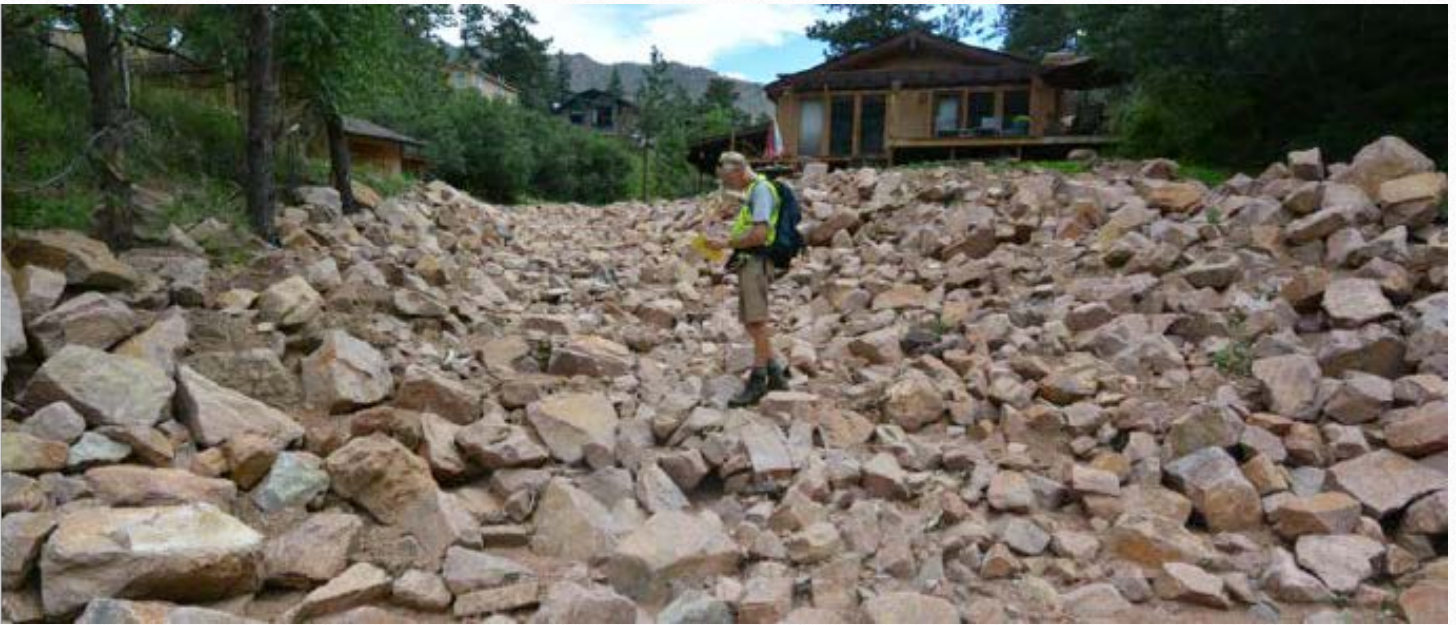
Non grouted rip rap channels function similar to grouted channels, but at less cost and with less impact on aquatic ecosystems. Non grouted rip rap channel treatments were used on the south and east sides of the burn with good results similar to the more expensive grouted treatments. We did note during the course of the survey that both grouted and non-grouted channels tended to fill with sediment over time, reducing channel roughness and increasing velocity and shear along the channel and banks.

Non-grouted riprap channel
