Sugar Creek Sediment Mitigation Project

Site Assessment, Conceptual Solutions, and Preferred Alternatives

Kyle Hamilton, Will Voss, Trent Miller/CH2M HILL

April 30, 2009

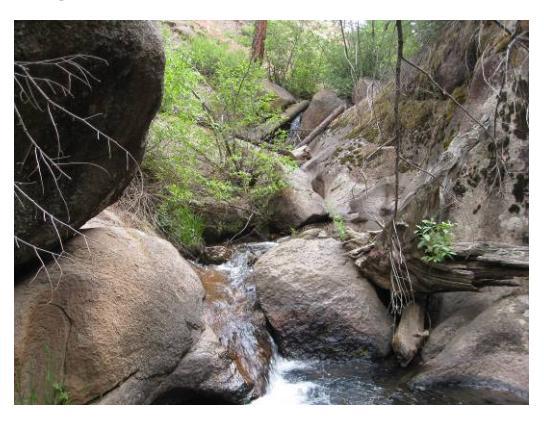
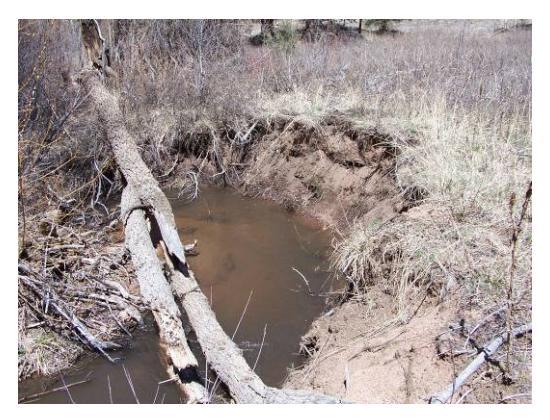
Only one reach had moderate bank erosion, as shown in photo to the right. This erosion is typical of streams and is caused by the soil and vegetation being unable to withstand the erosive forces of the channel flow. The toe of the bank has eroded, and the upper banks have thus sloughed off and the erosion now extends from the creek invert to the top of the right bank. Some loss of vegetation has occurred in this reach, including the right bank riparian fringe.

The eroded bank could be repaired by laying back the slope and protecting the bank with willows, erosion

control blanket, or buried rock. Due to the low occurrence of this poor bank condition, and the relatively short reach where erosion has occurred, this area could be improved or identified as a "watch area".

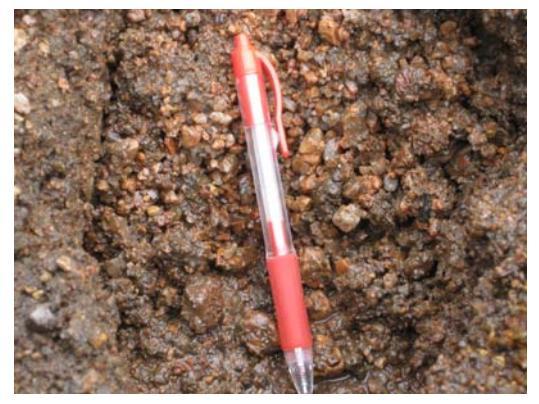
Primary sediment sources are the natural hill slopes,

CR 67 (imported gravel and natural material), the roadway fill slope adjacent to the creek, and some tributaries and hill side gullies. Tributaries with flow appear to be stable, and no major erosion was present. Some of the sediment from tributaries is being deposited at the confluences with Sugar Creek, but the deposition is localized and Sugar Creek appears to be flushing the sediment adequately.

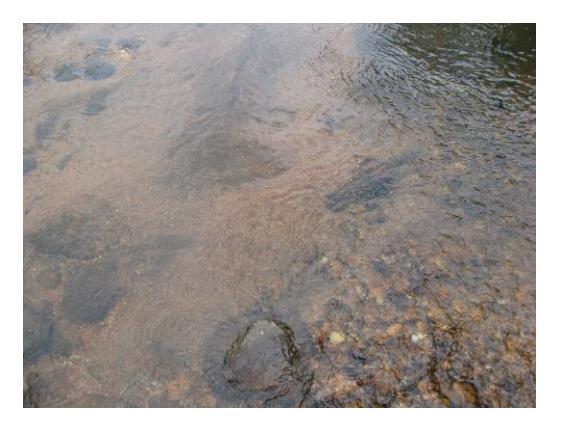
The imported gravel road base material from CR 67 was found in numerous locations along Sugar Creek.

The imported road base gravel differs in color and shape from the natural hill slope material, and is visually distinguishable. The gradation of the imported material is not significantly different from the native material, and appears to be transported by Sugar Creek downstream of its input location.

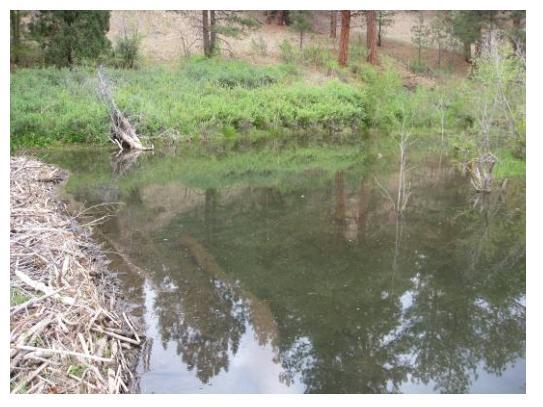
The beaver ponds are acting as natural sediment traps. The upstream ponds are filled with sediment, while the downstream ponds are in relatively good condition. Some of these ponds have completely filled in with sediment and have vegetation growing on the sediment

accumulation zones. Other ponds have minimal sediment accumulation and have nearly their full depth of water available (based on the distance between the original channel invert elevation and the water surface elevation upstream of the dam). No beavers were seen during this study.

The beaver ponds provide an opportunity to excavate sediment from Sugar Creek, which will decrease the amount of sediment in lower reaches of Sugar Creek, and decrease the sediment input from Sugar Creek into the South Platte. If sediment excavation is determined to be a desired solution, it is recommended that only the middle reach of ponds be used for sediment removal (see Page 2 of the Map Book). This recommendation leaves the downstream ponds functional, and leaves the upper ponds as-is to maintain the shallow, slow flow habitat where many trout fry were seen. If additional sediment trapping capacity is desired, the upper ponds, as identified in the Map Book, could also be excavated. Excavation of sediment would need to be done carefully to not destabilize the dam or the pond's banks.

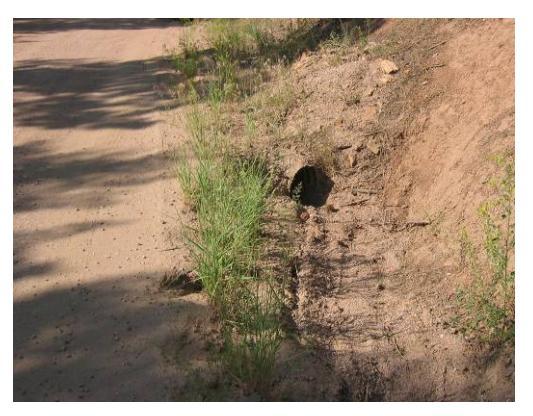
Many of the minor culverts have sedimentation ranging from 1 inch to 6 inches deep. A few of the culverts are 75-percent plugged. Many of the culverts appear to transport sediment from the hill-

side of the road to the creek side, and none of the culverts use inlets to trap the sediment. A few of the outlets trap sediment through use of vegetated swales and natural check dams.

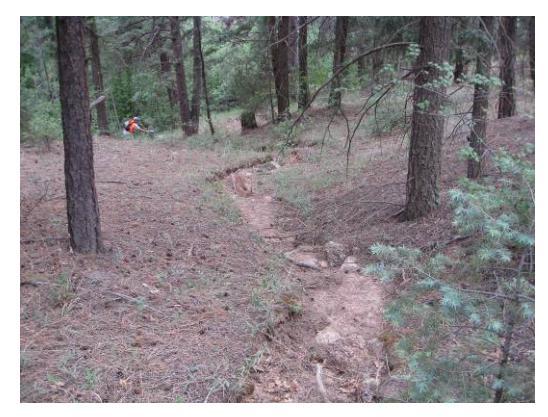
Loose sediment from the roadway or cut slopes is conveyed into roadside ditches and eventually into the cross culverts. This sediment is then carried through the culverts to the creek side of the roadway, or gets trapped and plugs the culvert. The flow is then discharged into the creek, onto the creek bank, or is conveyed down a rundown or swale to the creek. These rundowns are typically not stabilized with a hard surface, and rundown erosion is often present.

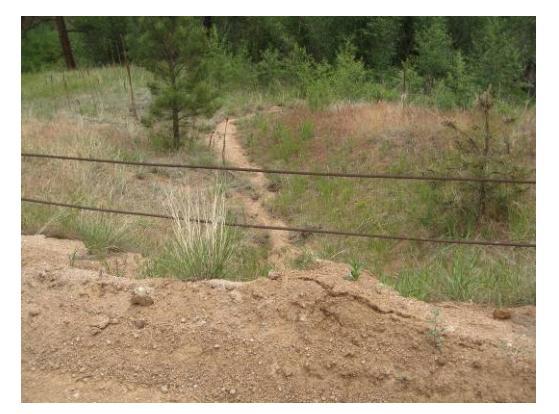
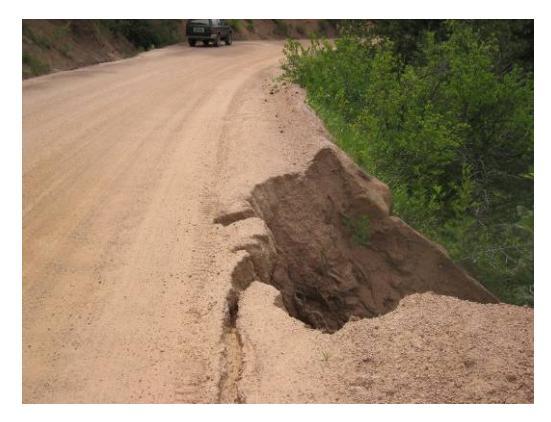
In some locations, roadway gravel berms have developed on the creek side of the road. These berms are the result of roadway grading operations where excess gravel has been pushed to one side. Many of the berms have failed after roadway runoff has collected along the berm without a location to appropriately discharge into the creek. Some of these failures are very substantial, with erosion cutting back into the travel lane, and a large amount of sediment flowing into the creek.

Douglas County noted that the gravel berm is not by design, and could removed. Removing the berms will allow sheet flow to be conveyed off the roadway, as opposed to allowing flow to concentrate and breach the roadside berm, thereby causing erosion.

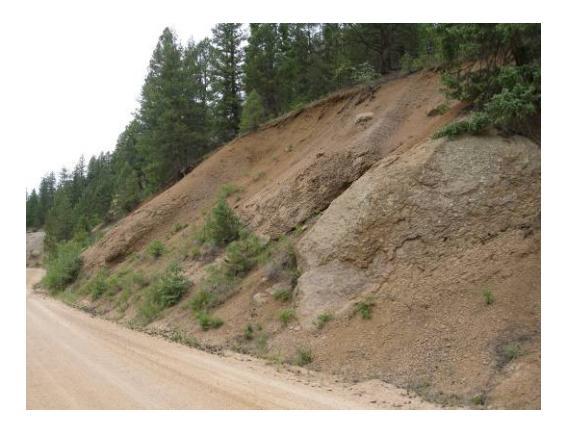
In general, the cut slope along the roadway has very low vegetation and a high tendency to erode into the roadside ditch. In some cases, the sediment will completely fill in the ditch, and ditch flow is forced onto the road. Thus, hillside sediment can be transported onto the road, which can then be transported across the road and into the creek.

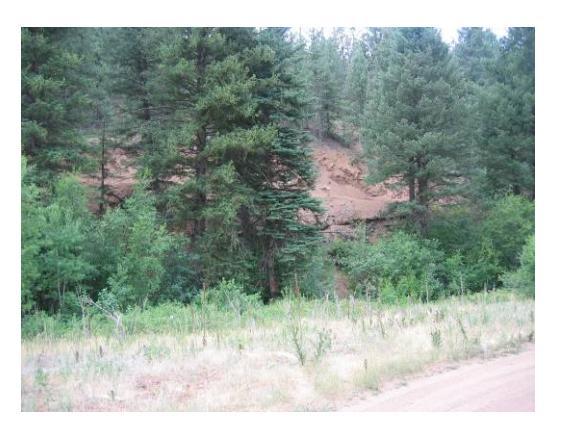
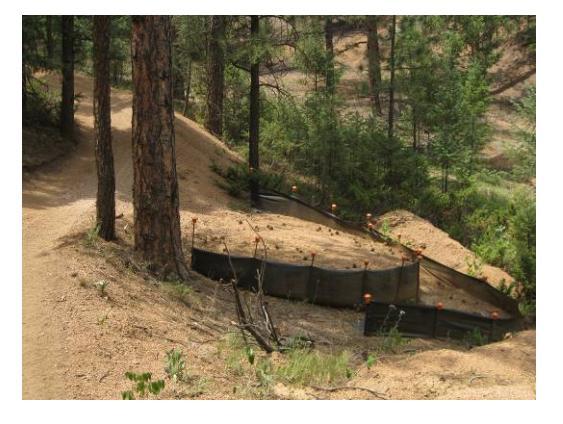
The OHV crossings of Sugar Creek have eroded deeply into the ground surface. The erosion has mobilized sediment which is being conveyed downhill by gravity, rainfall, and erosion. The USFS has a trail relocation plan underway to realign trails in order to minimize their impact on the creek. Depending on the timing of the trail relocation, stabilization of the trail crossings may be needed. Silt fence has been installed by Colorado State University to study the magnitude of the erosion (see photo). Additional stabilization measures could be considered, as shown in the Map Book.
