# Trail Creek Restoration

## Final Report

April 30, 2015

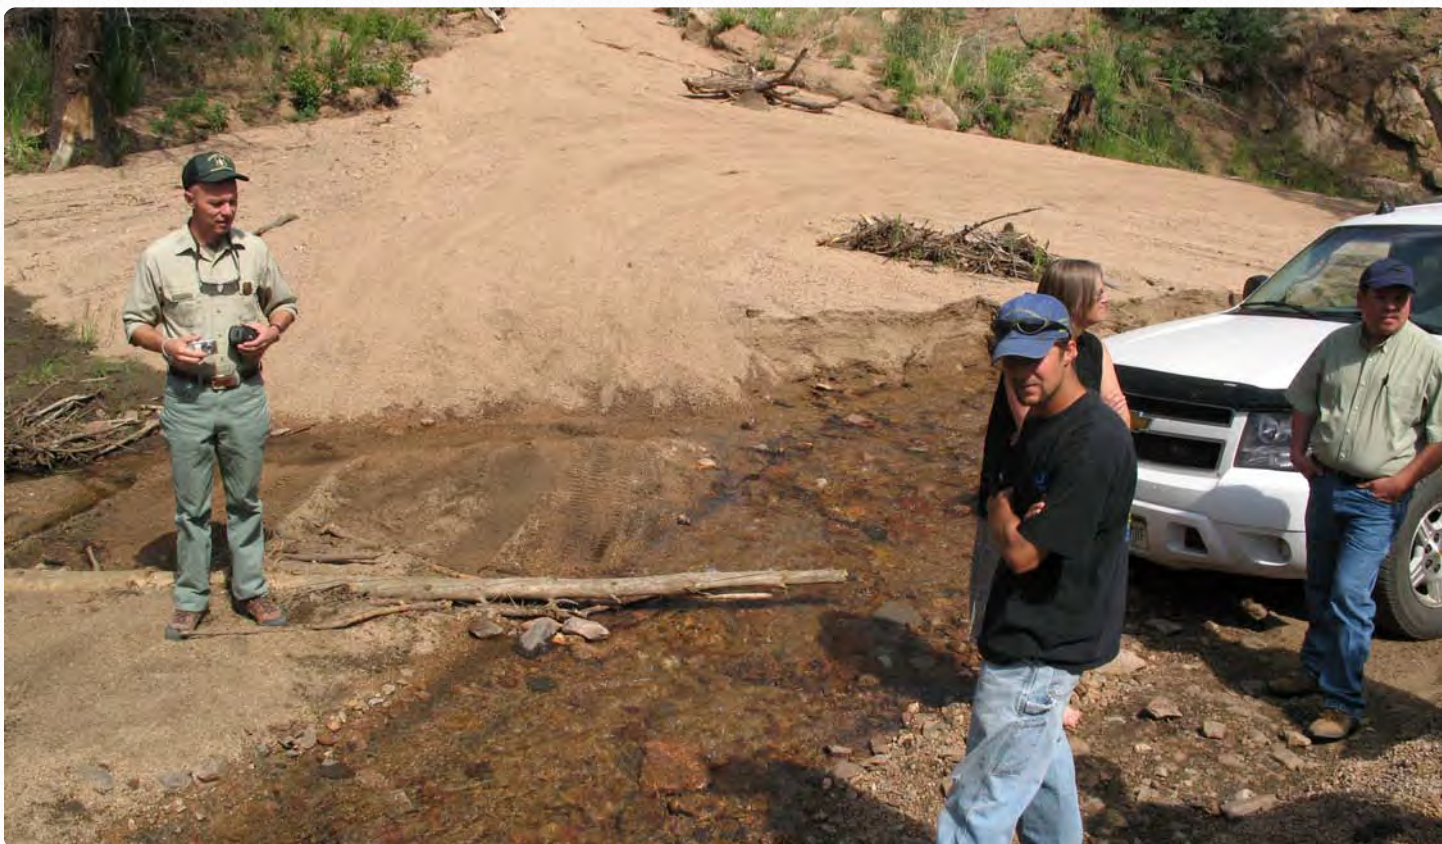
USFS, CUSP, and Teller County staff inspecting damage to Trail Creek Road, 2009

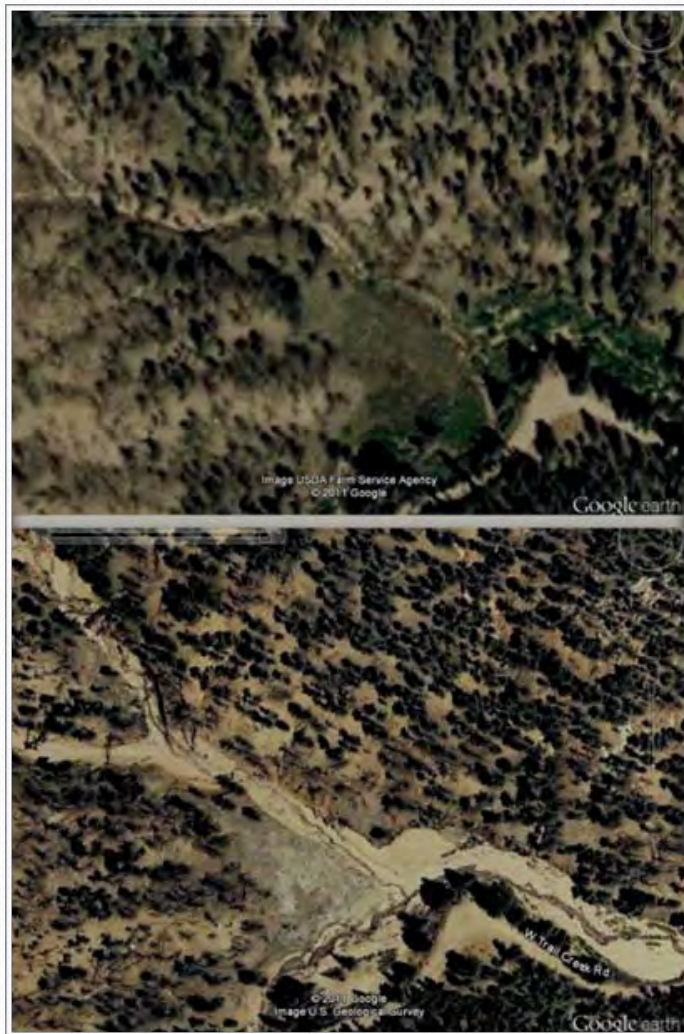
Trail Creek before the Hayman Fire (top)

Trail Creek after the Hayman Fire (bottom)

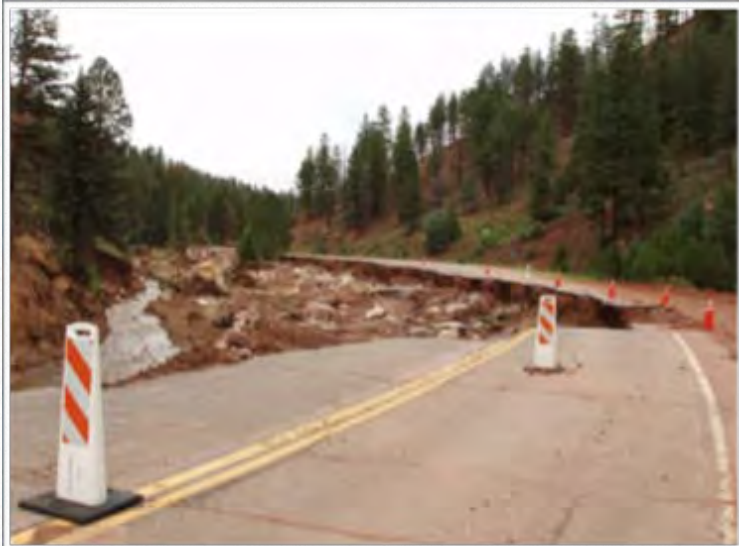
Highway 67 following post-fire flooding

This event caused all of the beaver ponds as well as a man-made pond to fail. This in turn caused the Trail Creek channel and riparian habitat to fail. Another storm event in July 2006 resulted in flood flows along West Creek exceeding 2,670 CFS, and destroying ~3 miles of State Highway 67. The highway remained closed for three months as the state repaired it.

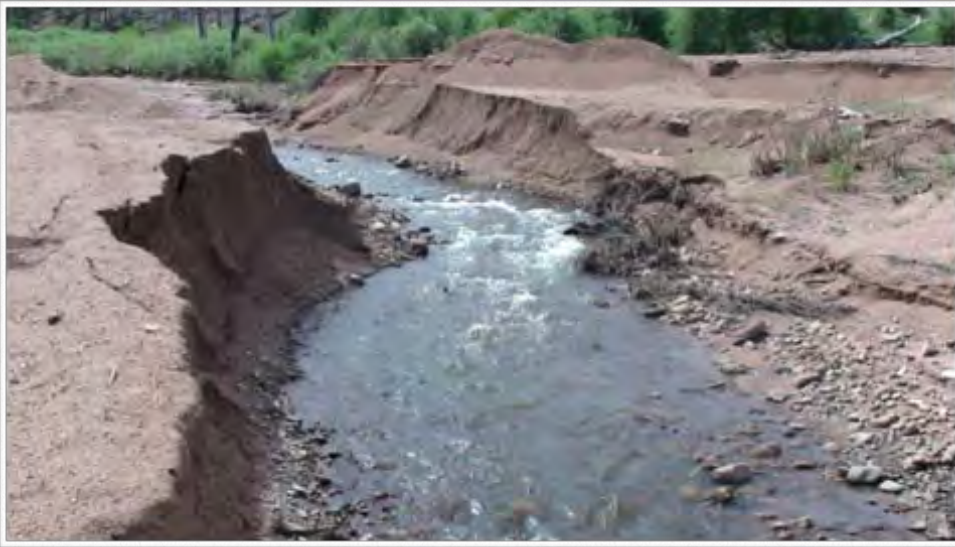
Channel degradation and streambank erosion in Horse Creek

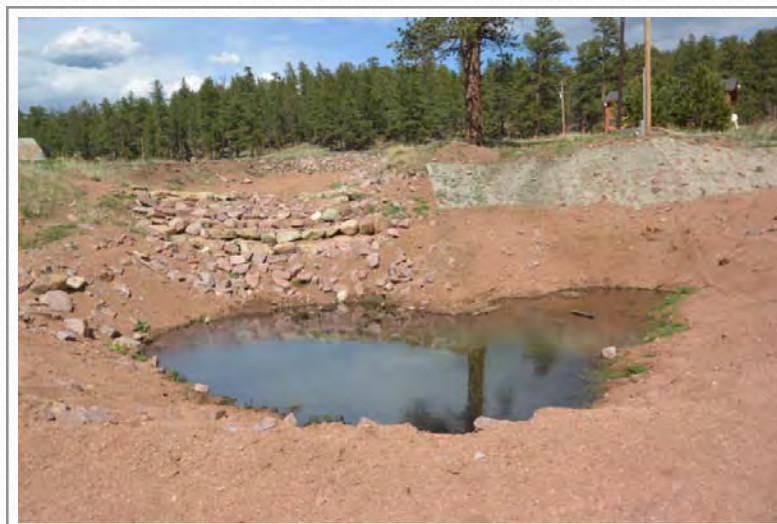
Sediment detention pond and drop structure at the downstream boundary of West Creek Ephemeral Draw #1

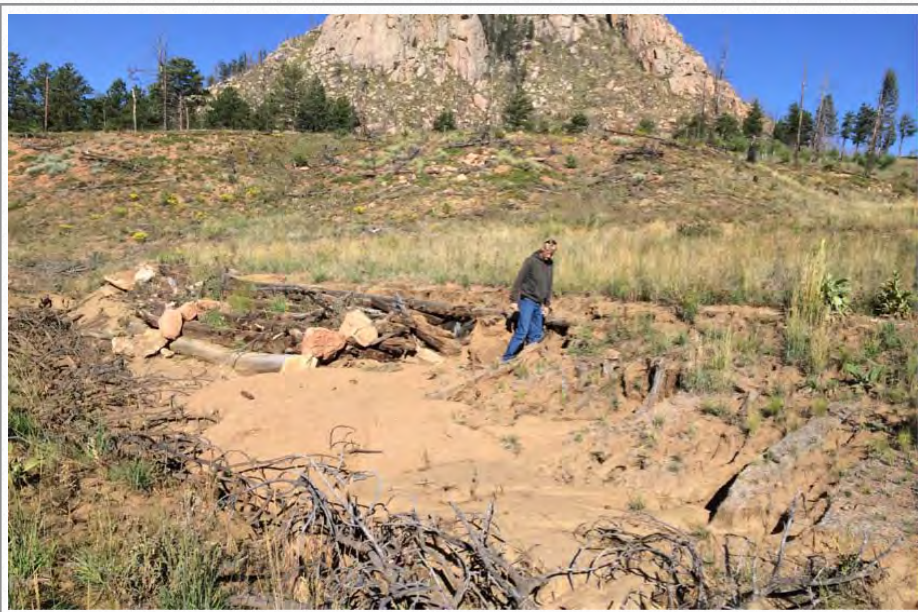
Partially filled sediment detention basin following August 2014 rain event

Restoration work at this site focused on re-establishing the function of the alluvial fan upstream of the road. Four large sediment detention basins were dug across the fan perpendicular to the direction of flow to provide the material necessary to completely fill the 20 foot wide and six foot deep F4b channel that had cut through the feature. Log sills were installed on the upstream and downstream edges of the basins to prevent the formation of new head-cuts. In addition to the sills, log cribbing, backed by geo-textile fabric, was used on the upstream edge of each basin to ensure that the elevation of the re-contoured alluvial fan upstream was maintained. A smaller incised channel was also filled on the eastern edge of the fan, and log-sills were utilized at intervals of 20 – 30 feet throughout the re-contoured fan to maintain grade. Log sills were also installed at the top of the cut slope along Stump Road to prevent head-cutting of any surface flows reaching the steeper cut slopes. To address the possibility of flows filling all of the basins, a log “Rock & Roll” B channel was constructed between the last basin and the Stump Road inboard ditch, immediately upstream of the culvert

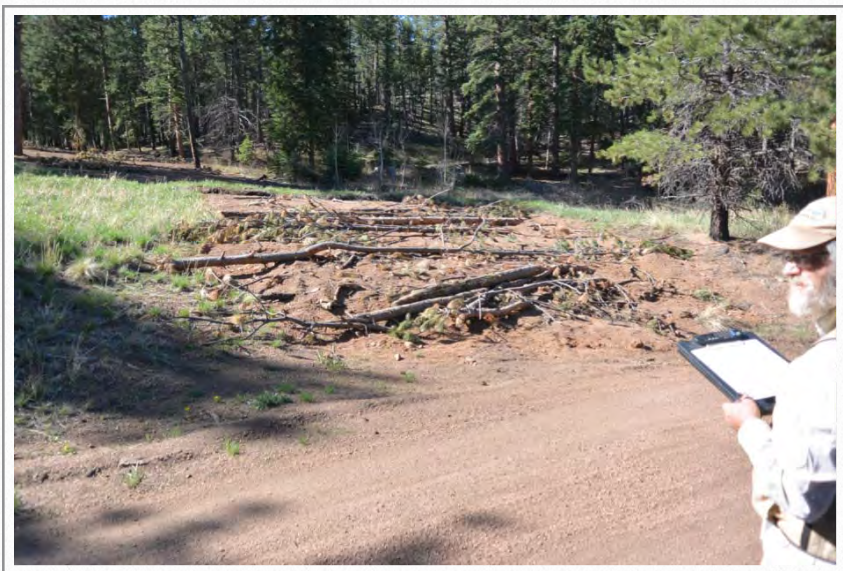
An F channel cutting through the fan in Basin #1 is filled, re-contoured, silled, and covered in slash.

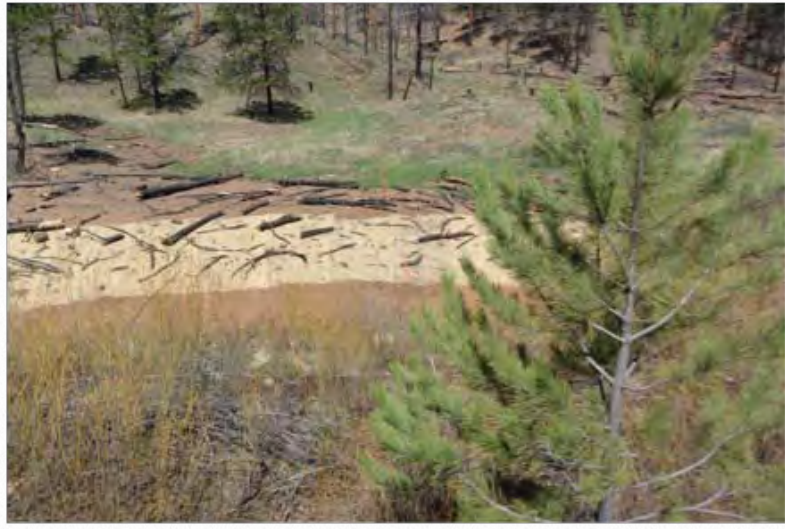
Treated fan toe and filled incised channel at Trail Creek Draw #7, adjacent to Reach 3

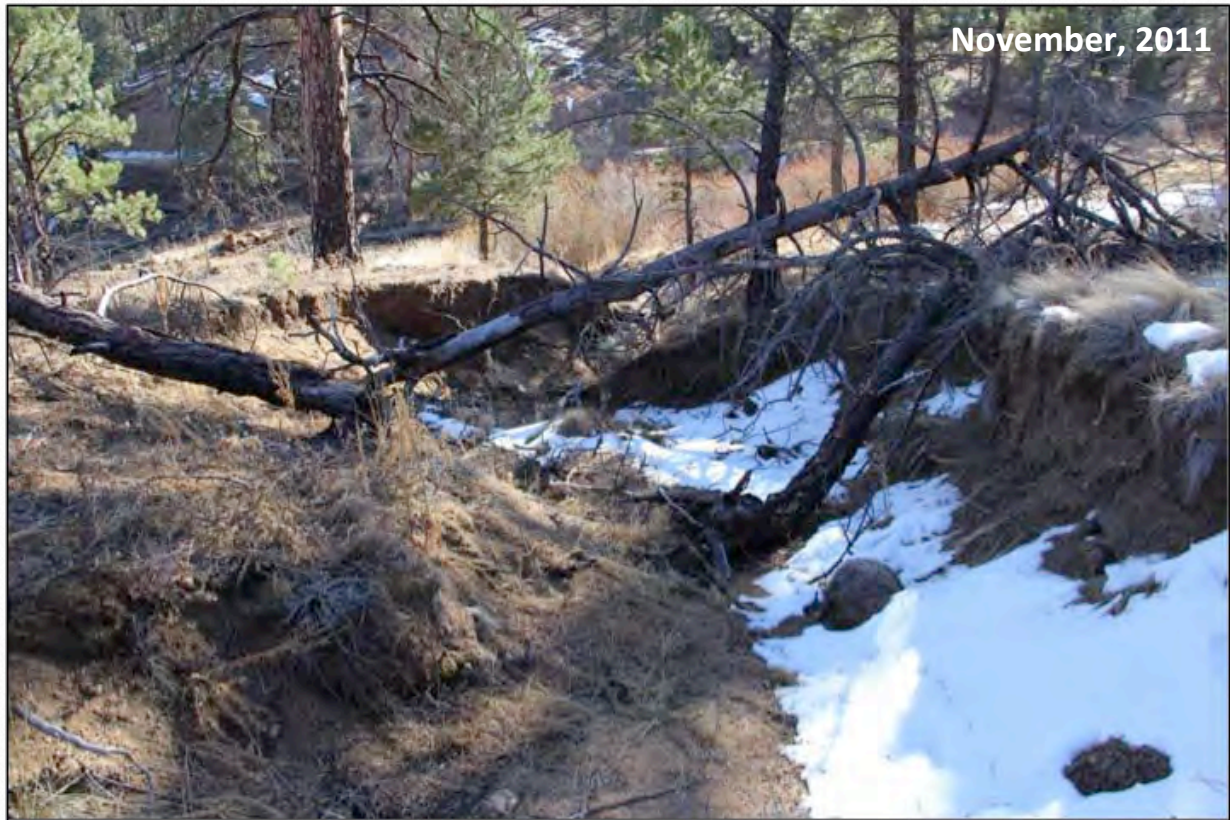
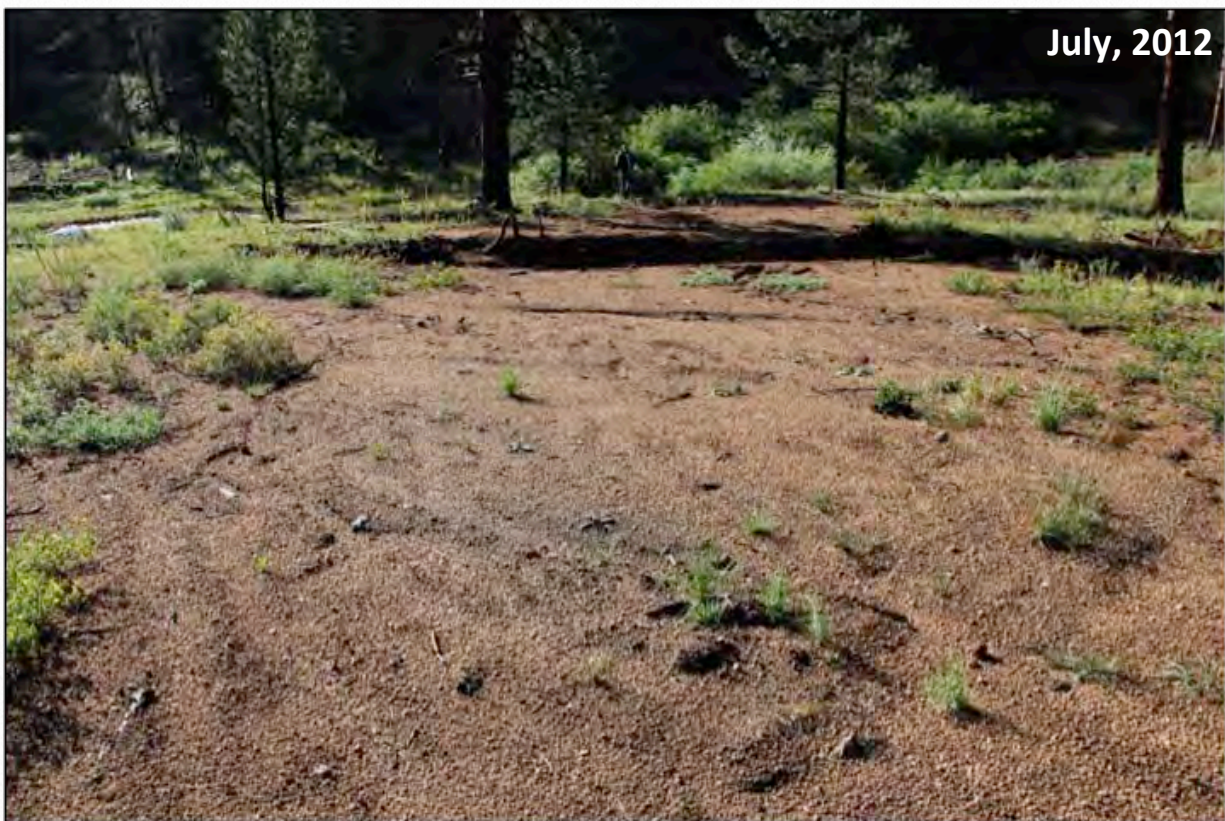
Before vs. After comparison of restoration showing an eroding bank at previous location of the incised channel of Trail Creek against an alluvial fan that was converted to an oxbow lake; Trail Creek was relocated away from the fan and reconnected to its floodplain (restoration implemented in July, 2012).
