Aquatic Habitat Assessment & Enhancement Plan Tarryall Creek - Landis Ranch Park County, Colorado

FIN-UP Habitat Consultants, Inc.

August 2015

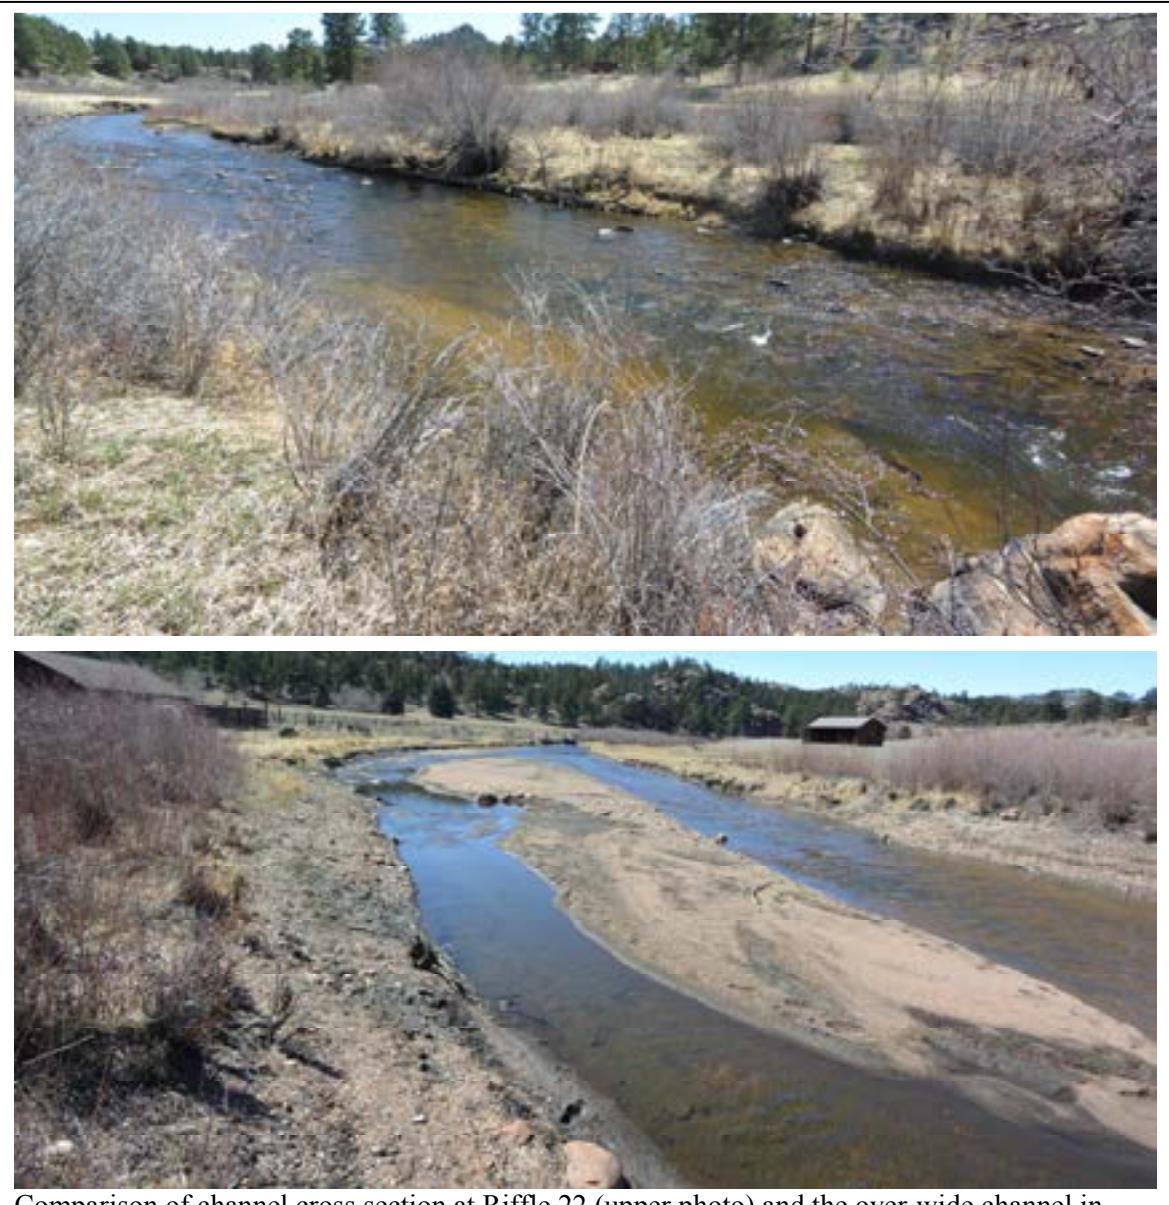
The chart below shows a comparison of channel cross sections through riffles in the study reach. The upper chart shows a typical channel cross section through Riffle 22. The lower chart shows the over-wide cross section through Riffle 5, upstream of the lower diversion structure. Width/depth ratios along this segment of the river were more than 2 times greater than in the other segments in the river, and appeared to be the result of river over-widening caused by the diversion structure itself.

Comparison of channel cross section at Riffle 22 (upper photo) and the over-wide channel in Riffle 5, upstream of the lower diversion structure in the lower segment of the study reach on Tarryall Creek within the Landis Ranch.

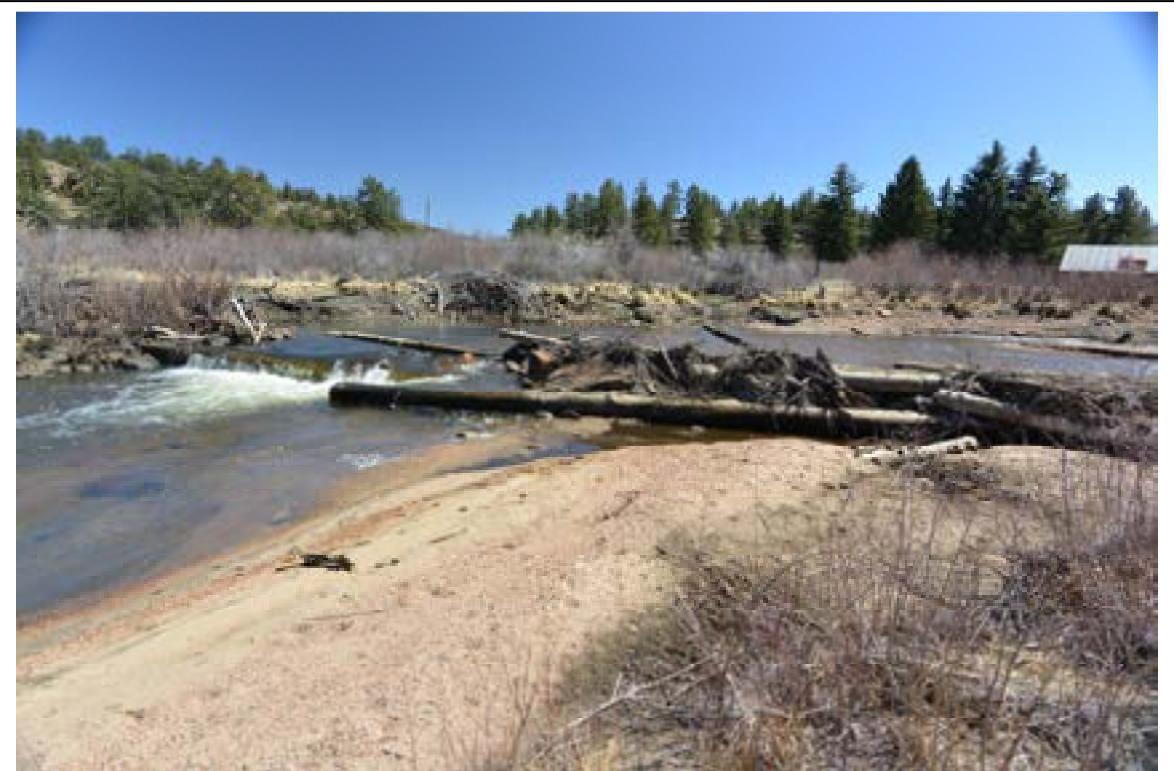
The failed lower diversion structure between Pool 3 & Glide 1, in the lower segment of the study reach on Tarryall Creek within the Landis Ranch.

We identified the two irrigation diversion structures as the most significant threat to the long term health of the river in the study reach. The lower structure, which has mostly failed, has resulted in significant over-widening of the river channel for several hundred feet upstream. Subsequent deposition of sediment and further weakening of adjacent

Priority #1: Lower Diversion Structure Reconstruction & Channel Realignment.

The lower diversion structure, also known as the Coors Diversion, will need to be reconstructed before the beginning of the next irrigation season. At present, if the structure is replaced with a similar structure at the same diversion point, the channel upstream will continue to aggrade and over-widen. The rebuilt structure will continue to function at great risk of failure due to lateral migration of the channel on the north side of the feature, and will continue to require regular maintenance. There is an opportunity here that will soon close to relocate the diversion structure 140 feet upstream, at a location that is considerably less susceptible to lateral migration. A large boulder crossvane would be constructed at this new diversion point, maintaining a stage at the head gate to provide 11 cfs to the diversion point at base flows. A 24" Waterman C-10 head gate will be installed upstream of the south leg of the structure where it ties into the river bank. The head gate will be attached to 24" HDPE smooth wall plastic pipe, which will convey diverted flow to the existing ditch at the original diversion point. A second boulder cross vane will be constructed immediately downstream of the existing diversion point to provide a grade control, and to limit the hydraulic jump of the diversion to less than 18", enhancing aquatic organism passage through the diversion point. We have made a preliminary inquiry with the Colorado Division of Water Resources, and have confirmed that we may move the diversion point up to 200 feet without necessitating a re-adjudication of the water right.

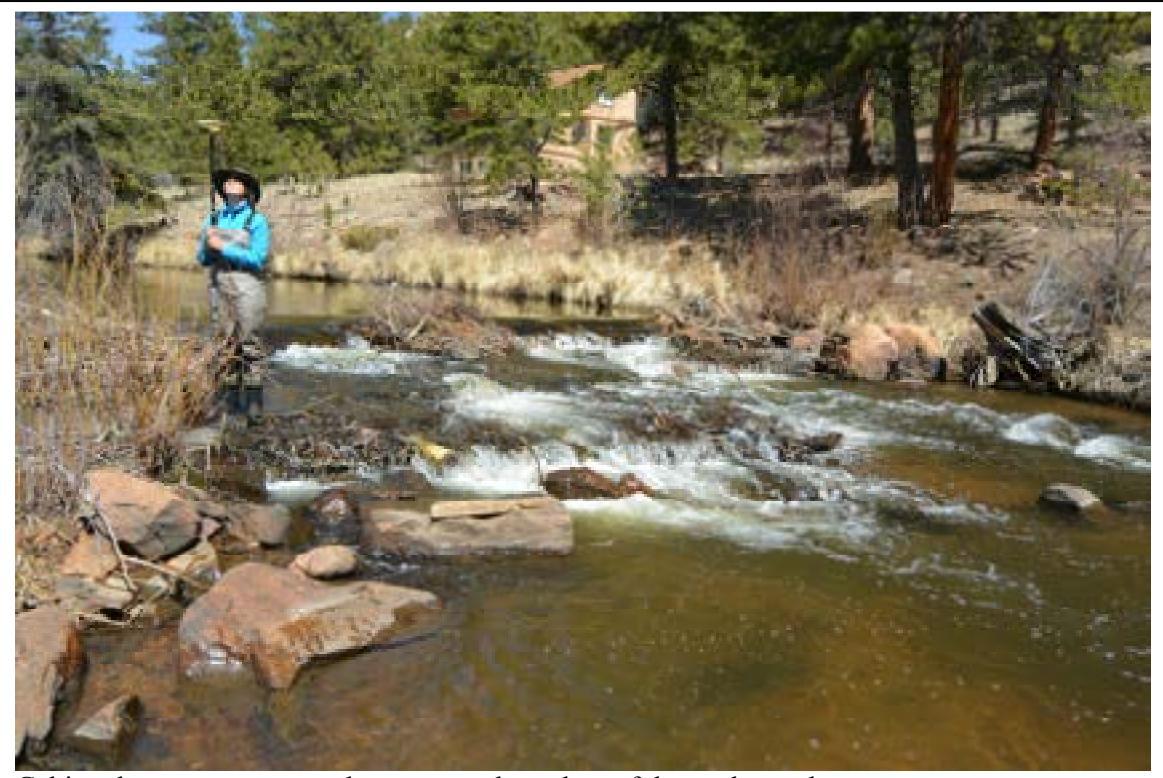
Gabion drop structure near the upstream boundary of the study reach.

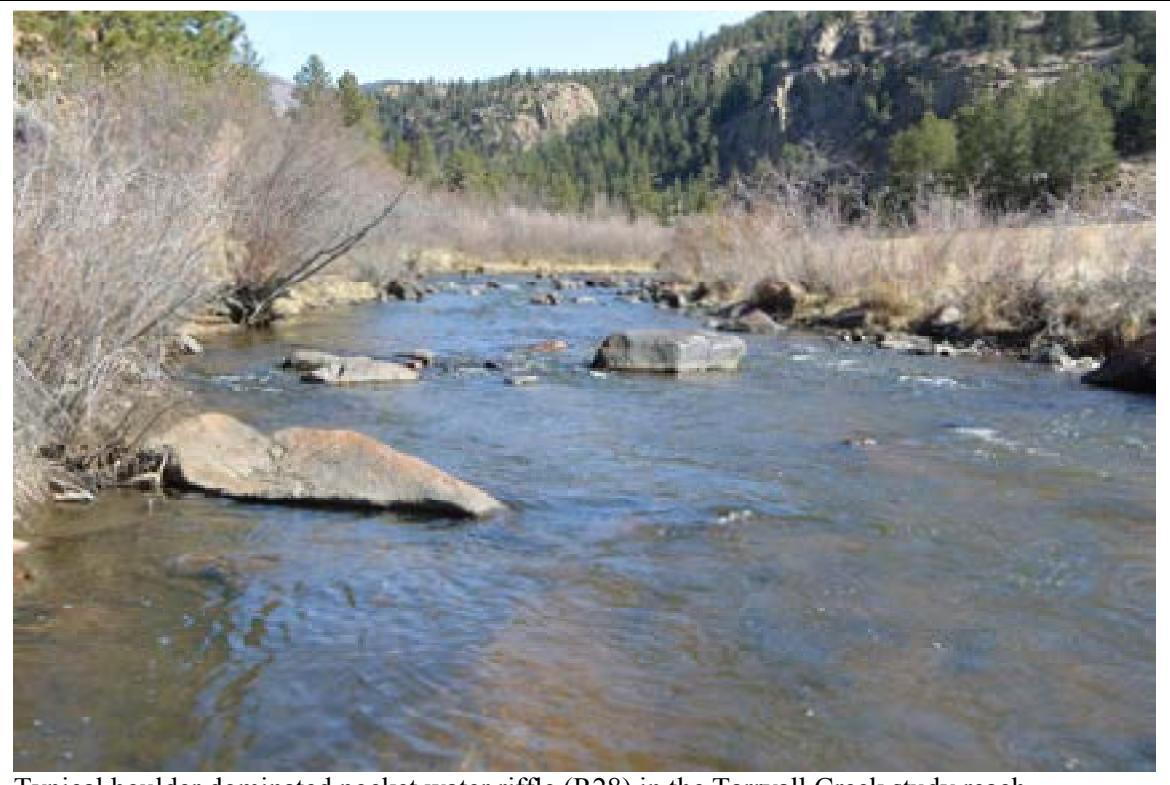
Typical boulder dominated pocket water riffle (R28) in the Tarryall Creek study reach.

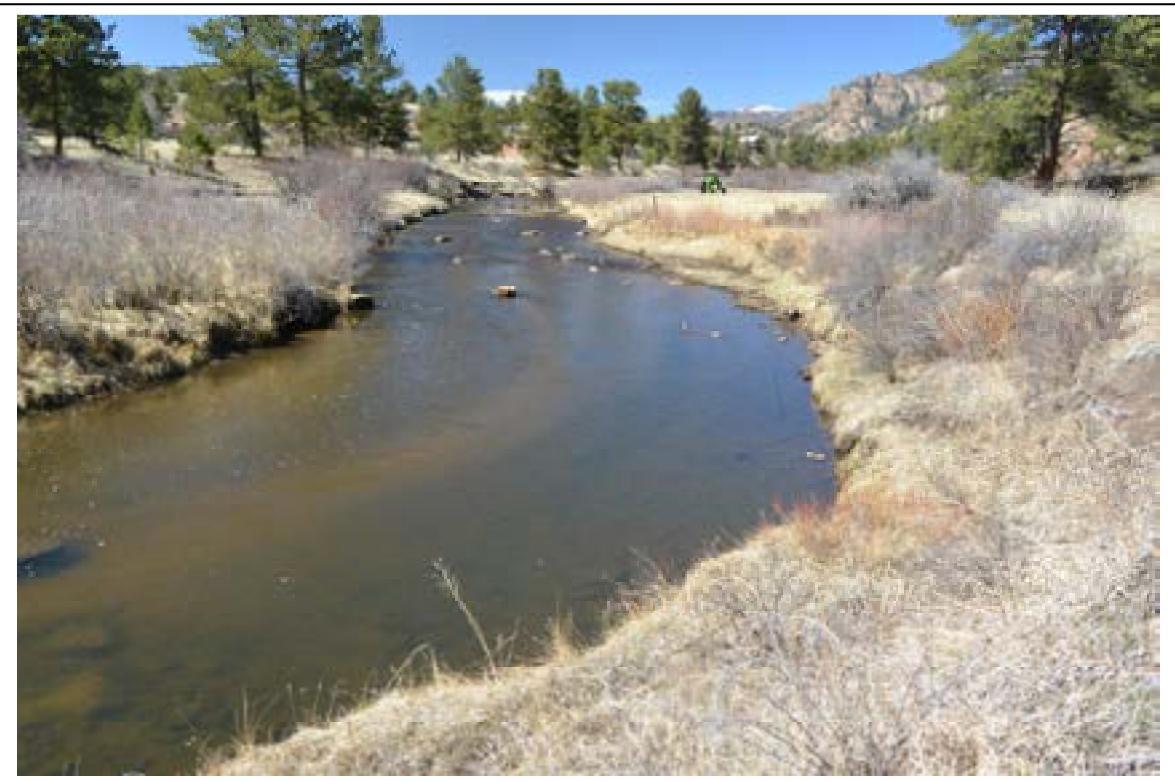
Most of the pools in Reach 1 exhibited some in-filling of sediment, mostly consisting of smaller particles of decomposed granite. The average pool depth in Reach 1 was 1.56 feet. Residual pool depth (RPD) in Reach 1 was found to range from 0.3 to 2.4 feet, with an average of 1.12 foot throughout the reach. Maximum pool depths ranged from 1.7 to 3.9 feet, with the average maximum depth found to be 2.4 foot. Residual pool depth (RPD) in Reach 1 was considered to only fair, but is likely adequate to provide overwintering habitat for salmonids in this segment of Tarryall Creek. Cover for trout accounted for slightly less than 20% of the total wetted area of the pools, and was considered fair for a stream of this size.

Sediment deposition observed in Pool 12 within the Tarryall Creek study reach.

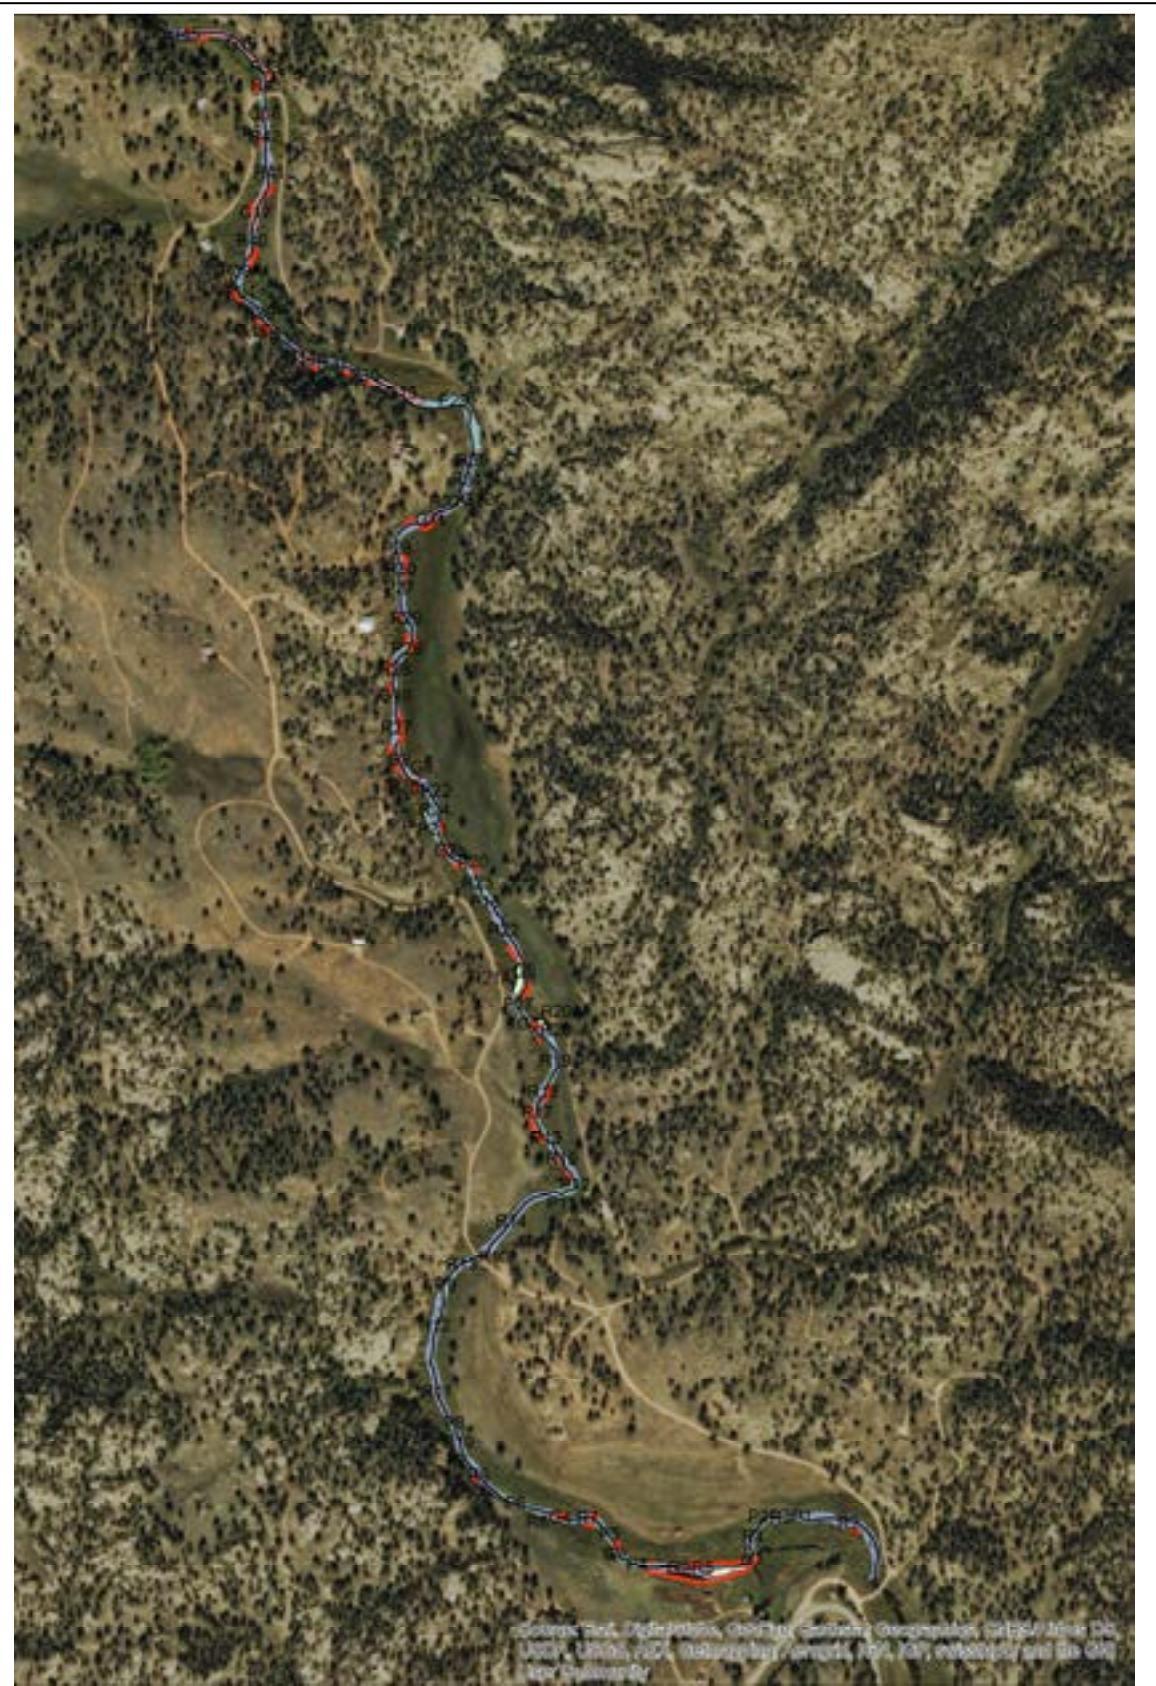
Map 5: Locations of active eroding banks on the Landis Ranch study reach. Red lines indicate areas of active bank erosion and collapse.

Active stream bank erosion in the study reach was a concern, comprising more than 15% of the total river bank length in the reach. Actively eroding banks in the reach were typically associated with areas where hay production is occurring immediately adjacent to the river, as well as in segments upstream and downstream of the lower diversion structure. Smaller lengths of active stream bank erosion occur throughout the reach, and a plot of these areas is shown in Map 5 on the previous page.

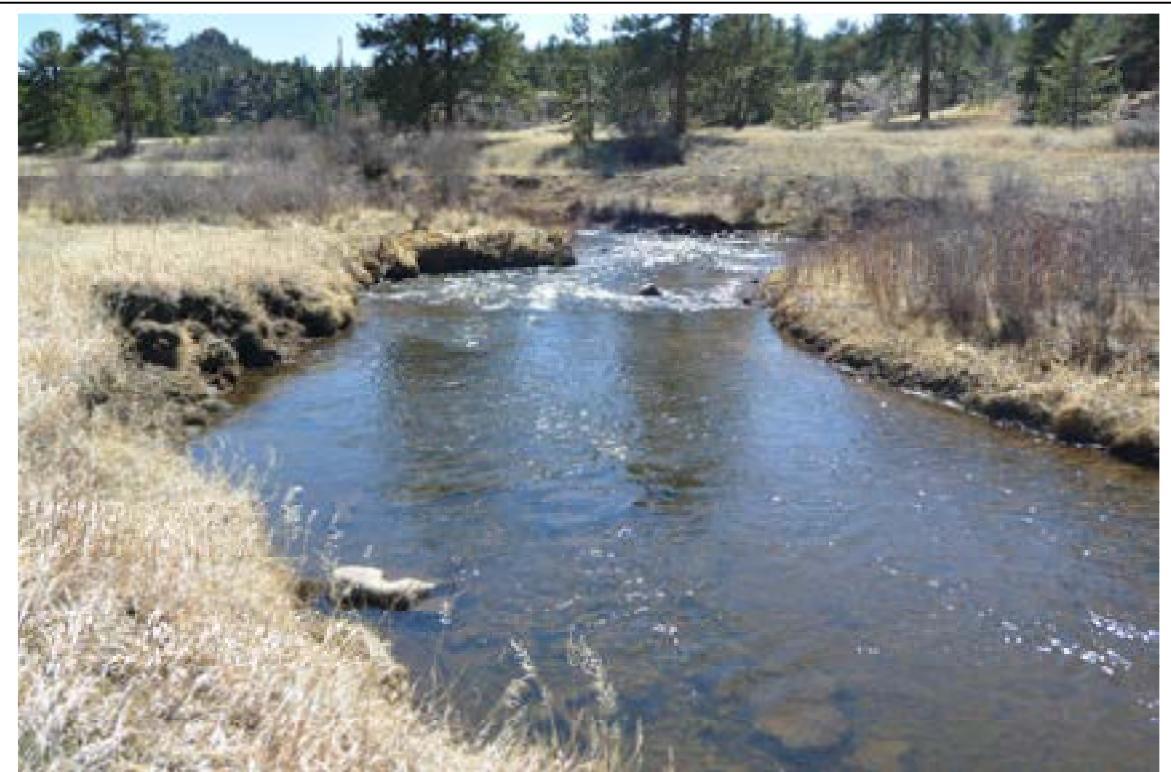
Eroding river banks observed along Riffle 21&Glide 6 in the Tarryall Creek study reach.

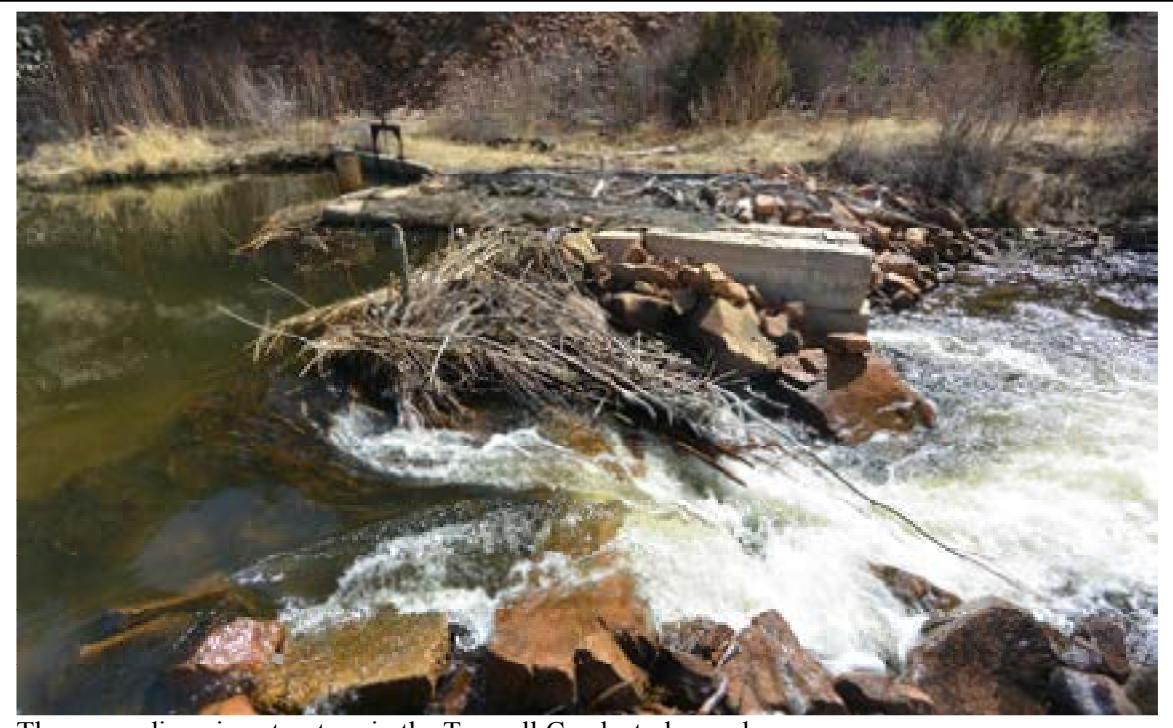
The upper diversion structure in the Tarryall Creek study reach.

stream banks is continuing to make this situation worse. The upper diversion structure, while structurally sound, is a significant barrier to aquatic organism passage, and effectively splits the upstream and downstream halves of the reach into two separate and isolated ecosystems. Reconstruction of these structures to allow for fish passage, sediment transport, and restoration of river dimension, pattern and profile will substantially benefit the overall health of the river within this reach.

The upper diversion structure is a significant barrier to fish migration, and is also at risk of failure over the long term due to the materials used in construction. The diversion drop structure consists of a series of wire gabion baskets stacked in the river channel perpendicular to the direction of flow, with a head gate and narrow sand-out channel on the northeast side of the structure. Gabion baskets for river control structures are notorious for failure due to corrosion of the containment wire, and are occasionally referred to as "time-release landslides", due in part to their short lifespan and high rate of failure. While frequently utilized in the past as a cost savings measure, or where adequate large rock was unavailable, these structures are generally not recommended any more for long term use in perennial rivers and streams.

The upper diversion structure may have already partially failed in the center, but the greatly accelerated flow through the center of the feature precluded a closer inspection. The longitudinal profile survey indicated that the feature has a hydraulic jump elevation of nearly 4 feet, with only a shallow and small pool feature below, severely limiting maximum burst velocity for fish attempting passage through the structure. The structure also presents a safety hazard for fishermen or other river recreationists in the large pool immediately upstream, who might be swept through the structure during high flows.

The priority #2 project would remove the existing structure, and replace it with a series of boulder cross vanes interlinked with each other to create a step pool cascade. The step pool cascade would tie together the existing channel slope above and below the diversion point while creating a "fish ladder" of sorts to allow for aquatic organism passage. The structure would begin approximately 75 feet downstream of the existing diversion, allowing the existing diversion point to be maintained. A considerable quantity of large boulders, of specific size and shape, will be required to successfully complete the new diversion, and we recommend that rock be imported from a nearby commercial quarry to ensure that properly sized materials are available for the work. We estimate it would take approximately 3 days to complete at a cost of \$40,250.00. Timeline for construction would be the fall of 2016.

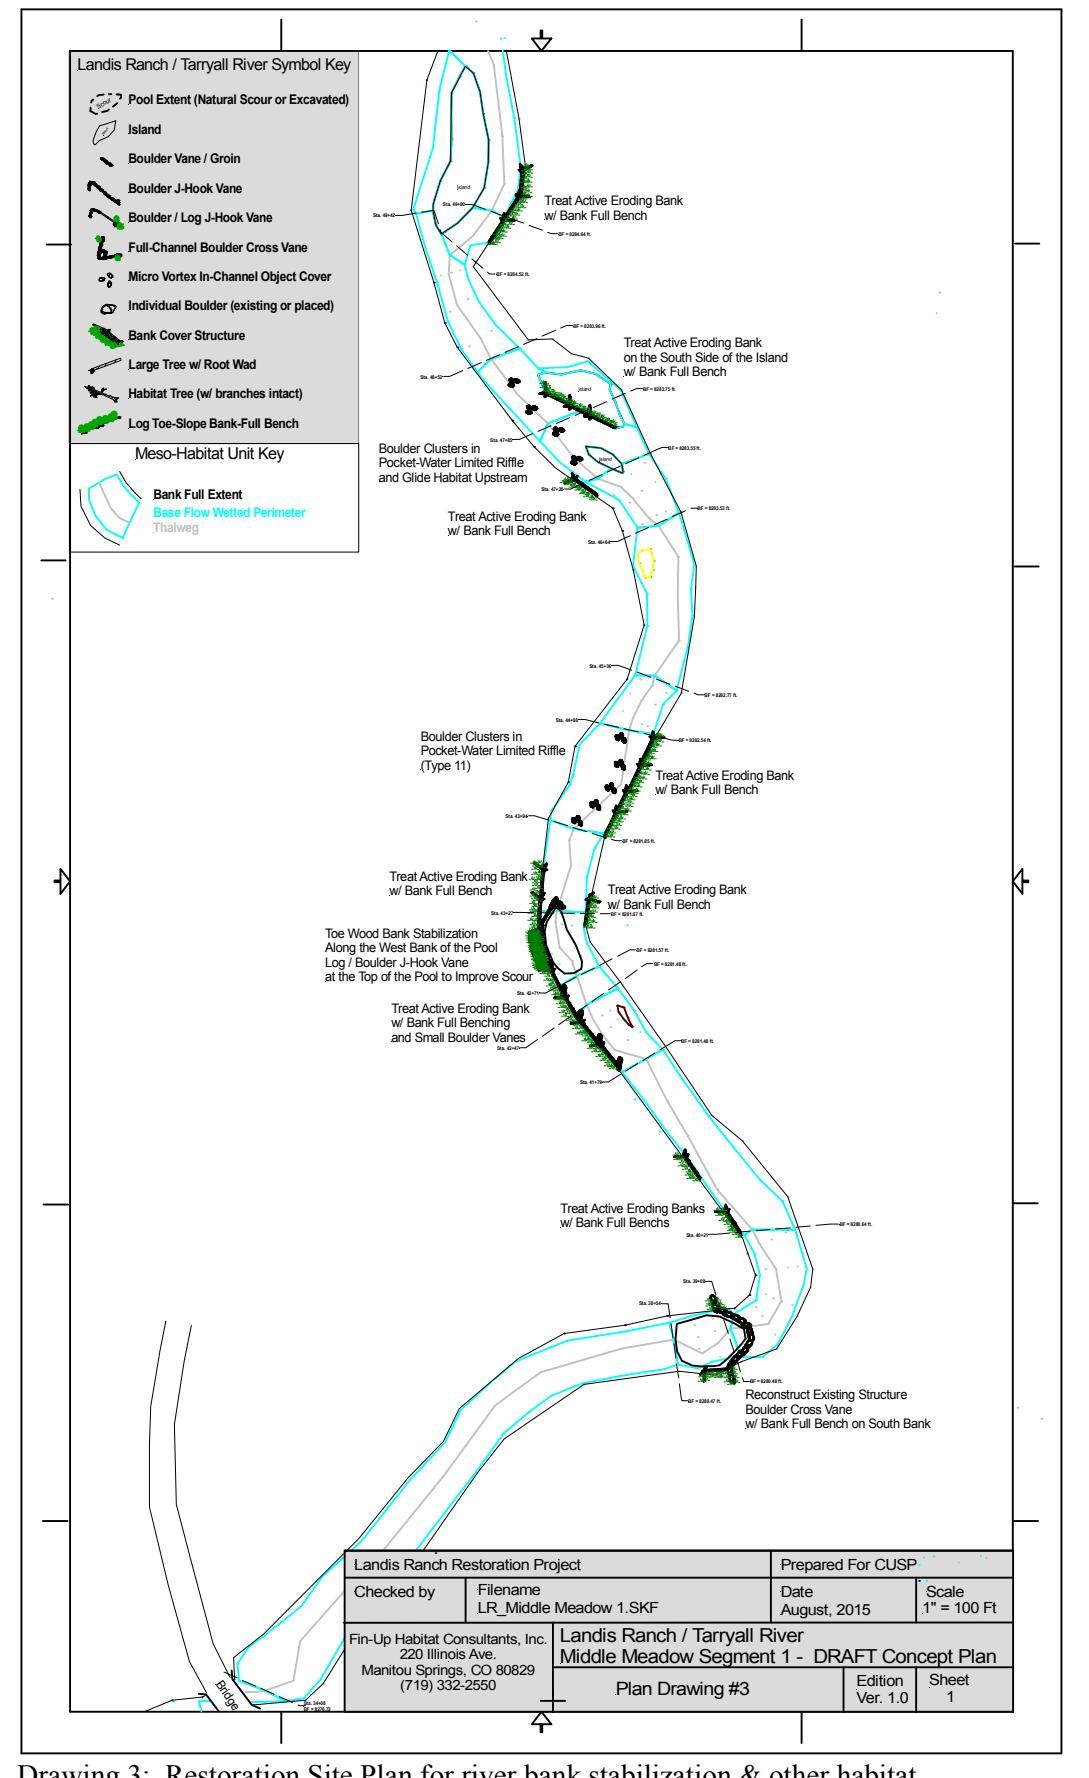
Drawing 3: Restoration Site Plan for river bank stabilization & other habitat enhancements in the middle segment of the study reach (Priority #3) and existing drop structure replacement (Priority #4).

The 3rd priority project should address the actively eroding and unstable river banks immediately adjacent to the hay meadows in the middle of the study reach. This segment would extend from the 2nd bridge across Tarryall Creek upstream to the 2nd diversion structure. Extensive bank full benching, utilizing large wood for toe slope armoring and native willow/sedge mat transplants harvested within the project area, will be constructed in this segment. Where appropriate, toe wood will be utilized in lieu of bank full benching to create deep pool habitat and complexity. In addition to the river bank mechanical treatments, extensive hand planting of willow can be accomplished by HOA volunteers under the direction of CUSP project staff.

Generally, we prefer to enter a segment of the river only once, and complete all recommended treatments and objectives, as this does less damage to the stream bed/banks, and adjacent riparian areas. In the case of priority project #3, we strongly recommend that the in-channel habitat features and enhancements be completed in conjunction with bank stabilization work. Two log/boulder J-Hook vanes, one boulder J-Hook Vane, 1 double log cross vane and up to twenty-five boulder clusters will be installed to increase holding areas and cover within the segment. The additional cost of building the habitat enhancements concurrent with the bank stabilization will be minimal, as most of the materials are available on site, and it will significantly reduce the recovery time of affected vegetation following construction. Drawings of the proposed restoration in priority #3 are provided in Drawings #3 & #4 on the next page and Drawing #5 on the previous page. High resolution drawings may also be found in the appendices to this document.
