Roads to Rivers Assessment Eleven Mile Canyon, Happy Meadows, and Sportsmen's Paradise Roads

September 2015

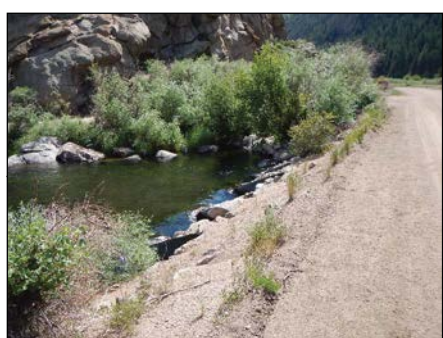
Photo 1
Approach to Bridge #1

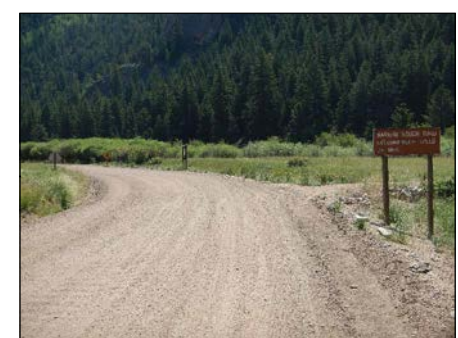
Photo 2
Typical Roadway Section

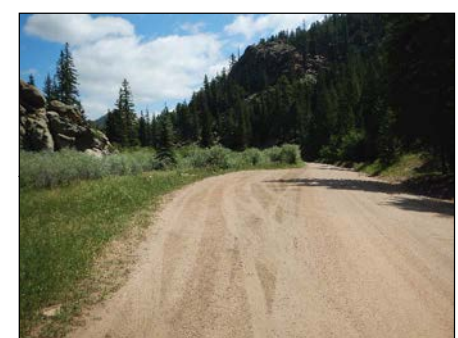
Photo 3
Typical Pullout Area

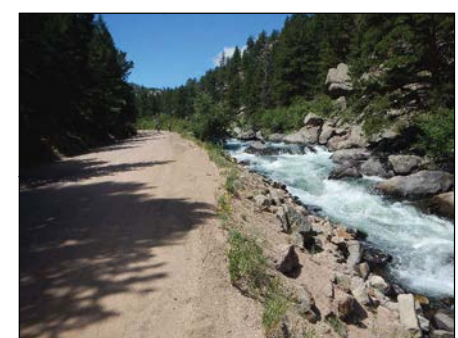
Photo 3
Steep Slope to River

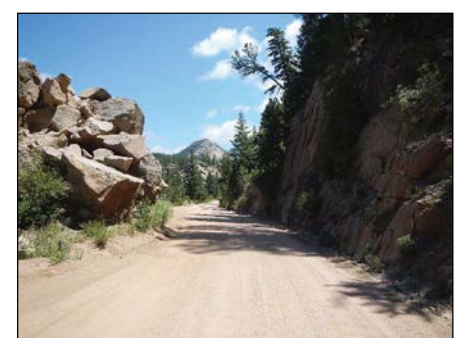
Photo 4
Narrow Rock Cut Section

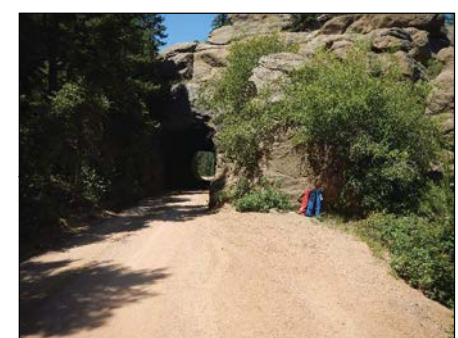
Photo 3
Approach to Tunnel, Pullout

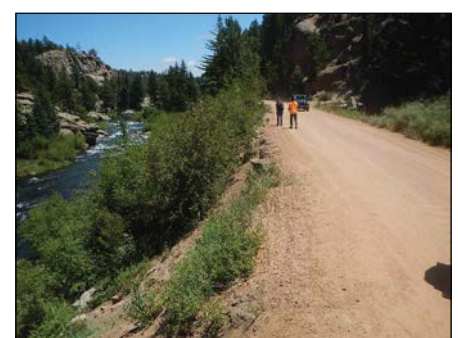
Photo 5
Steep Slope to River

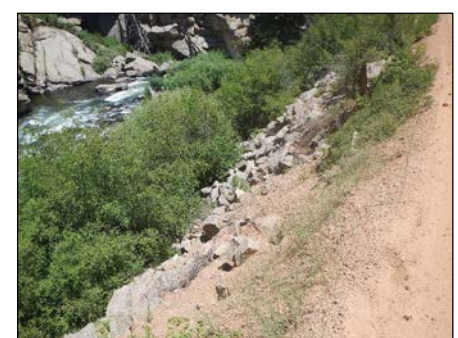
Photo 4
Steep Slope to River

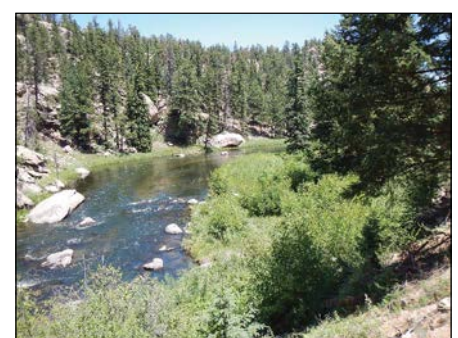
Photo 5
Wide Vegetated Buffer at Meander

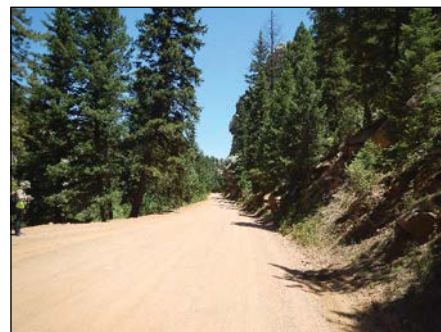
Photo 2
Wider Roadway Section

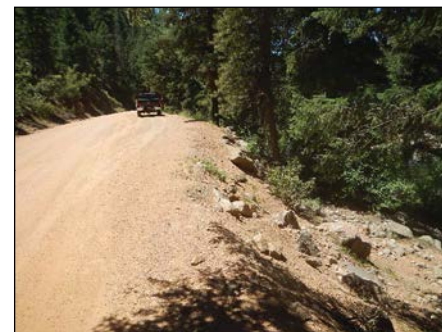
Photo 4
Limited Vegetation on Slope

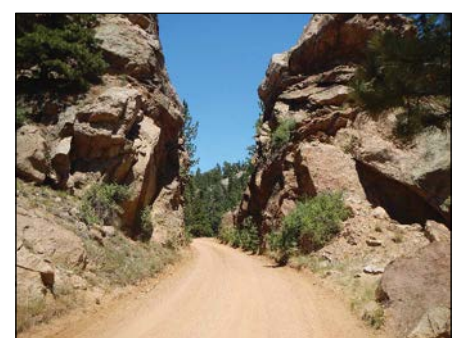
Photo 5
Large Rock Cut near Curve

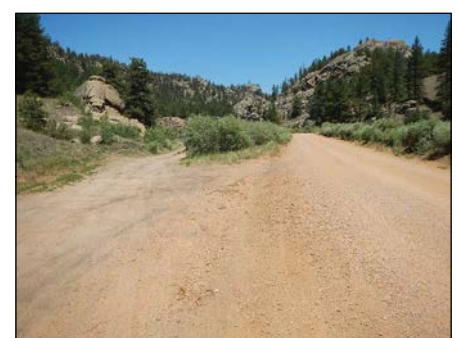
Photo 5
Approach to Road Intersection

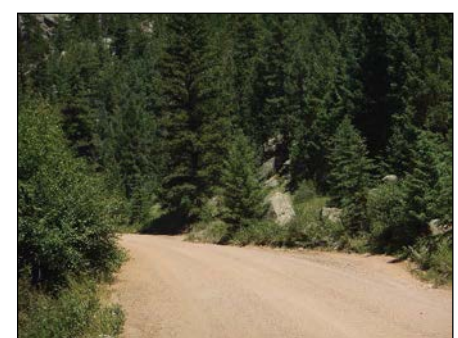
Photo 3
Limited Buffer Next to River

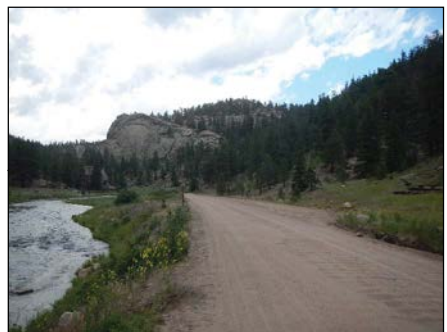
Photo 2
Pedestrian Rundown to River

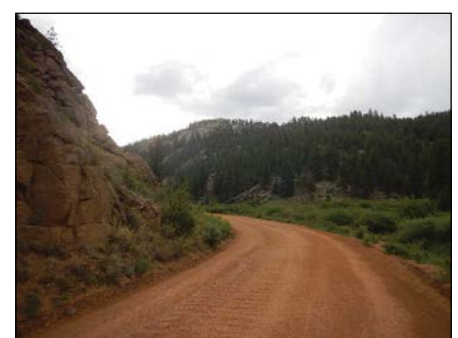
Photo 5
Typical Rock Cut Near Curve

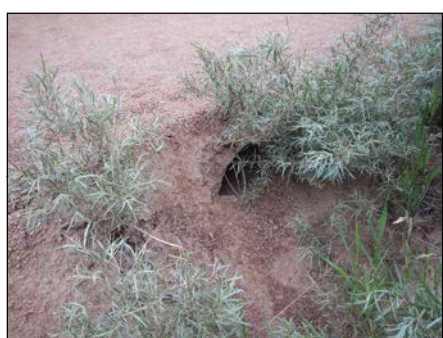
Photo 1
Culvert Blocked with Sediment

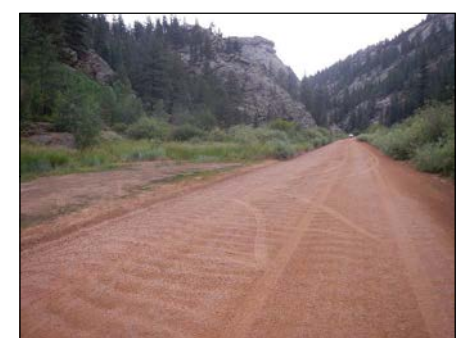
Photo 2
Typical Washboard Surface

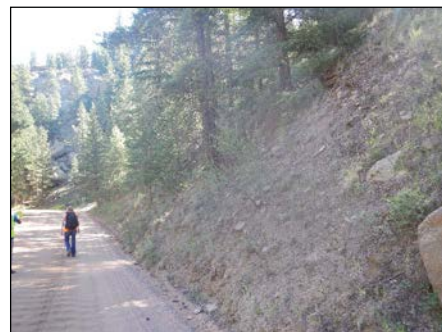
Photo 4
Typical Loose Cut Slope

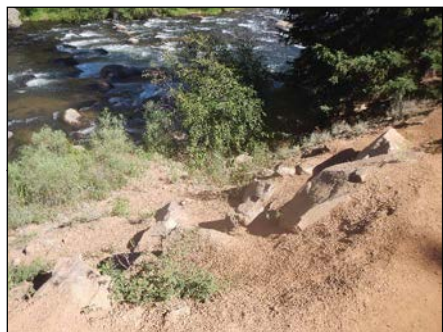
Photo 1
Pedestrian Access Location

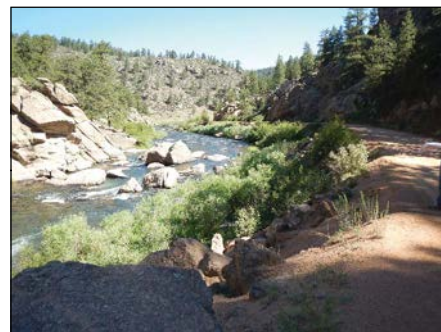
Photo 2
Typical Road Shoulder Drop

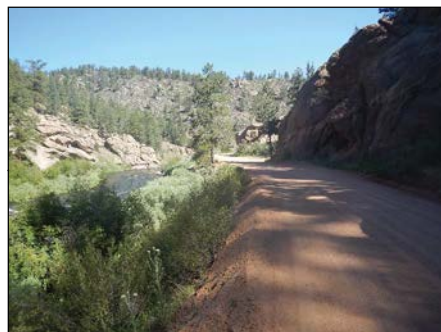
Photo 3
Typical Road Shoulder Drop

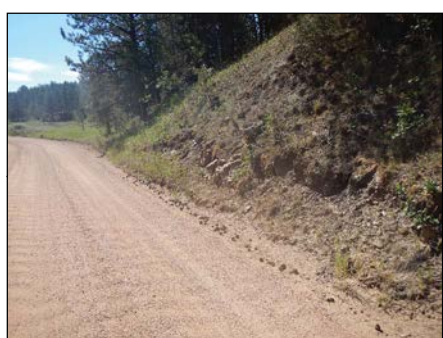
Photo 1
Typical Cut Slope

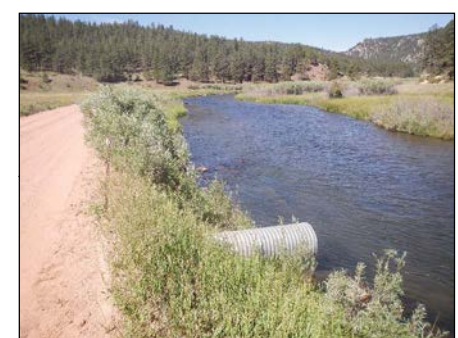
Photo 3
Culvert Outlet to River

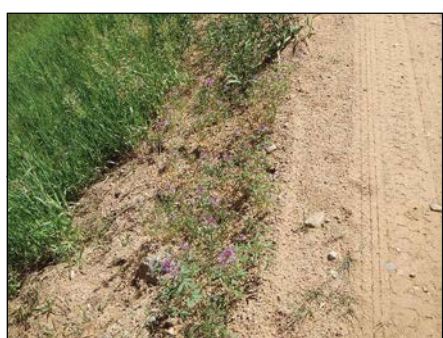
Photo 1
Shoulder with Loose Sediment

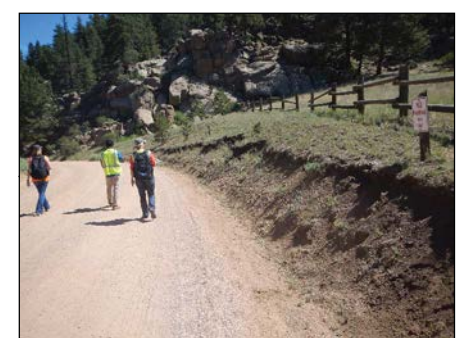
Photo 3
Cut Slope Near Campground

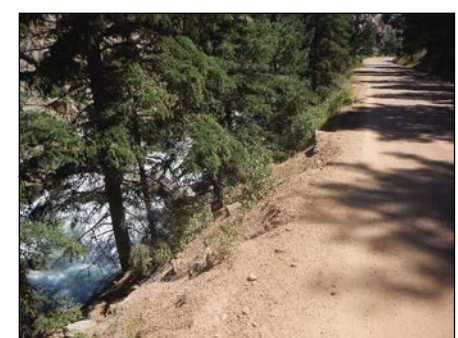
Photo 3
Limited Vegetation on Slope

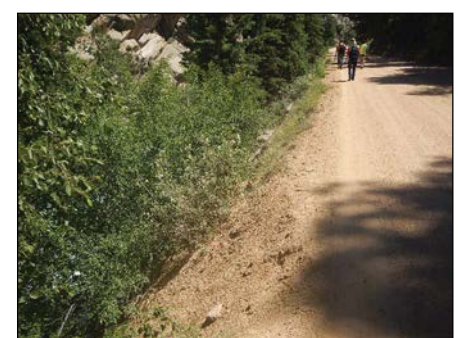
Photo 4
Steep Slope to River

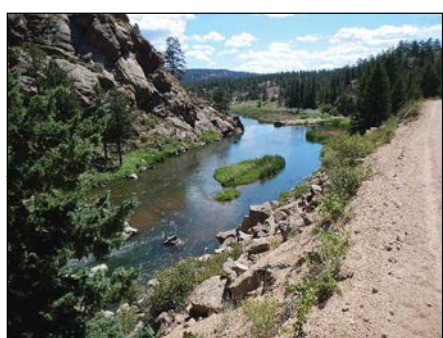
Photo 1
Banks Too Steep to Support Vegetation

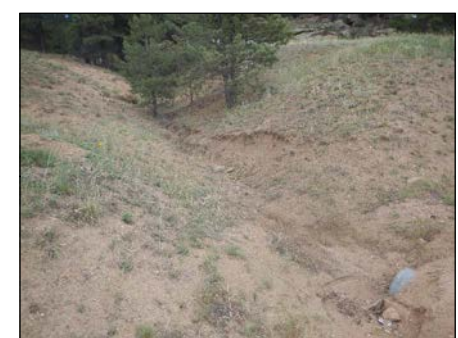
Photo 2
Hillside Drainage Erosion

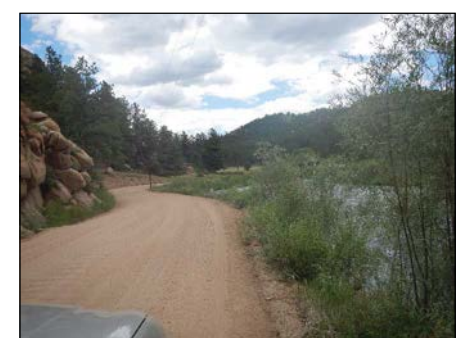
Photo 1
Lack of Woody Riparian Buffer

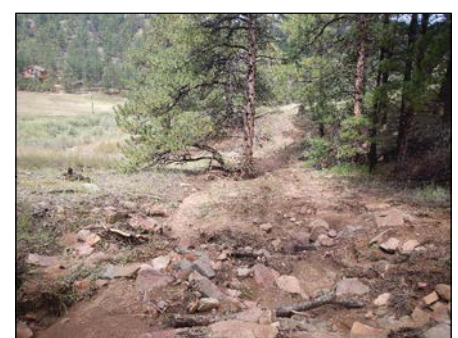
Photo 5
Drainage with Erosion

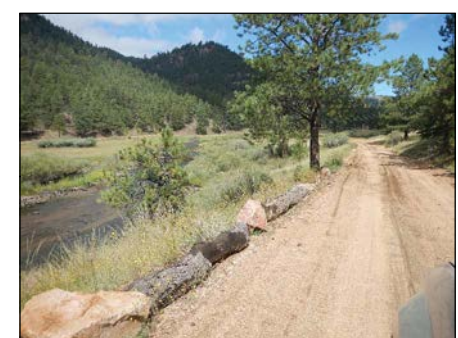
Photo 2
Roadside Erosion Protection

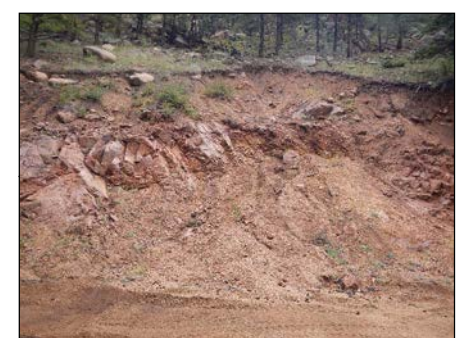
Photo 3
Typical Cut Slope
