Sugar Creek Sediment Mitigation Project

Site Assessment, Conceptual Solutions, and Preferred Alternatives

Kyle Hamilton, Will Voss, Trent Miller/CH2M HILL

April 30, 2009

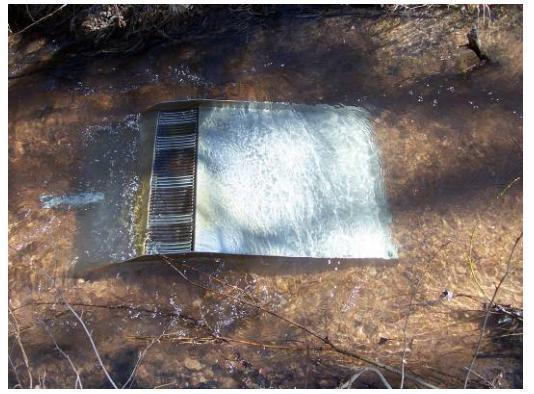
Streamside Systems installed a two feet wide stainless steel bed load collector in Sugar Creek to estimate the bed load. The installation occurred on April 23, 2008. This time of year is typically near the peak of the runoff hydrograph based on historic data. The installation was attended by Douglas County, USFS, and CH2M HILL. The installation went well; however, no bed load was collected after installations in numerous locations. It was determined that the sediment size in Sugar Creek (typically the pea gravel seen on the hill slopes), was not being transported

under the given flow conditions. The collector was also imbedded in the stream in order to force a head cut, but this too resulted in no mobilization of sediment.

This finding implies that the majority of bed load transported in Sugar Creek occurs during higher flows, which may be related to storm flows or very heavy snow melt runoff. The bed load collector was then provided by Streamside Systems to USFS so that it could be installed during a large storm event during the summer of 2008. No large storm events occurred on Sugar Creek during the summer of 2008, and the equipment was returned to Streamside Systems.

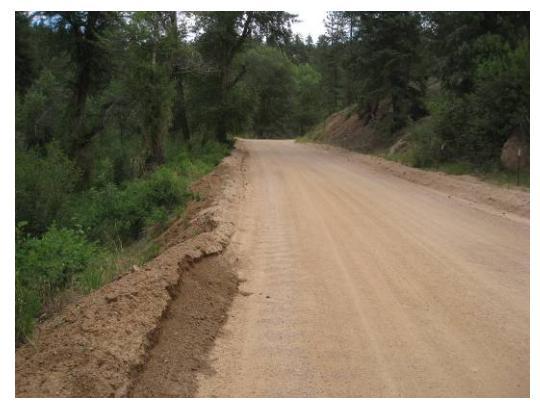
In some locations, roadway gravel berms have developed on the creek side of the road. These berms are the result of roadway grading operations where excess gravel has been pushed to one side. Many of the berms have failed after roadway runoff has collected along the berm without a location to appropriately discharge into the creek. Some of these failures are very substantial, with erosion cutting back into the travel lane, and a large amount of sediment flowing into the creek.

Douglas County noted that the gravel berm is not by design, and could removed. Removing the berms will allow sheet flow to be conveyed off the roadway, as opposed to allowing flow to concentrate and breach the roadside berm, thereby causing erosion.

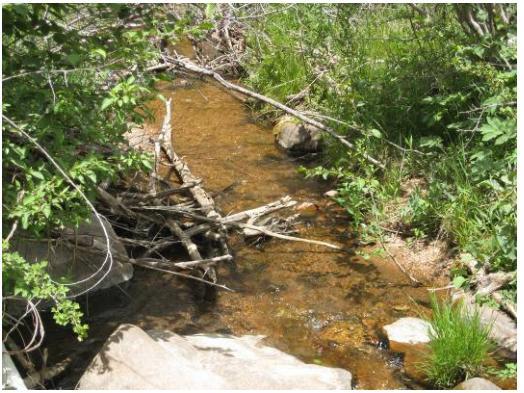
• Station 78+00 - No riparian corridor on RR due to exposed bedrock, and a very narrow riparian corridor on RL. Some evidence of road side stabilization (retaining wall); however, more is needed as runoff has flowed around it. In this area, due to the close proximity of the creek to the road, sediment is being conveyed directly into the creek. There is not enough

vegetation to act as an active buffer or filter. Some rills from the road are very serious and are beginning to extend into the road.

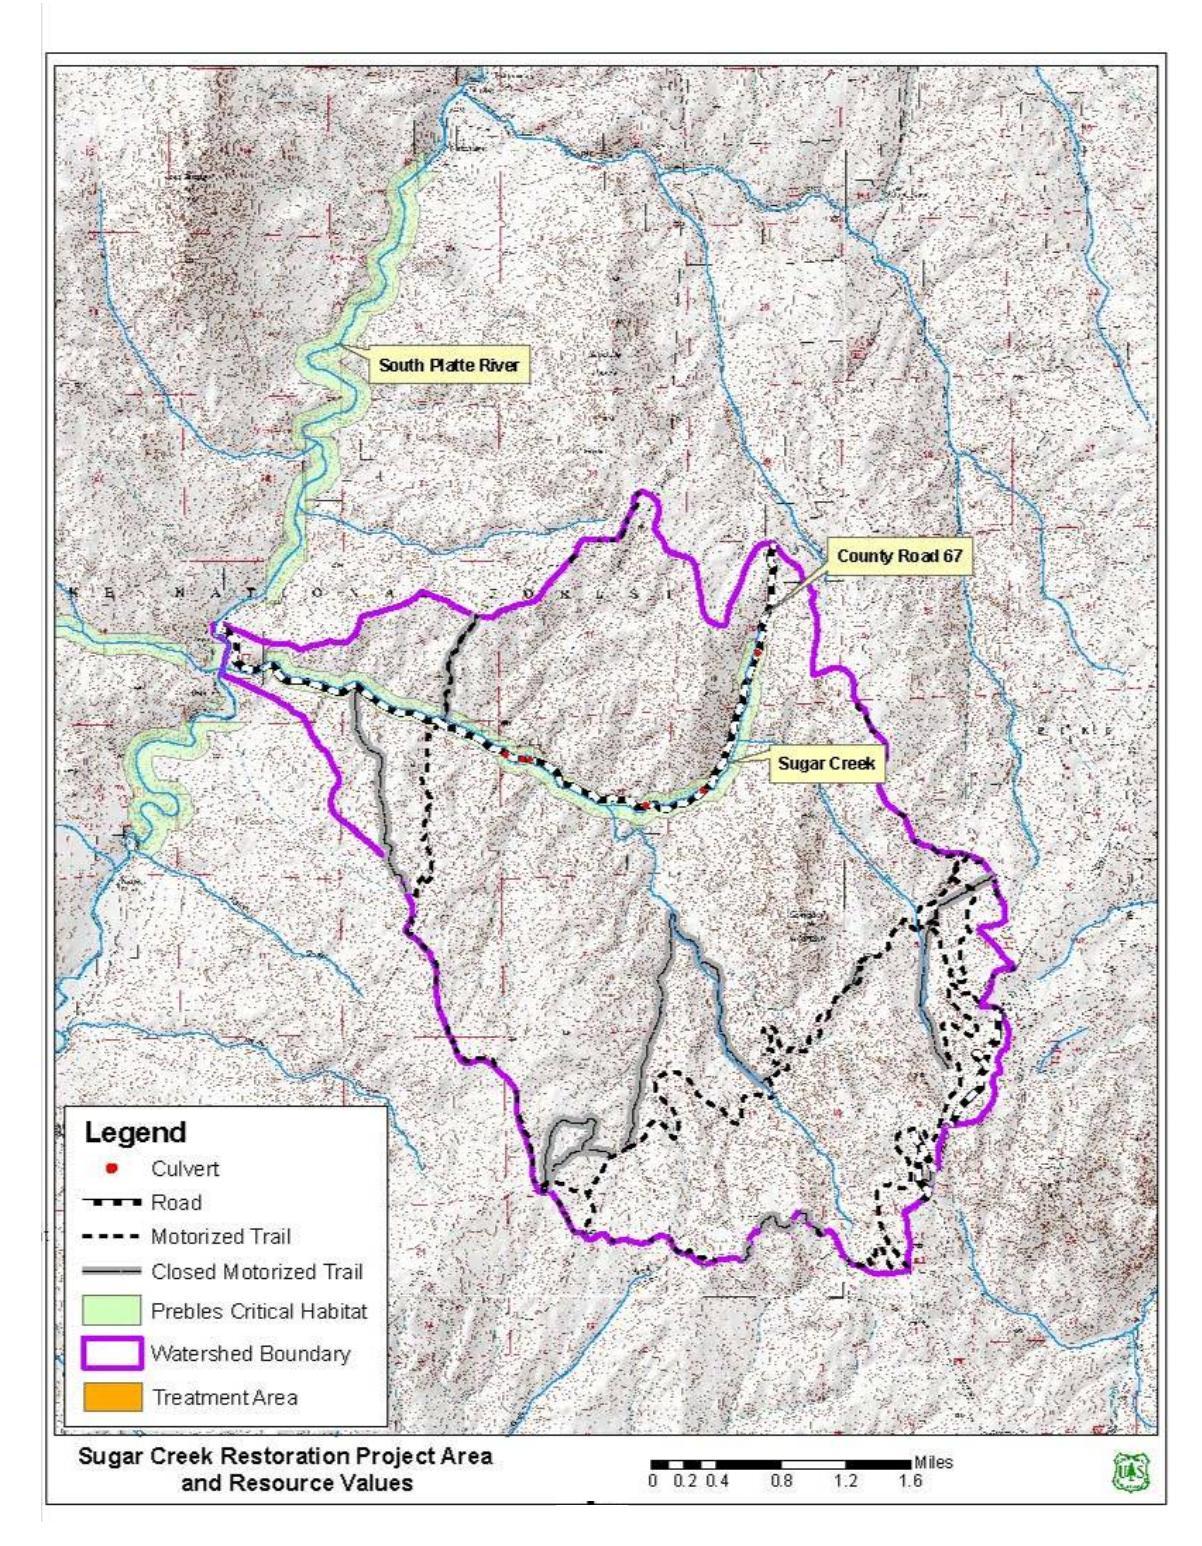
FIGURE 1 SUGAR CREEK ASSESSMENT CORRIDOR (provided by USFS)

The project is located along Sugar Creek and CR 67 in Douglas County, Colorado within the Pike National Forest, as shown on **Figure 1**. Sugar Creek enters the South Platte River upstream of Nighthawk, a small town located approximately 10 miles upstream of Strontia Springs Reservoir. The center of the project area is near coordinates 105°10′00″ and 39°18′00″ (NAD83). The Sugar Creek watershed is approximately 8,400 acres in area and is at an average elevation of 7,500 feet.
