# Trail Creek Restoration

## Final Report

April 30, 2015

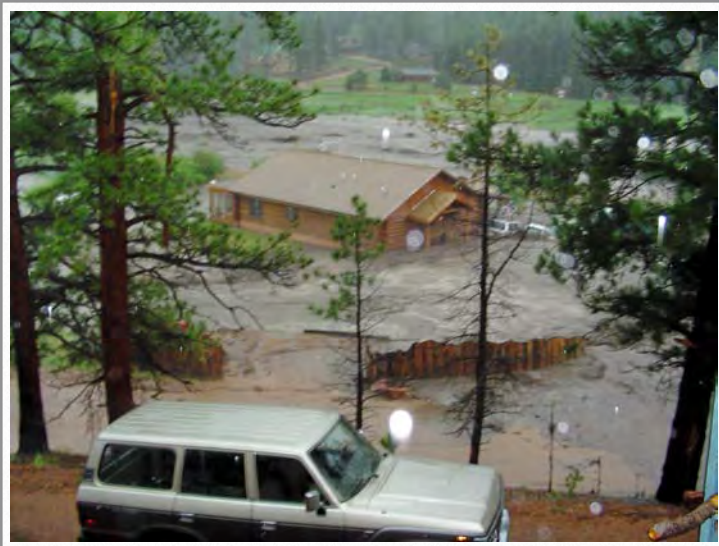
The stream's water discharge increased by orders of magnitude after the fire. For example the average annual discharge in cubic feet per second (CFS) based on 100 years of records was ~65 cubic feet per second (CFS). This soared to 1,235 CFS during a July 2003, one-inch rainfall event.

Flooding in Trail Creek, 2006

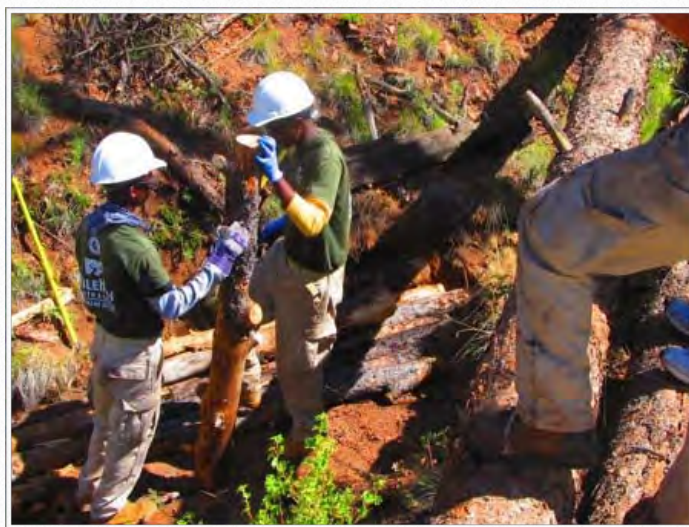
Mile High Youth Corps employees stabilize a headcut in Trail Creek

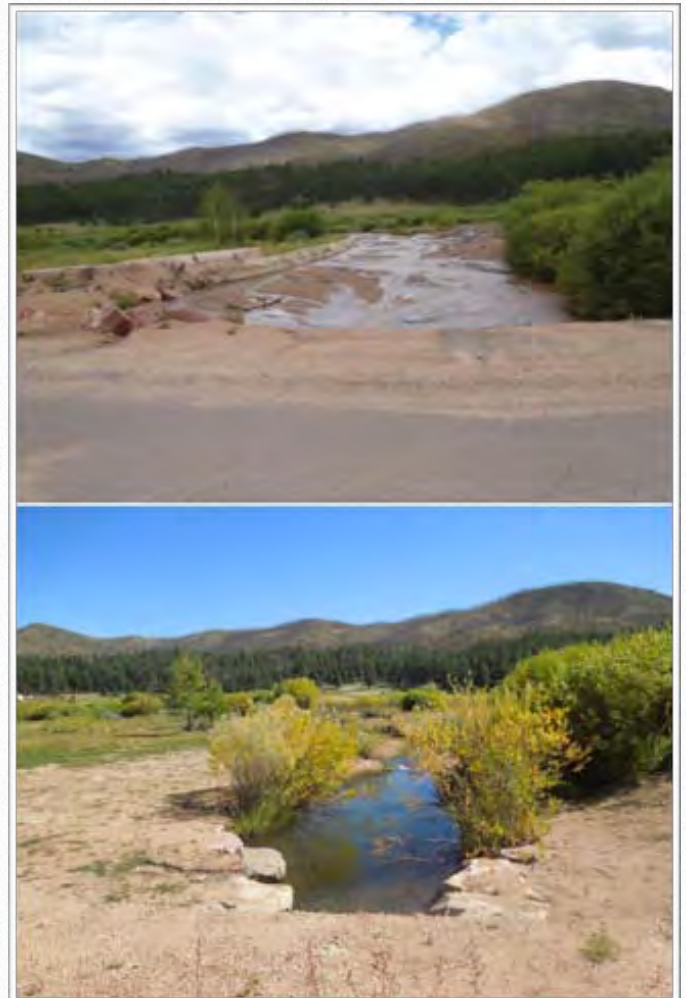
Before (above) and after (below) in-stream restoration

The WARSSS revealed many processes, including those of the creek, the channel, and side drainage instability, were contributed to unsustainable sedimentation in Trail Creek. To address these sources, the group focused much of their efforts on in-stream construction. This involved changing the path of the channel, the elevation of the riverbed, and the flow of water and sediment.

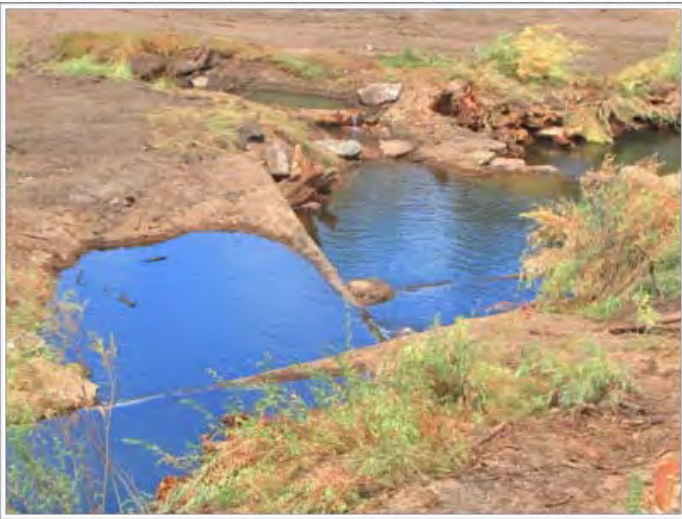
“Rock & Roll” log structure

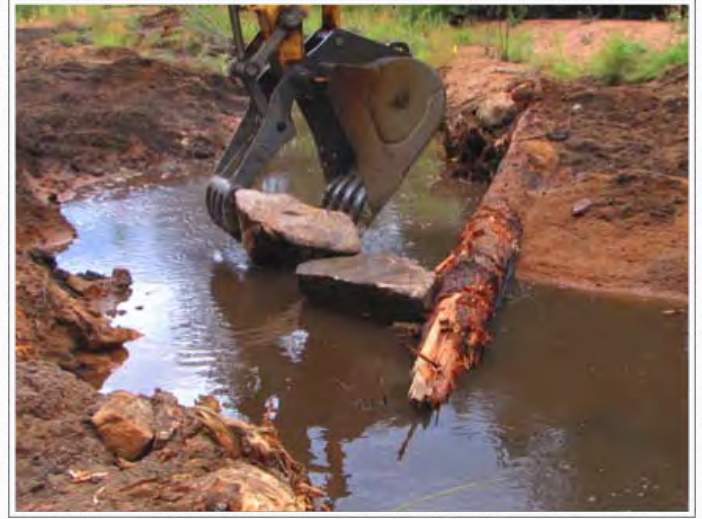
J-hook construction

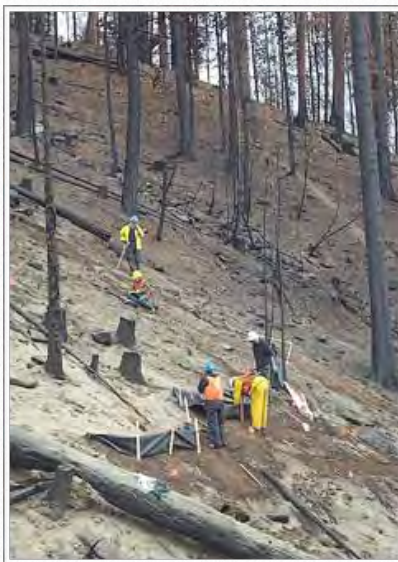
Hillslope stabilization

Erosion control structures on the land were designed to keep sediment from entering the stream and contributing to waterway impairment. After some trial and error, partners soon discovered erosion control fabric was needed when installing log erosion barriers – logs installed across slopes to slow water and sediment. The erosive granite soil in the area necessitated this extra step, a step that would likely be unneeded in areas with different soil types.

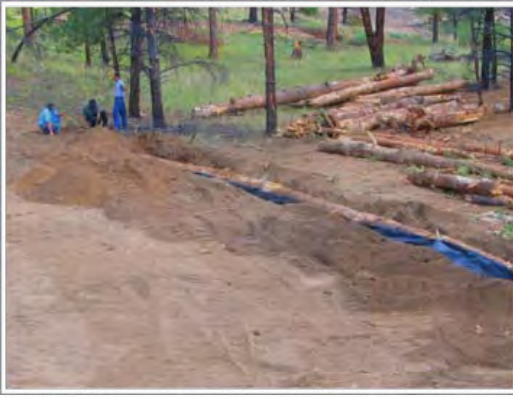
Sill logs installed with erosion control fabric help reestablish alluvial fans

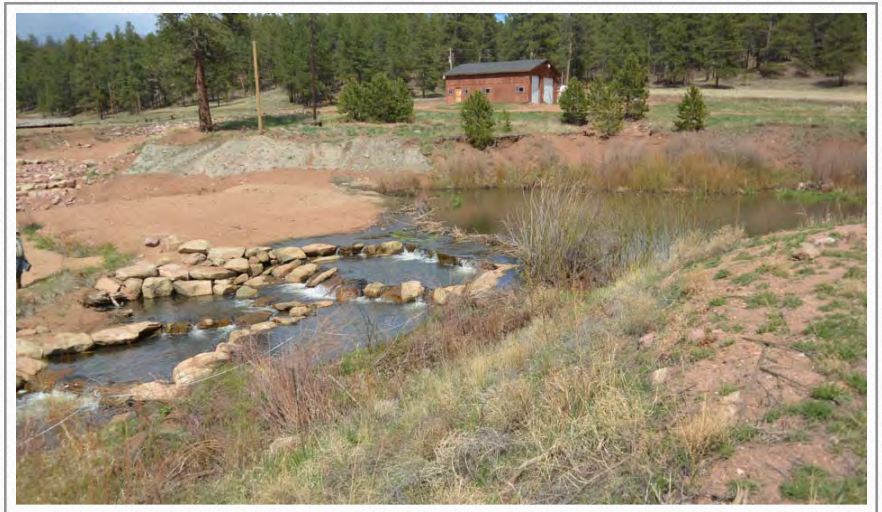
The boulder step pool structure at the top of West Creek Reach 1

constructed in the project reach, creating 29 new pool habitats along this segment of West Creek. A large and complex boulder cross vane structure was constructed at the upstream boundary of the project reach, immediately downstream of the bridge, to maintain a large beaver pond immediately upstream of the bridge. Other in-channel features included numerous large wood J-Hook vanes and cross vanes, convergence boulder and log wood structures, toe wood riparian bank stabilization and extensive willow mat

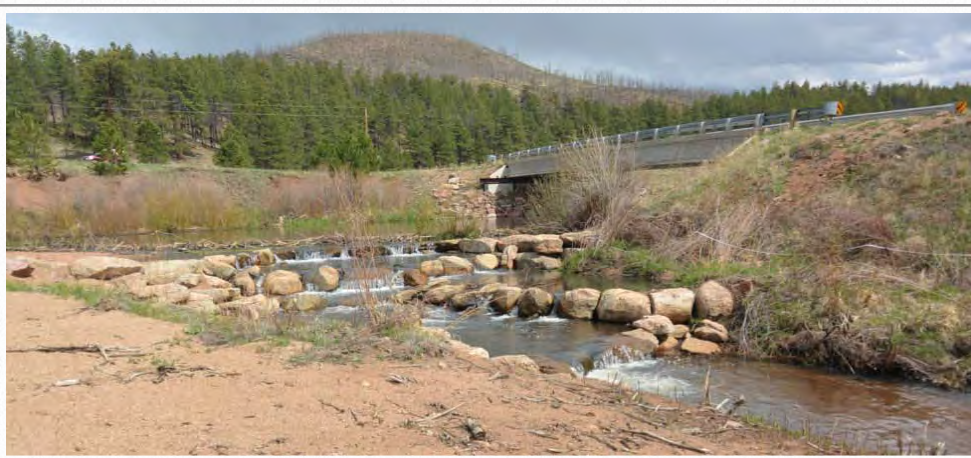
The complex boulder cross van near the upstream boundary of West Creek Reach 1

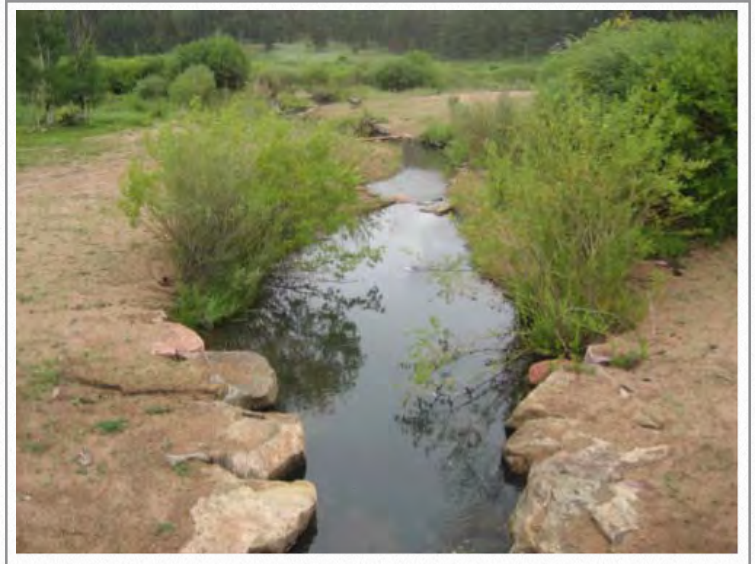
Trail Creek Reach 1, looking downstream from CR 72

Work on the reach was completed in August of 2012, and included removal of the concrete block levy, re-contouring and replanting of the floodplain, and construction of 504 feet of new single thread C per-

ennial channel between the confluence with West Creek and the box culvert at CR72. Eleven new pools were created through the installation of 12 structures in the channel, including log J-Hook vanes, boulder cross vanes, and toe wood pool/riparian bank features. Work in the reach was complemented by the re-design and reconstruction of the box culvert crossing described in the next section.

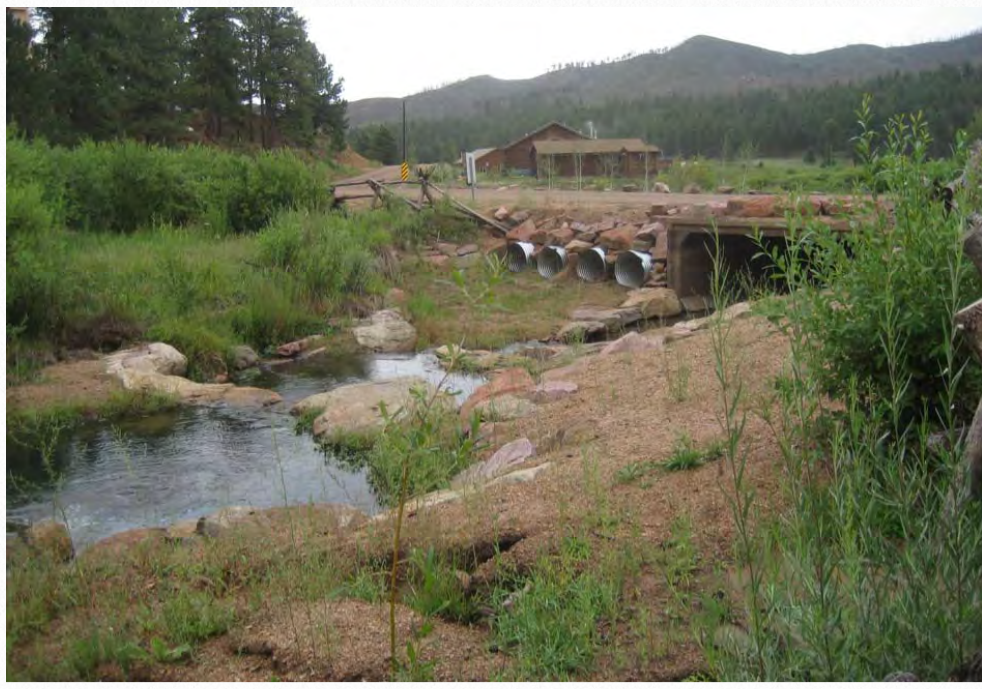
Significant deposition of sediment and flood debris since the Hayman fire in 2002 had nearly buried the large concrete box culvert at the CR72 crossing of Trail Creek. Attempts by the county to raise the level of

Realigned/reconstructed Douglas County Road 72/Trail Creek crossing

the road and add additional steel culverts above the box culvert proved ineffective. During the course of the WARSSS assessment and restoration design process, it was determined this critical infrastructure would need to be completely redesigned and reconstructed. The new design called for raising the box culvert approximately four feet to match the grade of the newly constructed stream channels in Reach 1 and Reach 2. Five additional 24 inch steel culverts would be set at the bank full elevation on either side of the newly aligned box culvert to allow flood flows to pass the crossing without significant pooling upstream of the road. The culverts will also allow for periodic inundation of the newly

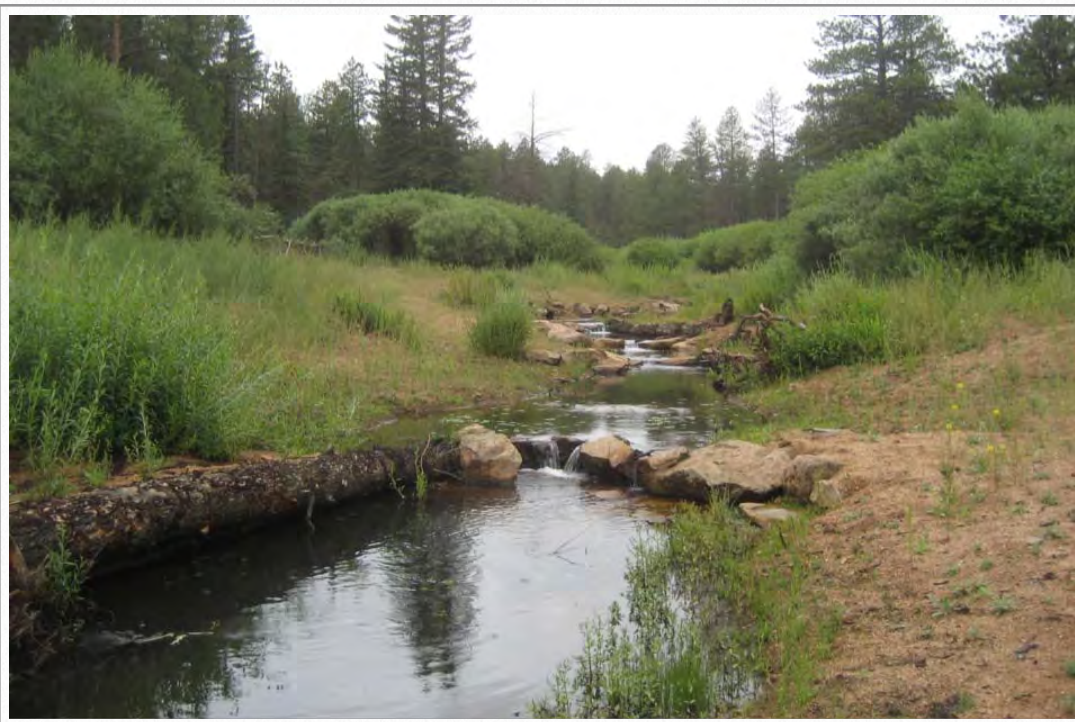
Channel reconstruction featuring new pool habitats formed by log J-Hook structures in Reach 2

duce slope through this segment. 104 in-channel structures and other features were constructed along the reach, creating 88 new pools for resident brook and brown trout. Log J-Hook structures and toe wood pool/riparian bank features were exten-

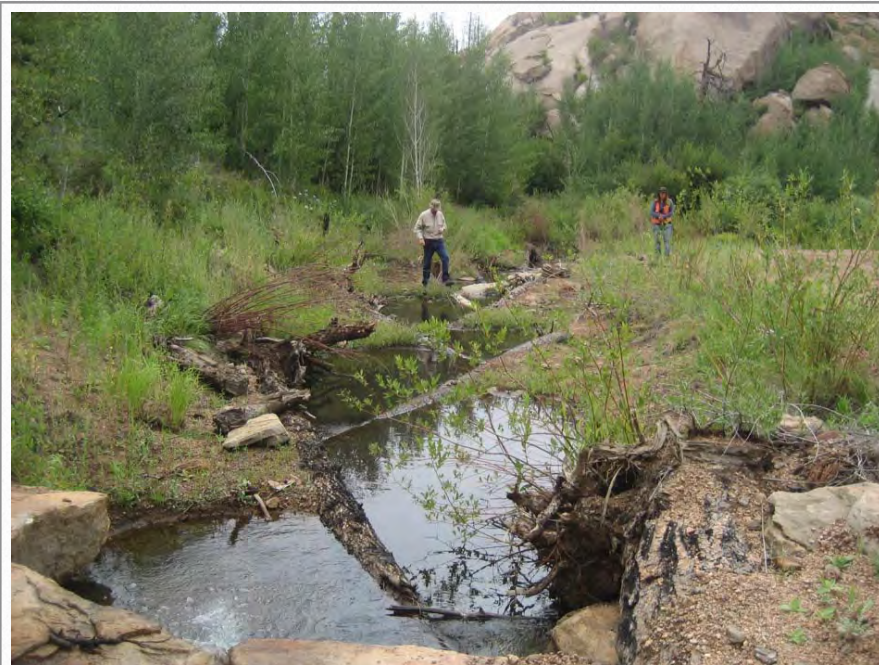
Channel reconstruction featuring “Rock & Roll” logs formed pools and new road alignment in Reach 4

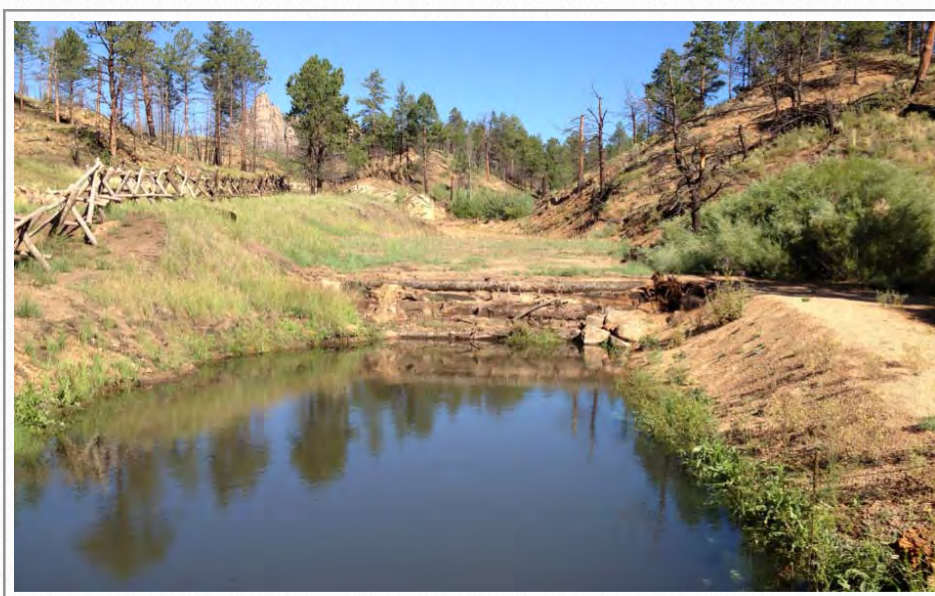
Looking upstream from the 1st basin in Basin 6 Lower Fan, 6 months following construction.

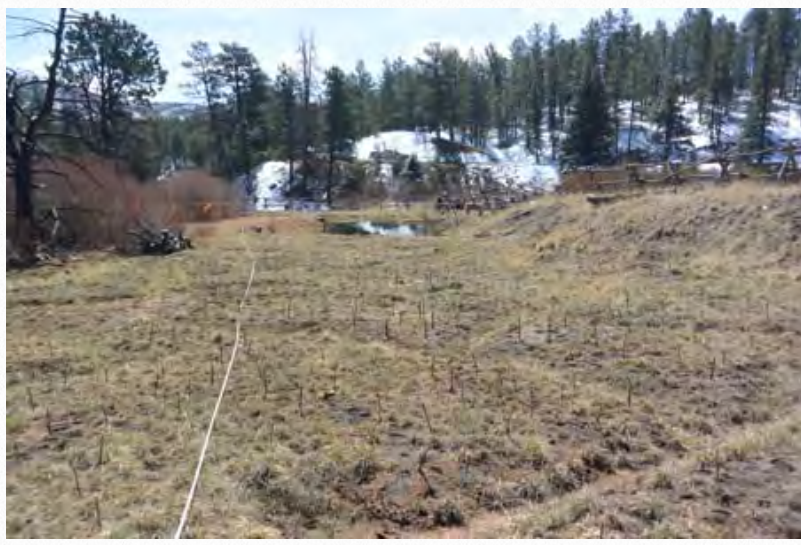
D channel rivulets between Sediment Basins 1 & 2

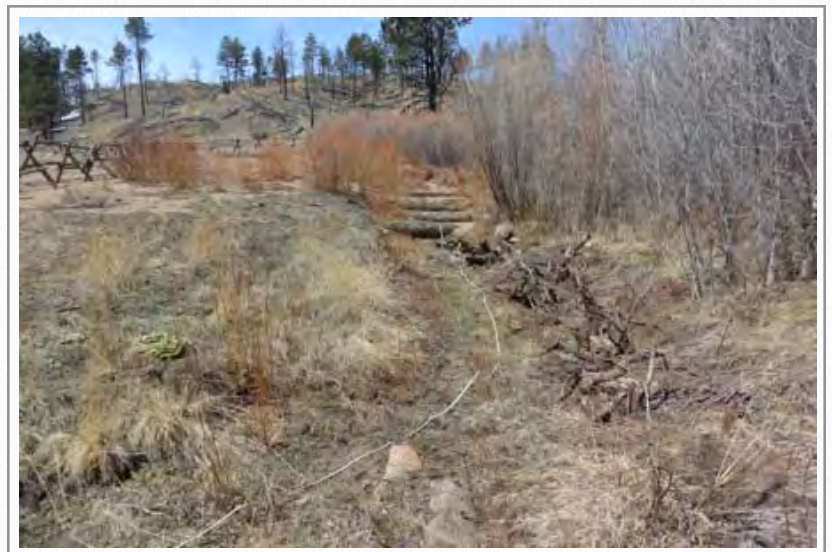
Constructed B channel below Sediment Basin 1

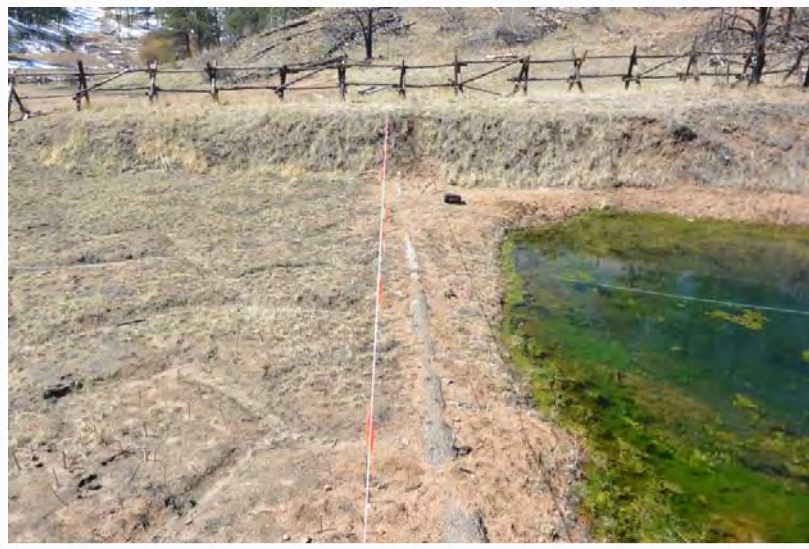
Divergent channels on the D channel surface below Sediment Basin #2 in Basin 6.

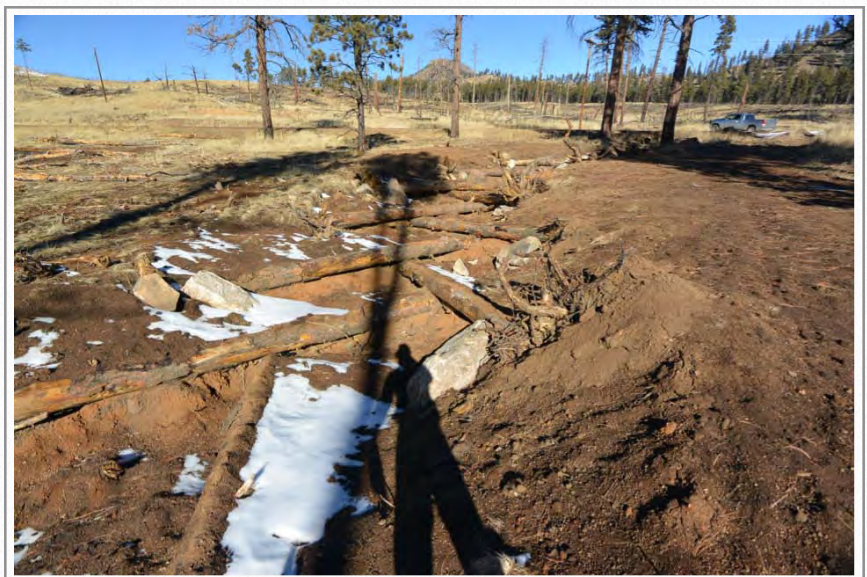
Trail Creek Basin 6 (Stump Road) Fan #2 is located in the center Sub-Basin 6, approximately  $\frac{3}{4}$  mile upstream of the Basin 6 lower fan site. The project site consists of a deep gully cutting through a natural fan along a small tributary in the basin draining the north and east side of the Sheep’s Nose granite outcrop. The gully has formed as a result of a culvert on Douglas County Road 33 (Stump Road).

Log Rock & Roll structures on the stabilized channel through Basin 6 Fan #2

Restoration work at this site was completed in October 2014. The work focused on stabilizing the vertical profile of the gully and routing flood flows past the fan and into the main channel of Basin 6. One sediment detention basin was established near the bottom of the project reach. Log sills were installed on the upstream and downstream edges of the basin to prevent the formation of new head-cuts. In addition to the sills, a log crib structure (2013 design), backed by geo-textile fabric, was used on the upstream edge of the basin to ensure the elevation of the channel bed was maintained. A log “Rock & Roll” B channel was constructed between the sediment detention basin and the Stump Road, immediately upstream of the culvert to convey excess flow to the main stem of Sub-Basin 6.

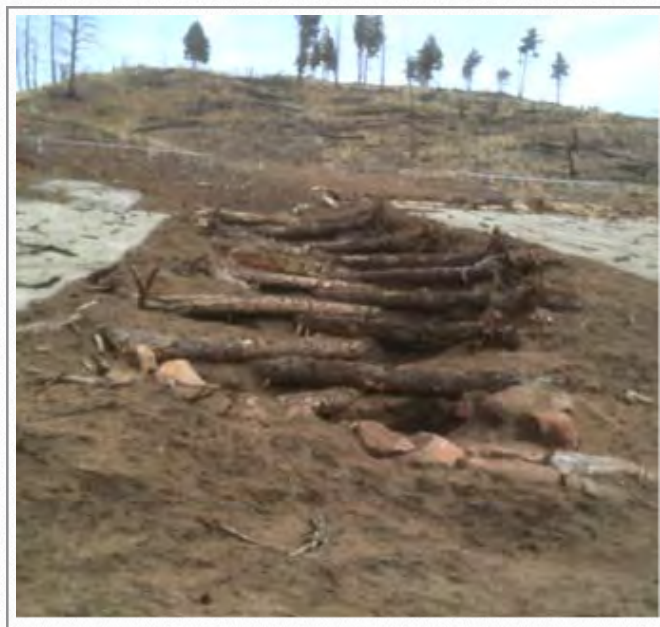
The “Rock & Roll” Channel

In August of 2014, this site was subjected to a significant rain event equaling the design flow estimate. All four basins filled completely with run-off flow, and water flowed down the log Rock & Roll constructed channel. During this event, the upper most basin filled completely with sediment, and a few of the sills suffered minor damage. During the fall 2014 construction period, we were able to do minor maintenance of this site, digging out the upper basin, and repairing the damaged sills. Additionally, we did some additional work on the main channel immediately south of Douglas County Road 33 in this project reach, including the installation of twelve log “Rock & Roll” structures and four boul-

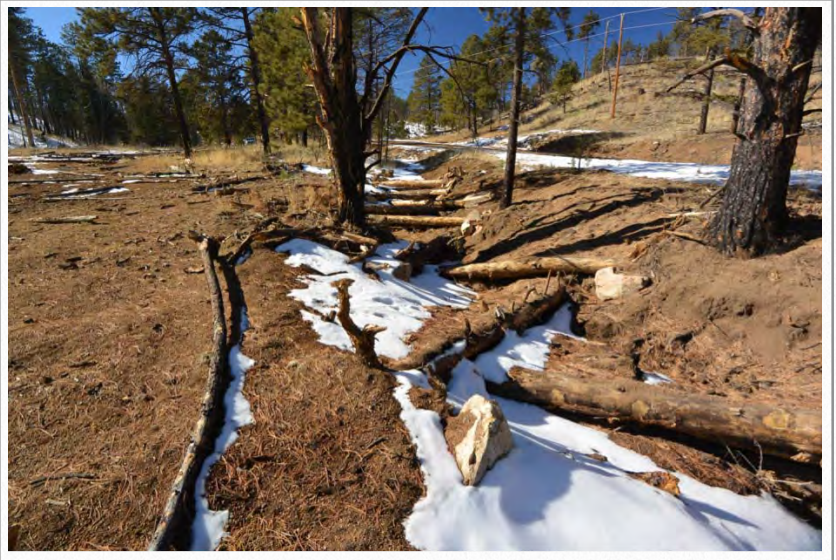
Log “Rock & Roll” structures on the main stem of Basin 6 below Stump Road - Basin 6 Fan #4 Site

north. The project site consists of a deep gully cutting through a natural fan along a small tributary draining the headwaters of the basin south of Douglas County Road 33. This gully is most likely the result of the main stem channel down-cutting below the culvert on Douglas County Road 33.

Restoration work at this site was completed in October 2014. The work focused on stabilizing the vertical profile of the gully and routing flood flows past the fan and into the main channel of Basin 6. Two large sediment detention basins were established. The first of these basins was constructed at the active head cut on the tributary channel. The second, larger basin was constructed at

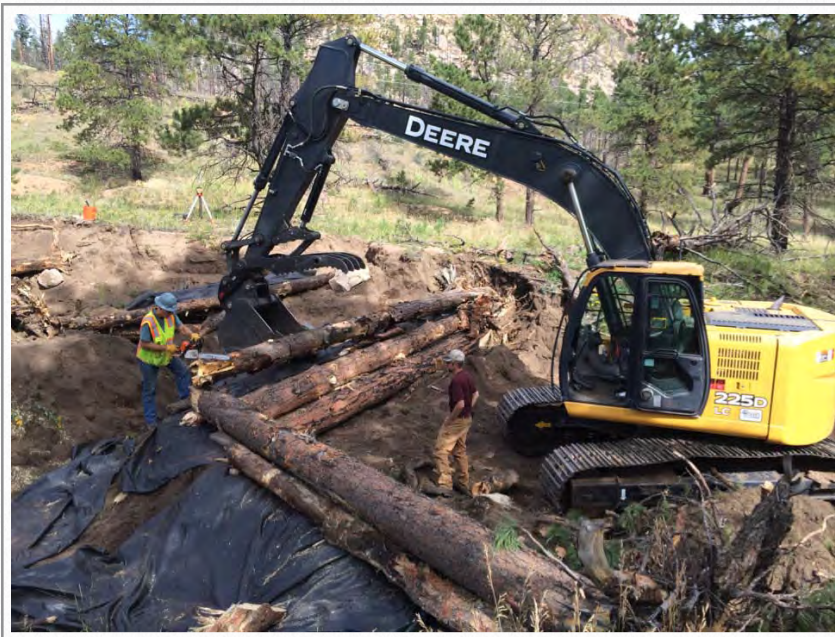
Constructing a log crib structure (2013 design) at the confluence of the two channels in Basin 6 Fan #4

the confluence of the main stem and the tributary channel. Log sills were installed on the upstream and downstream edges of the basins to prevent the formation of new head-cuts. In addition to the sills, log crib structures (2013 design), backed by geo-textile fabric, were installed on the upstream edge of each basin to ensure that the elevation of the channel bed was maintained. A log “Rock & Roll” B channel was constructed between the lower sediment detention basin and the Stump Road culvert to convey flows through the project reach. Additionally, a log crib structure (2011 design) was utilized to maintain the toe elevation of another tributary fan entering the project reach from the south.

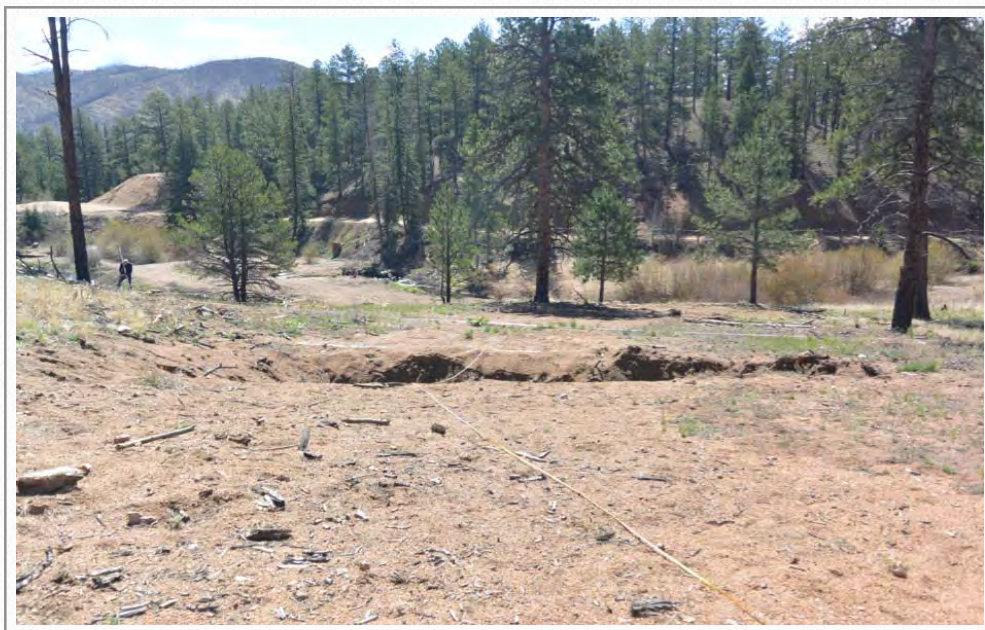
Looking downstream towards Trail Creek from the uppermost basin in Trail Creek Basin 6Face

sins at the top of the fan, and at intervals along the longitudinal axis of the fan to provide necessary fill material to fill the incised channel between basins. In Trail Creek Basin 6Face, four small basins were required to generate the fill necessary to fill the F4 channel back to the grade of the original fan. Log crib structures were installed along the upstream

side of each basin, and log sills were installed around the remaining edges. Additional log sills were added at intervals along the filled channel to ensure stability of the material until vegetation could become established.

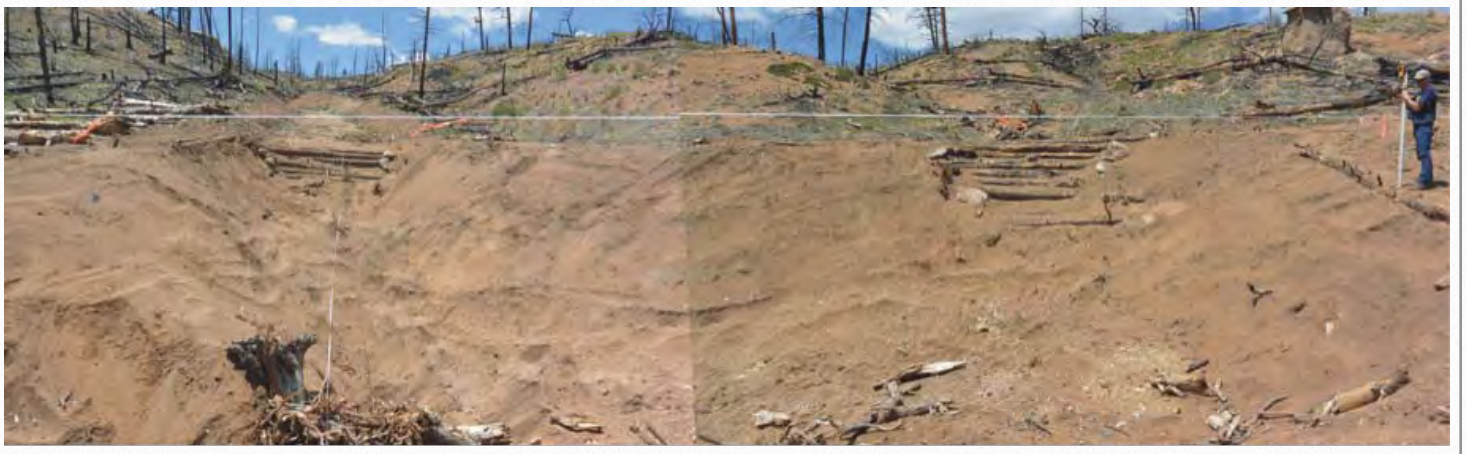
The large sediment basin at the top of the alluvial fan - Trail Creek Basin 6C worksite (Sub-Basin 6C)

The Trail Creek Basin 6C Fan is located on the west side of Trail Creek Reach 2, immediately upstream of Trail Creek Basin 6Face, at the bottom of Sub-Basin 6C. The restoration effort was similar to work in the other sub-basins, filling multiple incised channels that had cut through a compound alluvial fan at the bottom of the basin. 569 feet of ephemeral channel were treated and stabilized. The multiple channel threads were filled to an elevation

matching the surrounding lobes of the compound fan. Log sills were placed perpendicular to the direction of flow every 25 – 30 feet along these filled channels to stabilize the fill materials. Additionally, several sills were installed across the entire fan for additional protection. A very large single sediment detention basin (approximately 1 acre) was dug at the top of the fan in lieu of multiple sediment detention basins being dug at intervals. This technique produced the necessary fill material with less

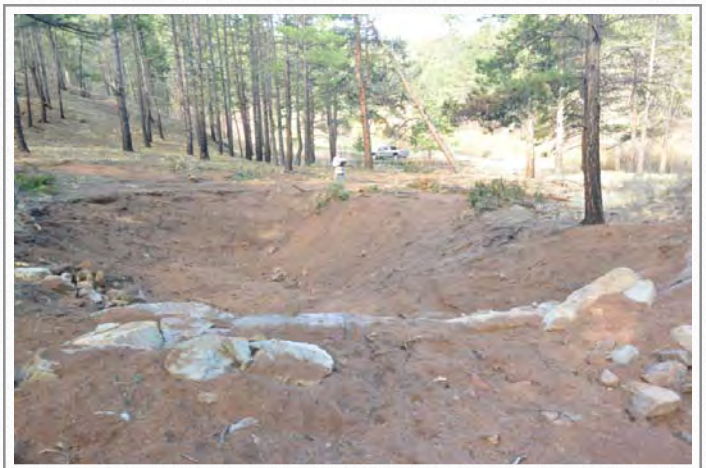
Sediment detention basin and restored alluvial fan at Trail Creek Basin 2Face3 work site.

Trail Creek Basin 2Face3 is located ¼ mile upstream of Reach 3, on the east side of the Trail Creek Road. The project site consisted of an alluvial fan restoration and incised channel repair at the bottom of Sub-Basin 2Face3. The Trail Creek Road traverses the lower third of the fan, and has concentrated flows into a single thread below the road. Subsequent flooding created a head-cut, which migrated upstream

time and effort due to the fewer log cribbing structures required. In all, twenty structures were needed to complete the stabilization work, which occurred in August 2012.

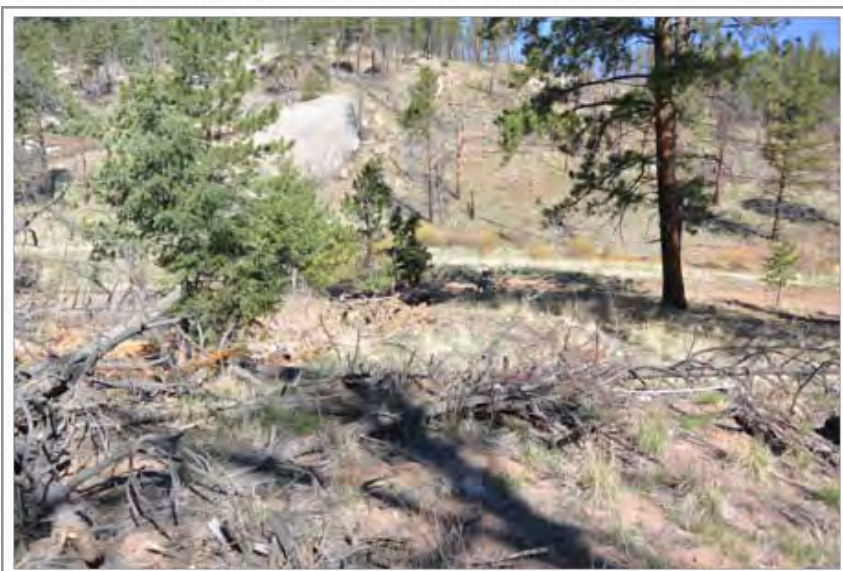
Incised channel filled with wood at Trail Creek Ephemeral Draw #6

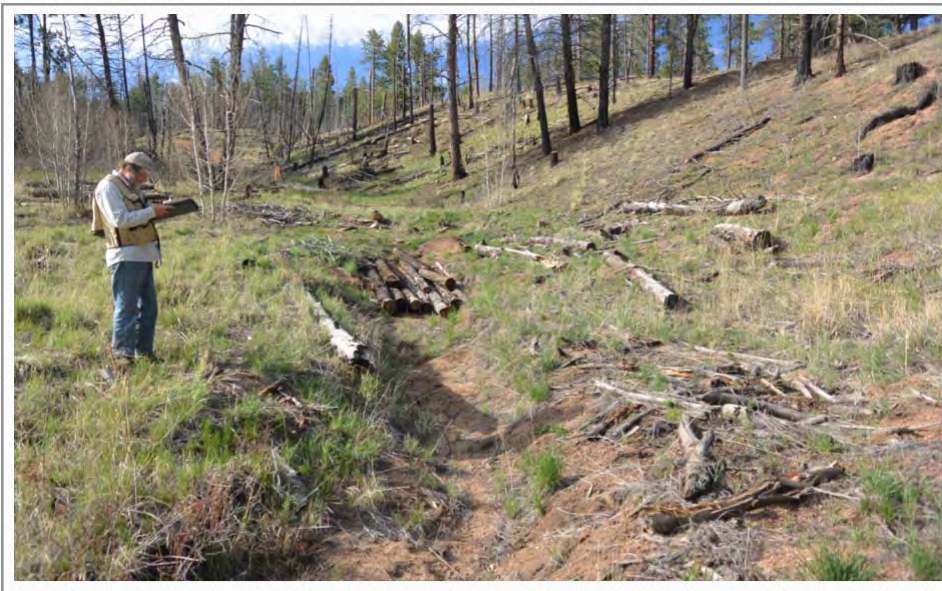
Layered log head cut stabilization structure in a small channel along the right edge of the fan

along the left edge of the fan to disperse water over the surface. The head cuts were stabilized using layered wood cribbing placed parallel to the direction of flow in the channel to tie together the elevations upstream and downstream of the head cut. Downstream of Trail Creek Road, the deeply incised channel near the edge of Trail Creek was stabilized by constructing two large boulder cross

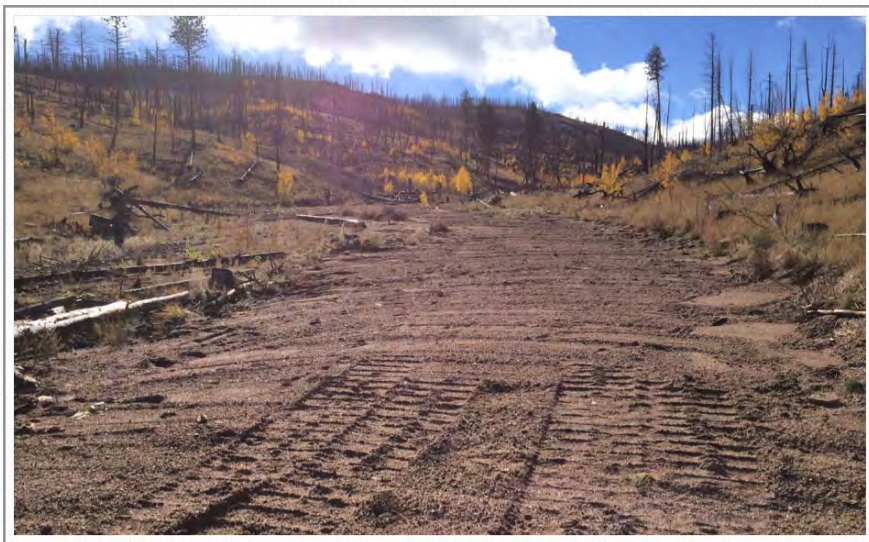
Filled down-cut channel in between the two sediment detention basins in Trail Creek Basin 60

the sub-basins empty into the main stem channel of Trail Creek. Teller County Road 3 crosses Trail Creek at two low-water crossings within the project area, and traverses the toe of both of these alluvial fans. A channel has down cut through the Basin 60 fan. The Basin 62 fan is in better condition, and is still

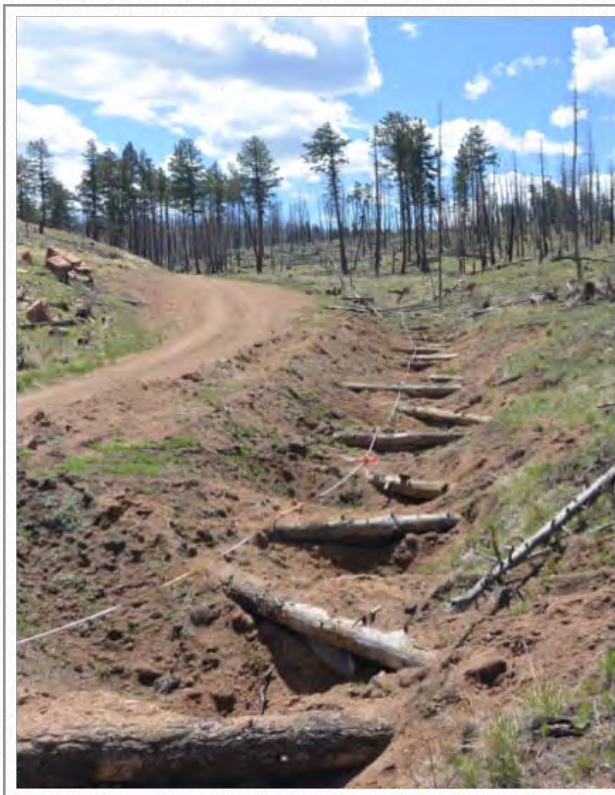
Log “Rock & Roll” channel along FR364

The 2011 WARSSS Assessment recommended this segment of FR364 for closure or re-route. Unfortunately, a suitable re-route has not yet been identified, and closure is likely not an option unless a suitable alternative route can be found. During the summer of 2012, the Forest Service conducted major maintenance of the road, including construction of a large

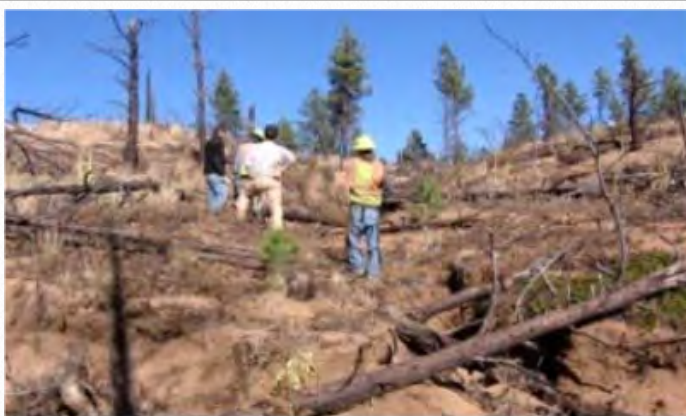
**Before**

Headcut is causing increased erosion and will continue to migrate upslope.

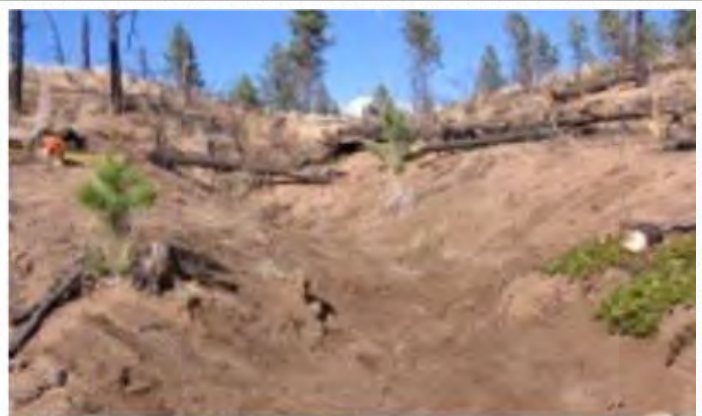
**After**

Base has been hardened, land re-contoured & stabilized. Minimal disturbance of surrounding land.

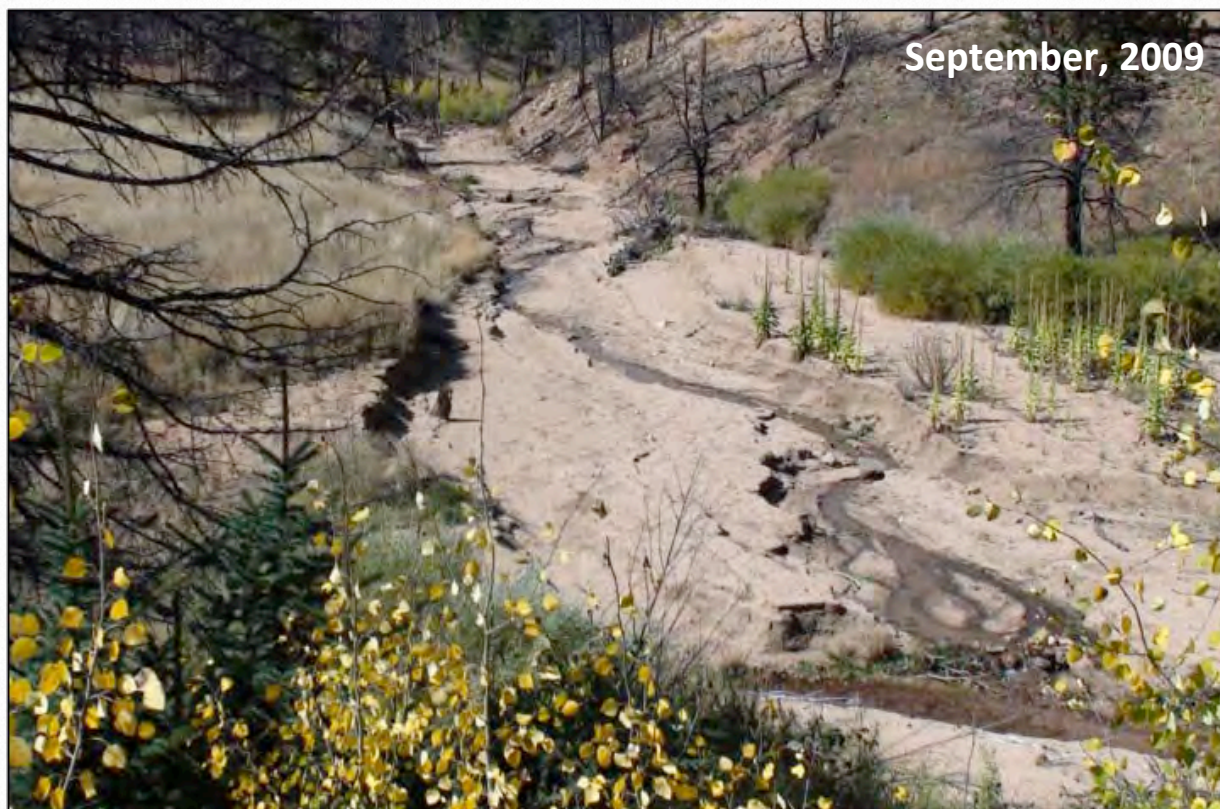
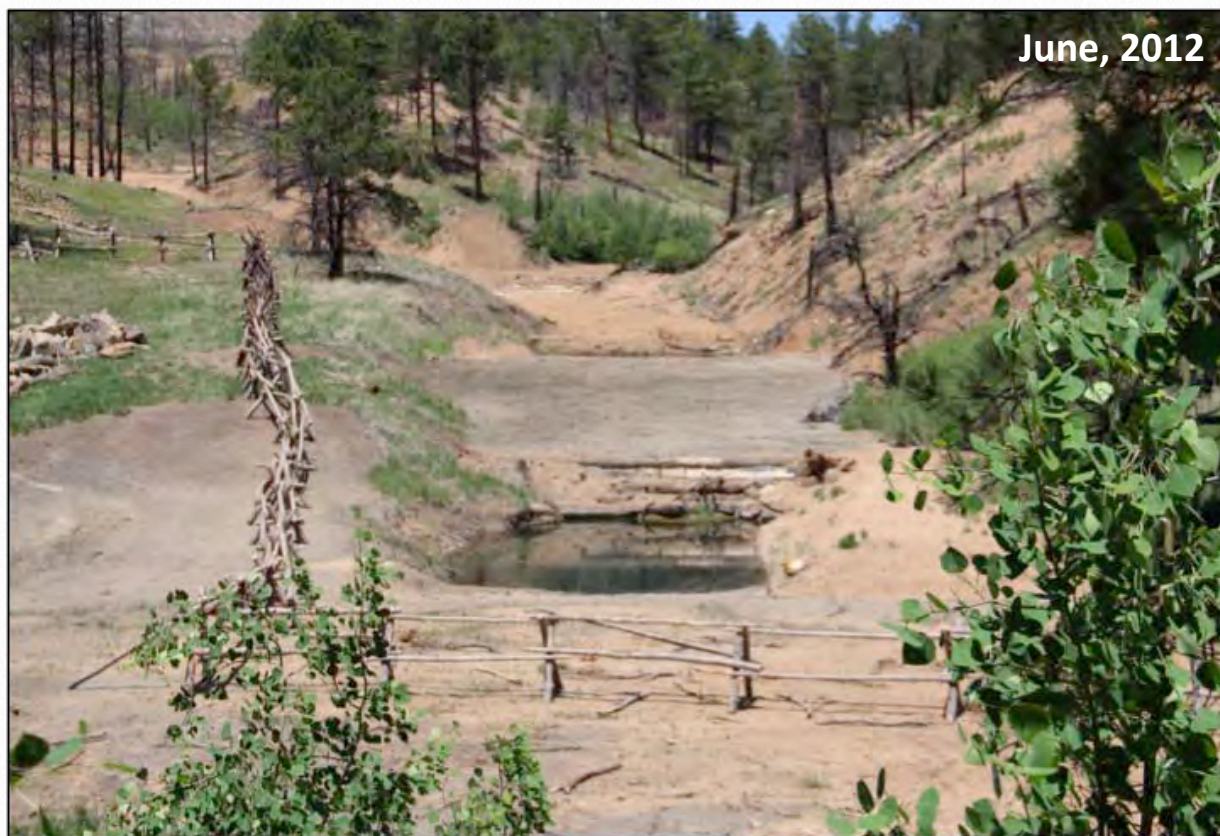
Headcut and incised F4b stream type at the mouth of Sub-watershed 6 showing Before vs. After comparison of sediment detention basin and braided, D4 stream type on raised surface constructed in November 2011.

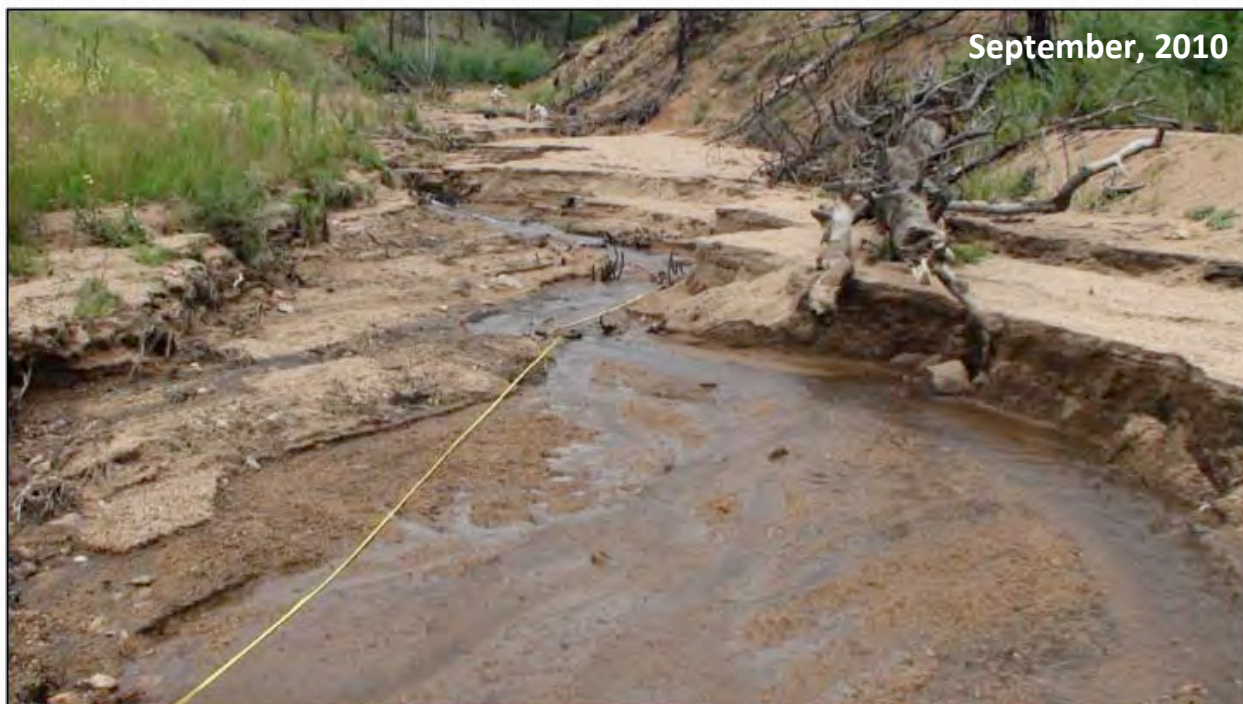
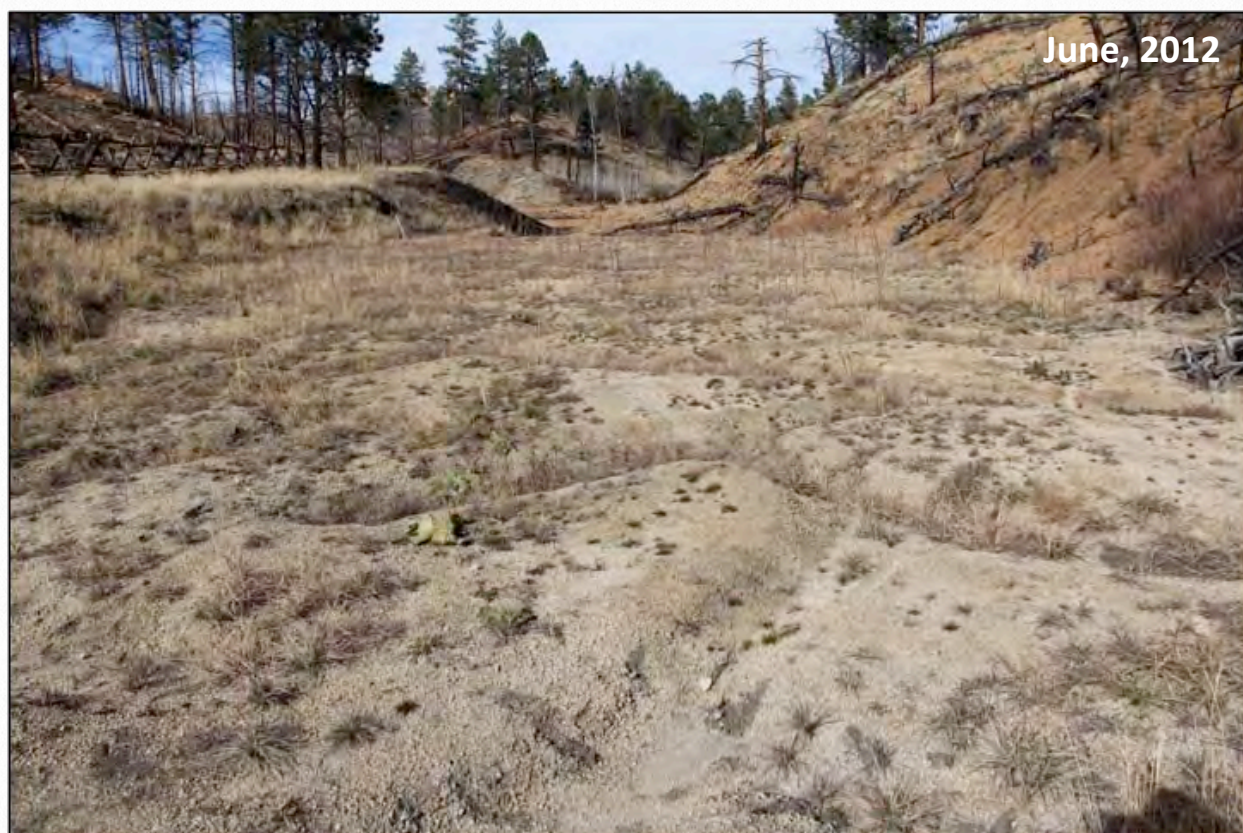
Before vs. After comparison of conversion of a F4b to a braided (D4) stream type as constructed in November, 2011 at the Trail Creek confluence of this tributary draining sub-watershed 6. Material from excavated sediment detention basins was used to raise bed elevation 5 feet and eliminate the gully with convergence/divergence, multiple channels constructed to disperse flow energy and deposit sediment. A 2-year storm in 2002 produced no sediment transport or flows into Trail Creek as flood peaks were diminished and sediment was stored on the new surface and in the constructed basins.
