# Trail Creek Restoration

## Final Report

April 30, 2015

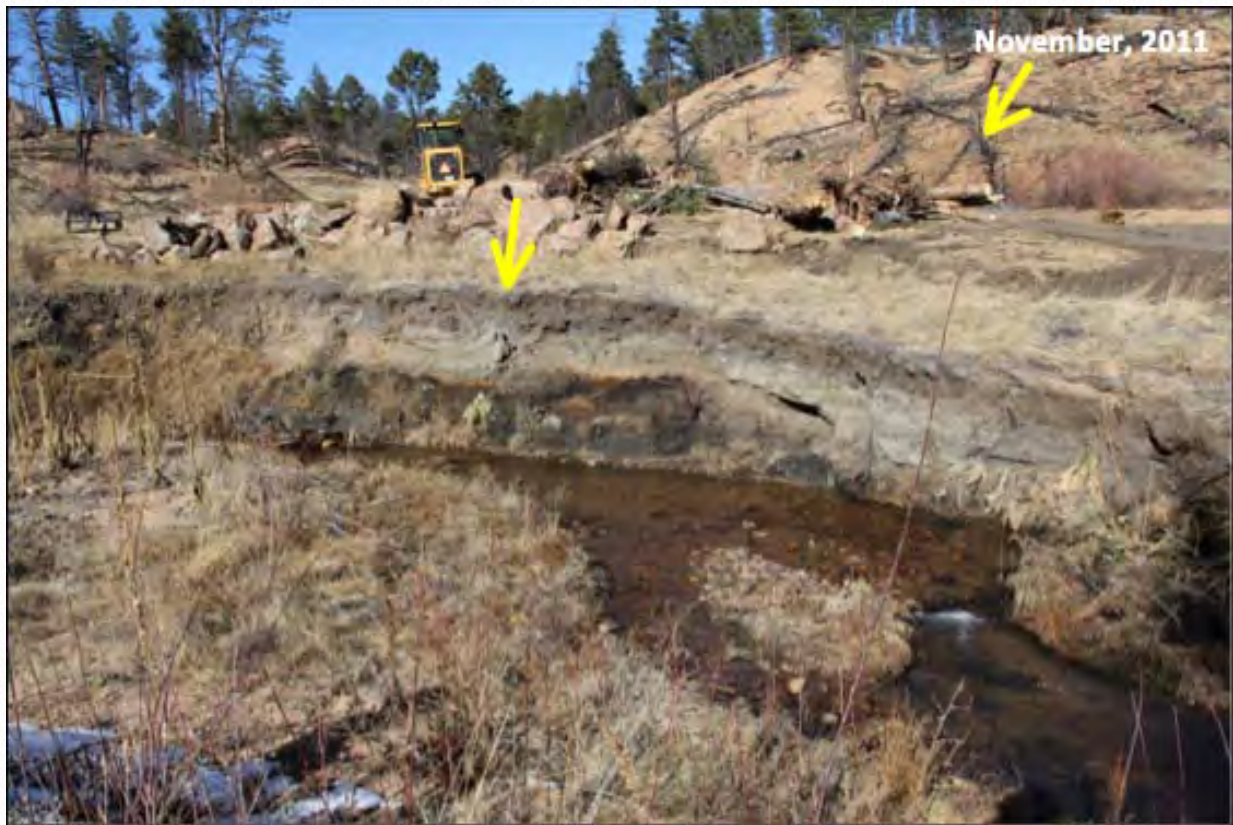
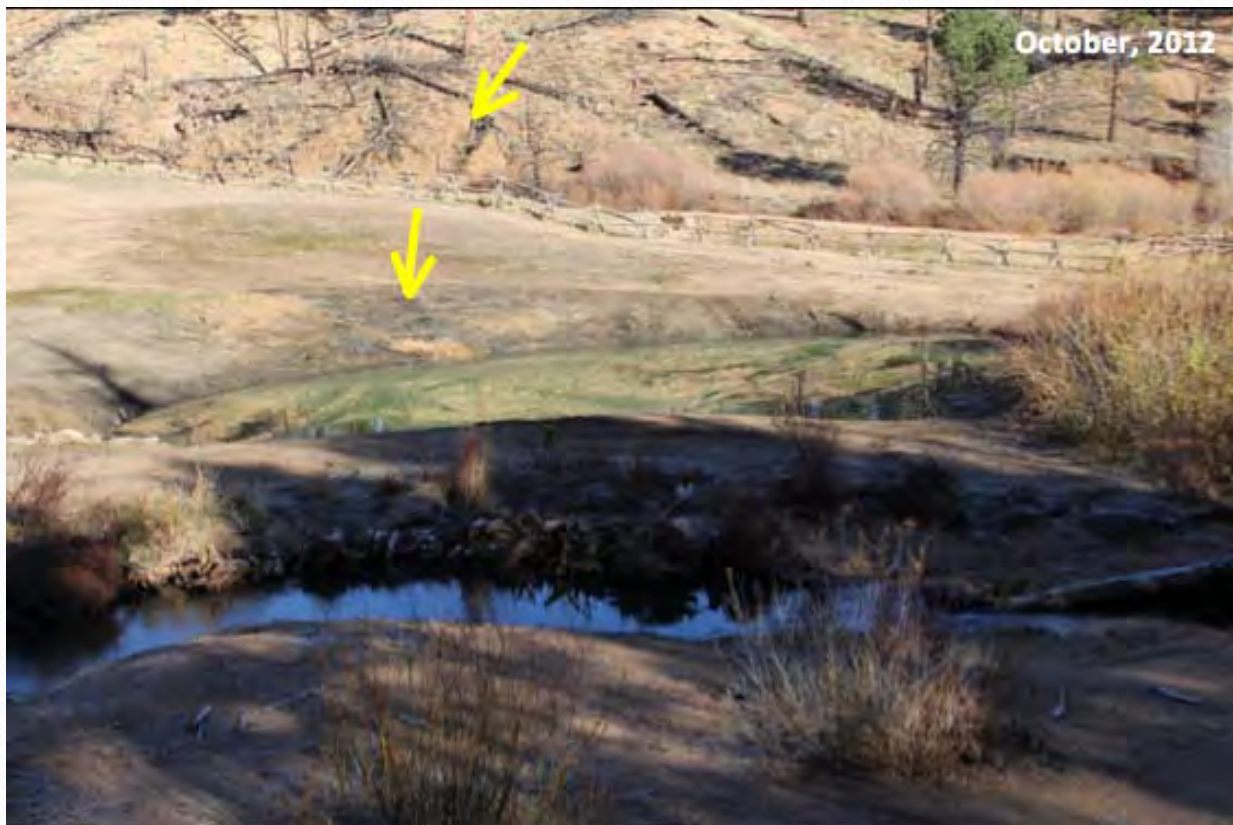
Before vs. After comparison of restoration showing an eroding bank at previous location of the incised channel of Trail Creek against an alluvial fan that was converted to an oxbow lake; Trail Creek was relocated away from the fan and reconnected to its floodplain (restoration implemented in July, 2012).

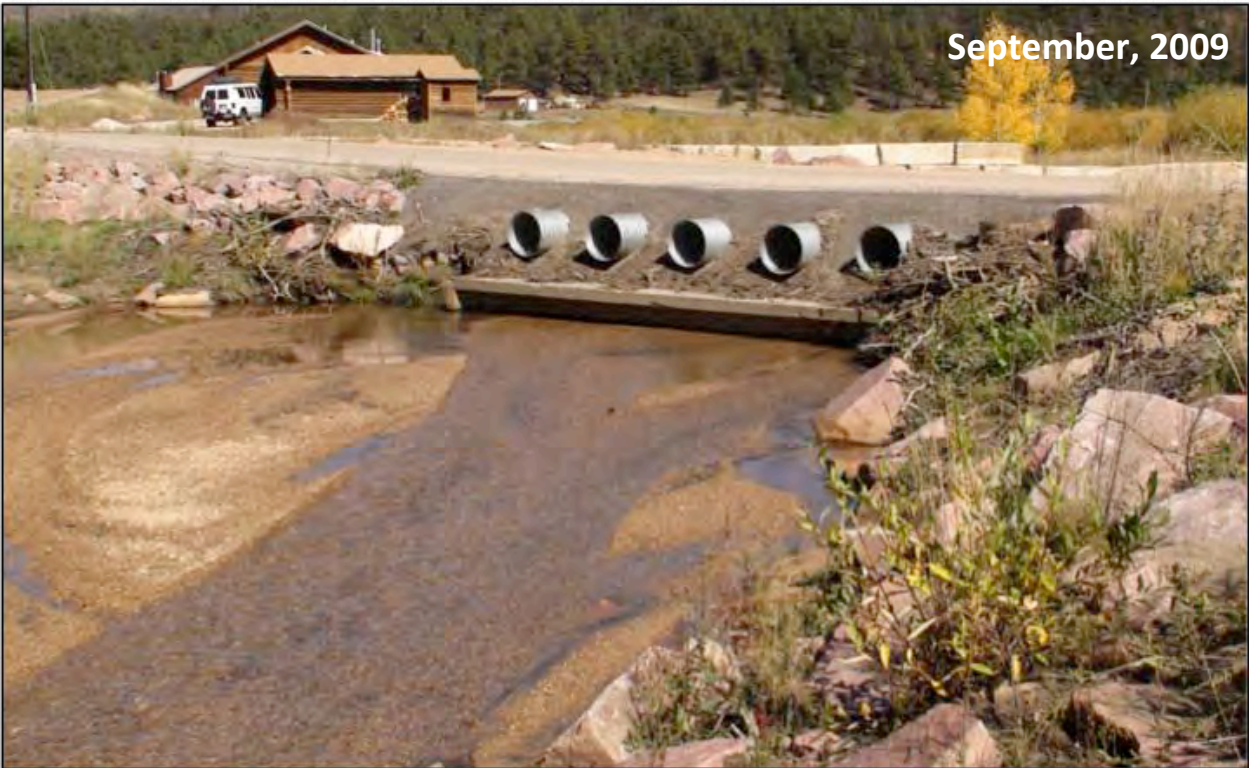
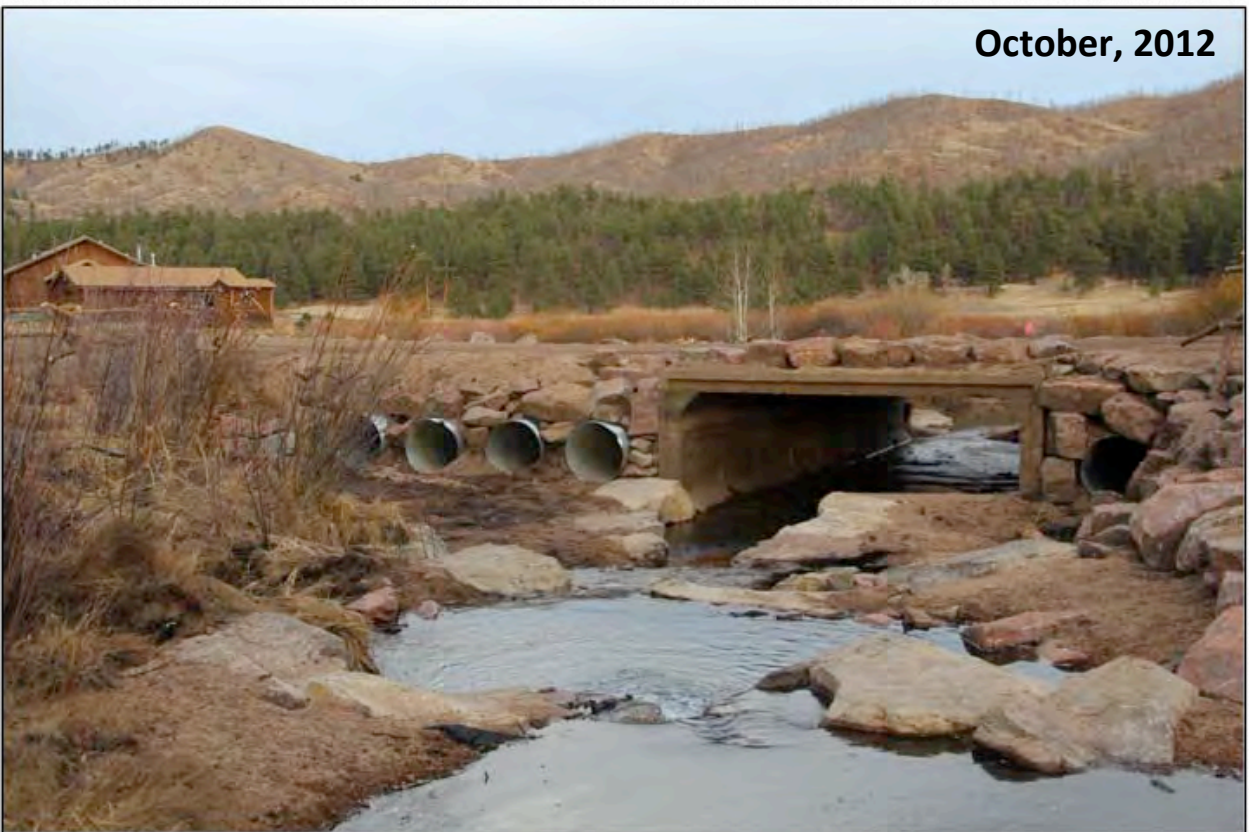
Before vs. After comparison of the conversion of an overwide, aggrading channel through the raised concrete box culvert on Trail Creek at the West Creek road crossing with relief flow culverts placed on a newly created floodplain as constructed in October, 2012. Flow is constricted at the approach and outlet sections of the box to emulate the width and depth of the bankfull discharge channel to maintain sediment transport capacity.

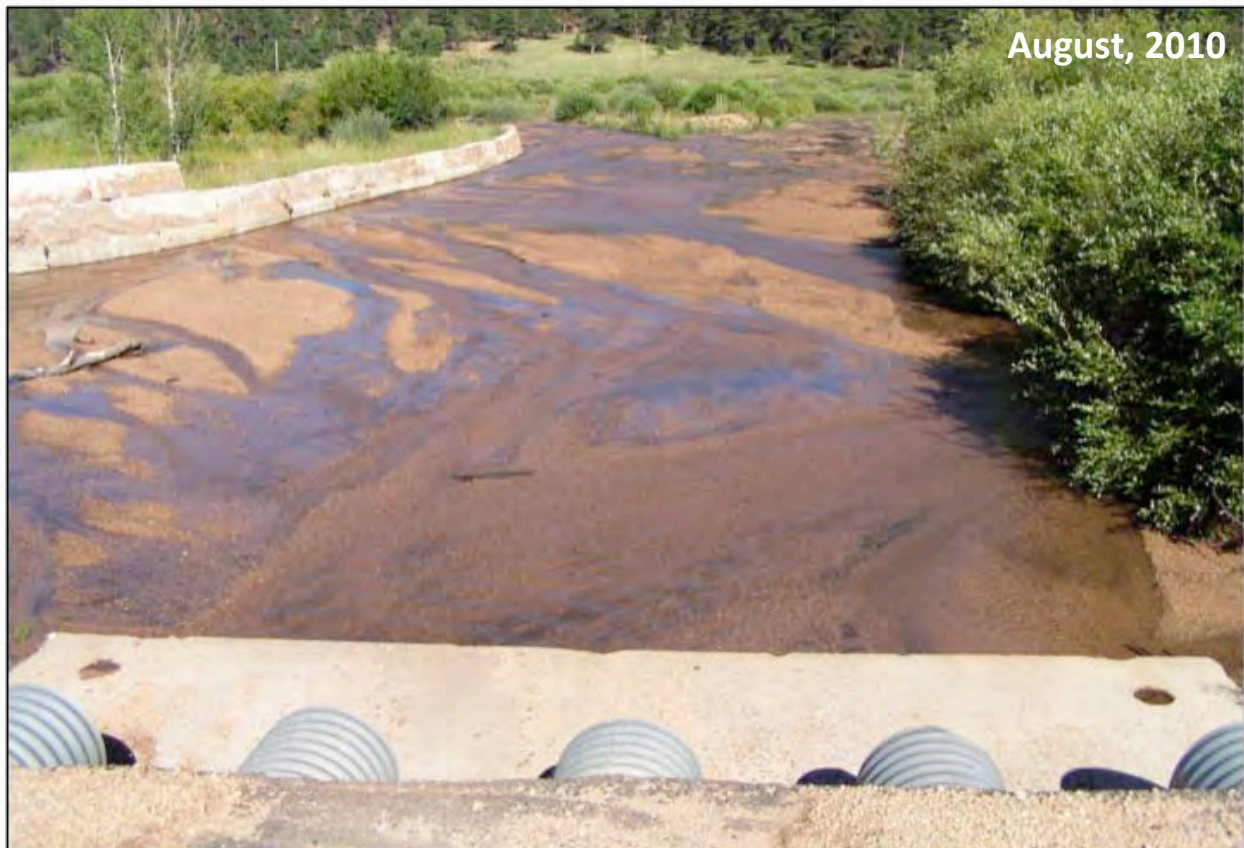
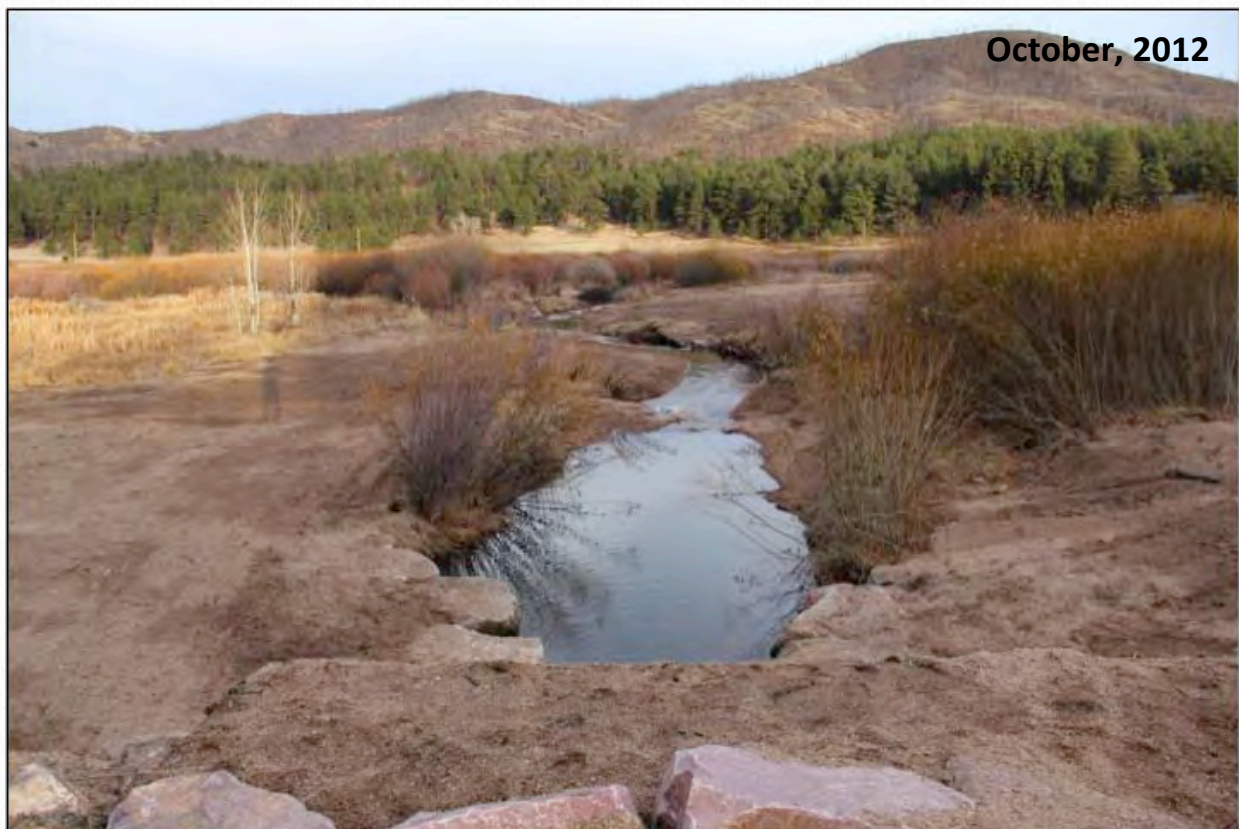
Before vs. After comparison of the downstream view of changes on Trail Creek at the West Creek road. The channel was converted from a braided (D4) to meandering (C4) stream type with removal of concrete barriers and re-establishment of floodplain as constructed in October, 2012. Aggrading channel was lowered 3 feet to match previous floodplain elevation behind the concrete barriers.

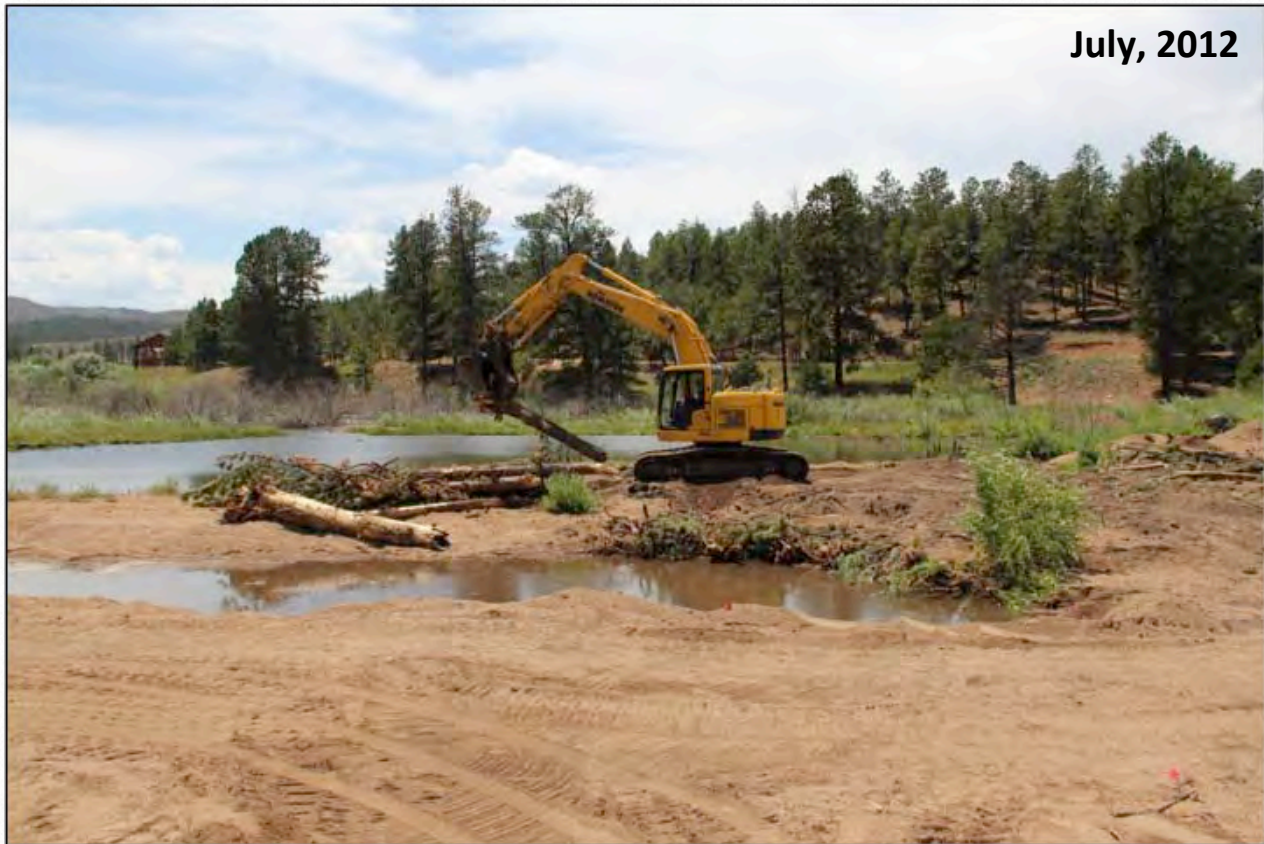
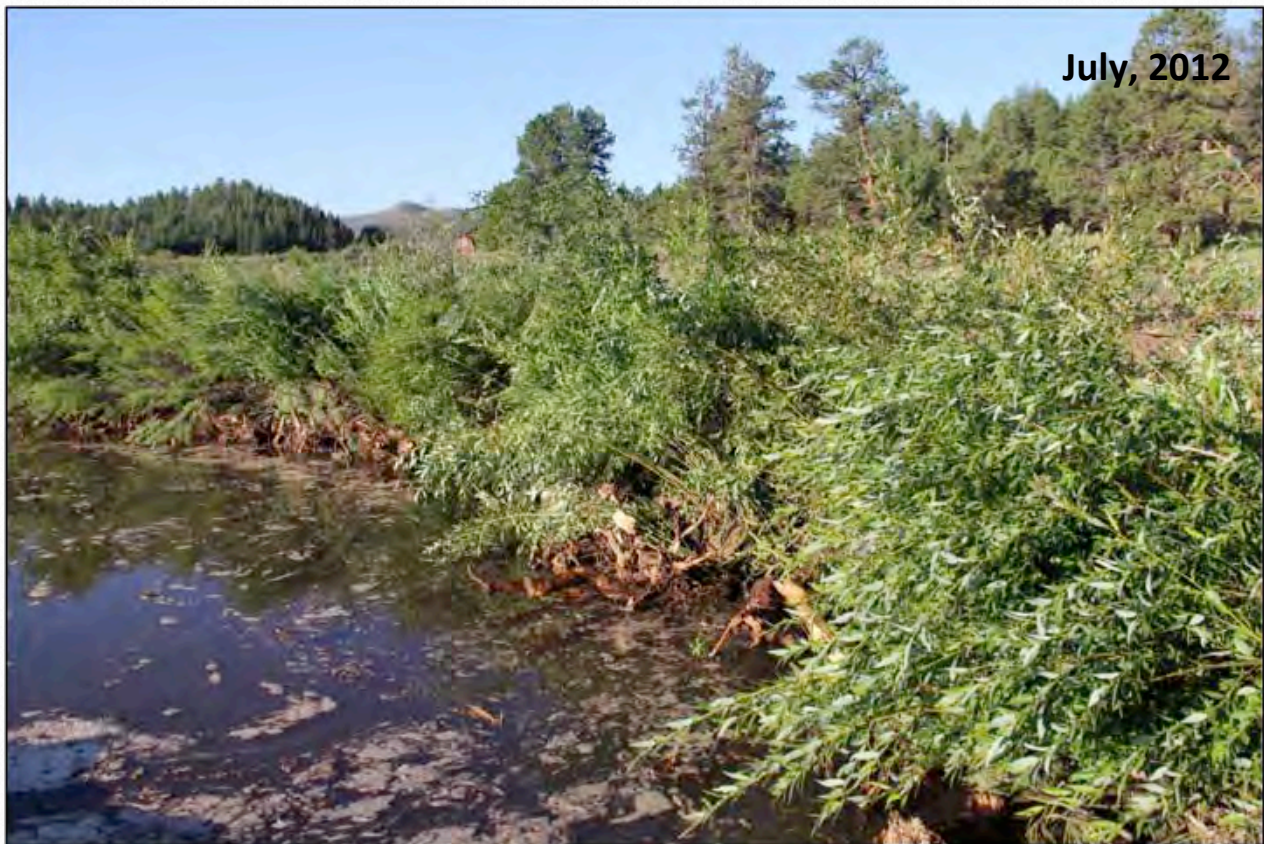
Before vs. After comparison of conversion of a braided (D4) to single-thread meandering (C4) stream type on West Creek showing the excavation and placement of toe wood with transplanted willow riparian vegetation as constructed in July, 2012. Beaver pond in background was reinforced for floodplain function and a raised water table.

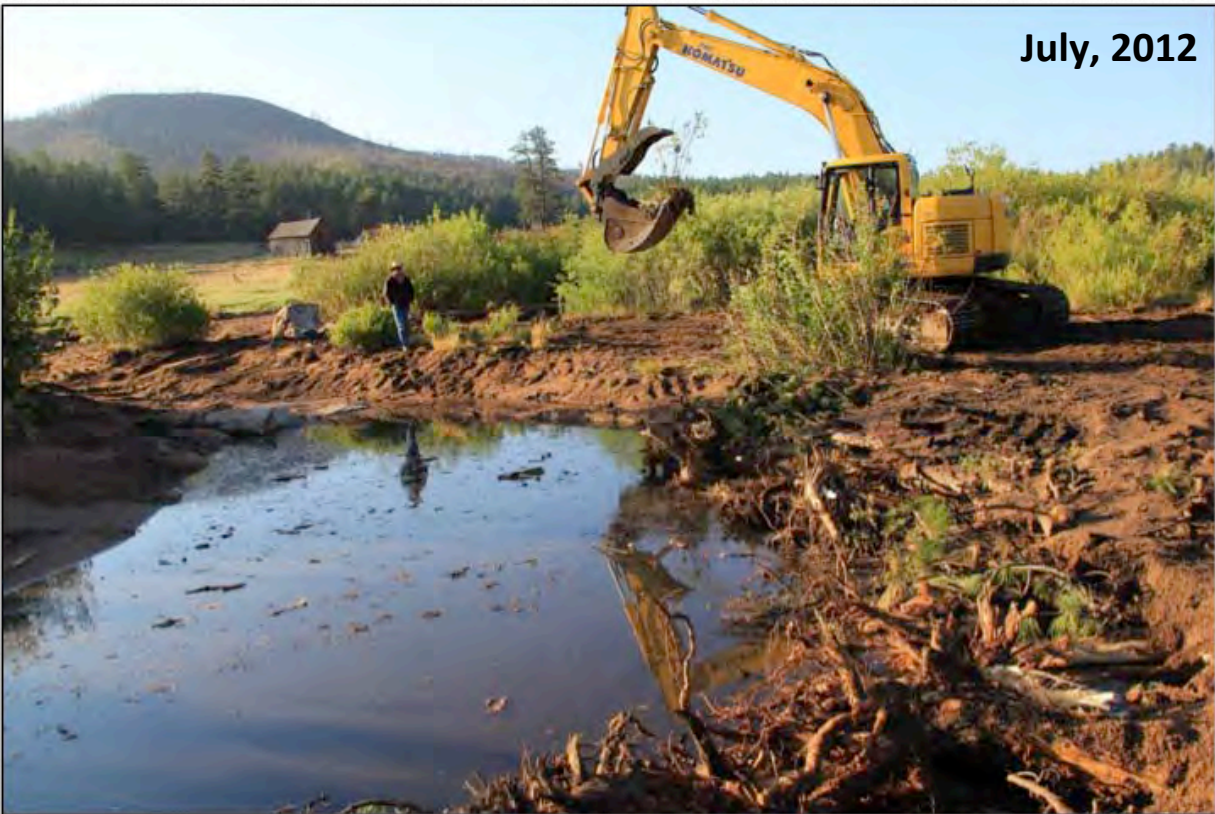
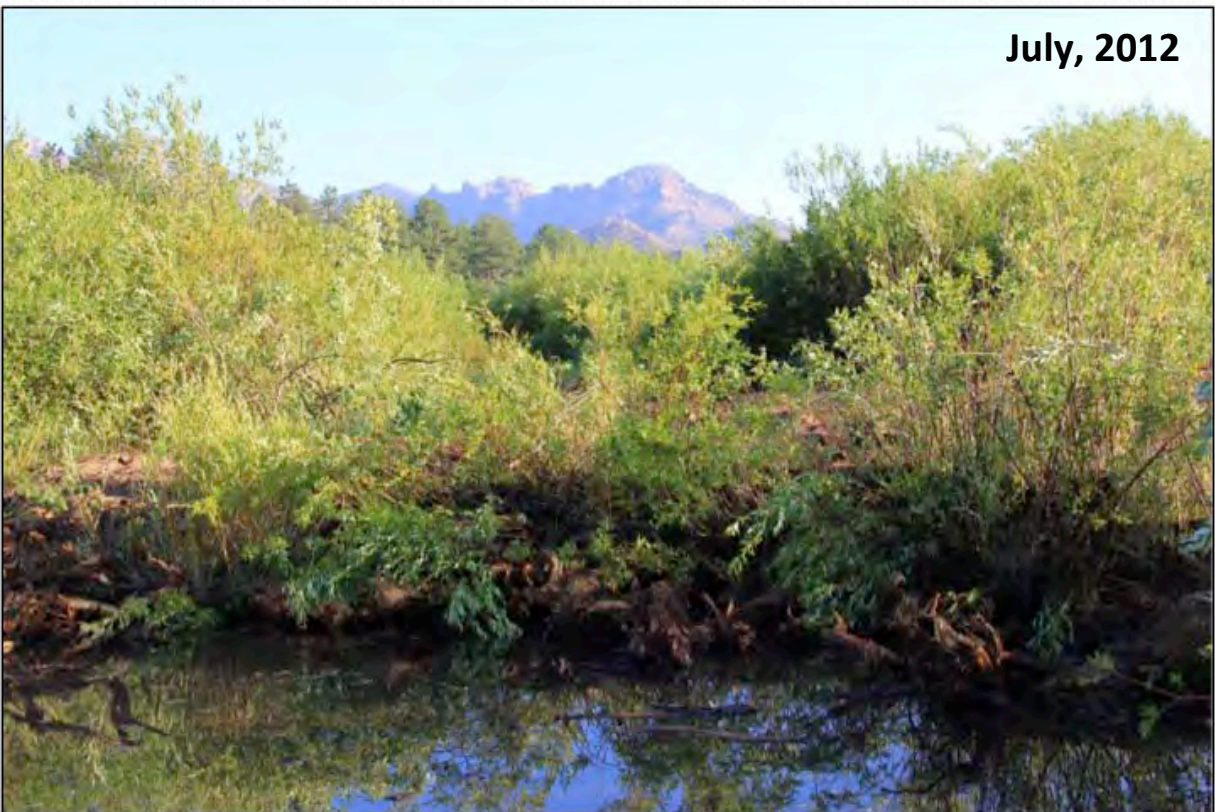
Before vs. After comparison of converting a braided (D4) stream type to meandering (C4) stream type on West Creek using toe wood revetment and fish habitat as constructed in July, 2012.

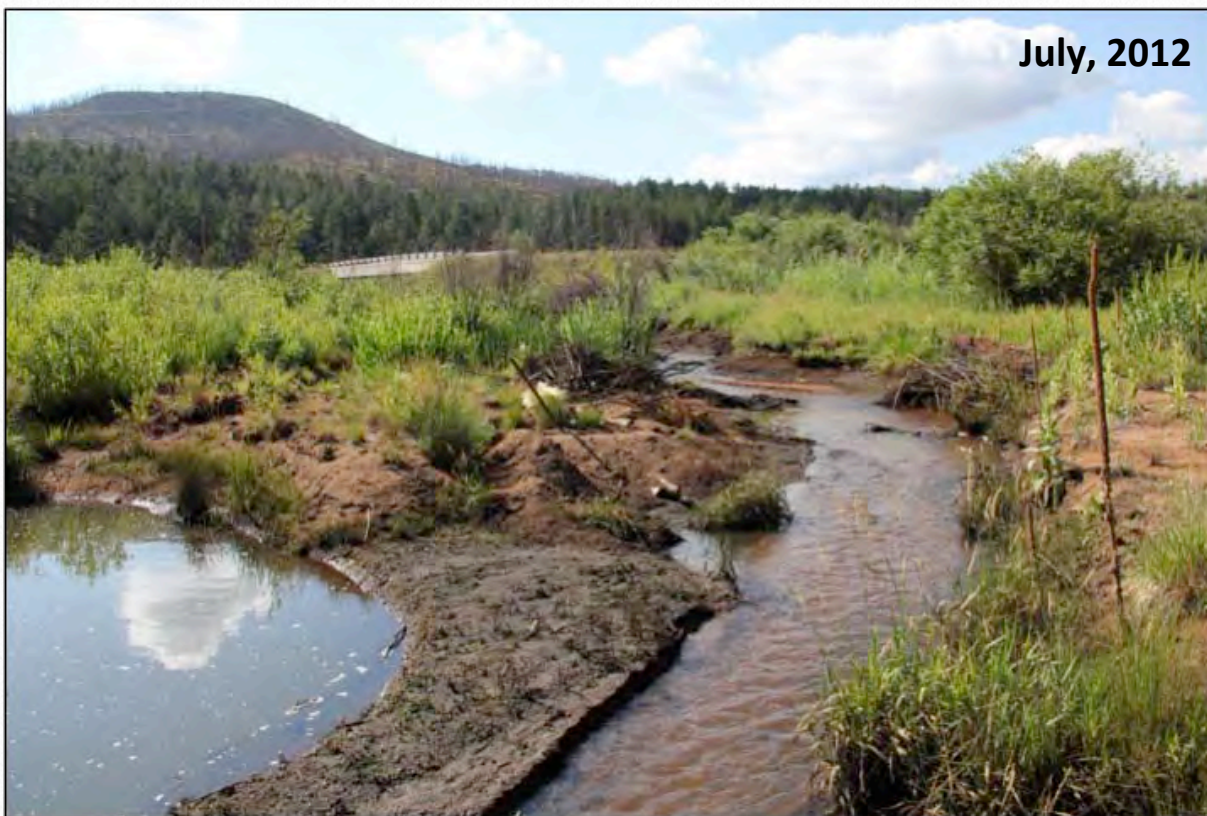
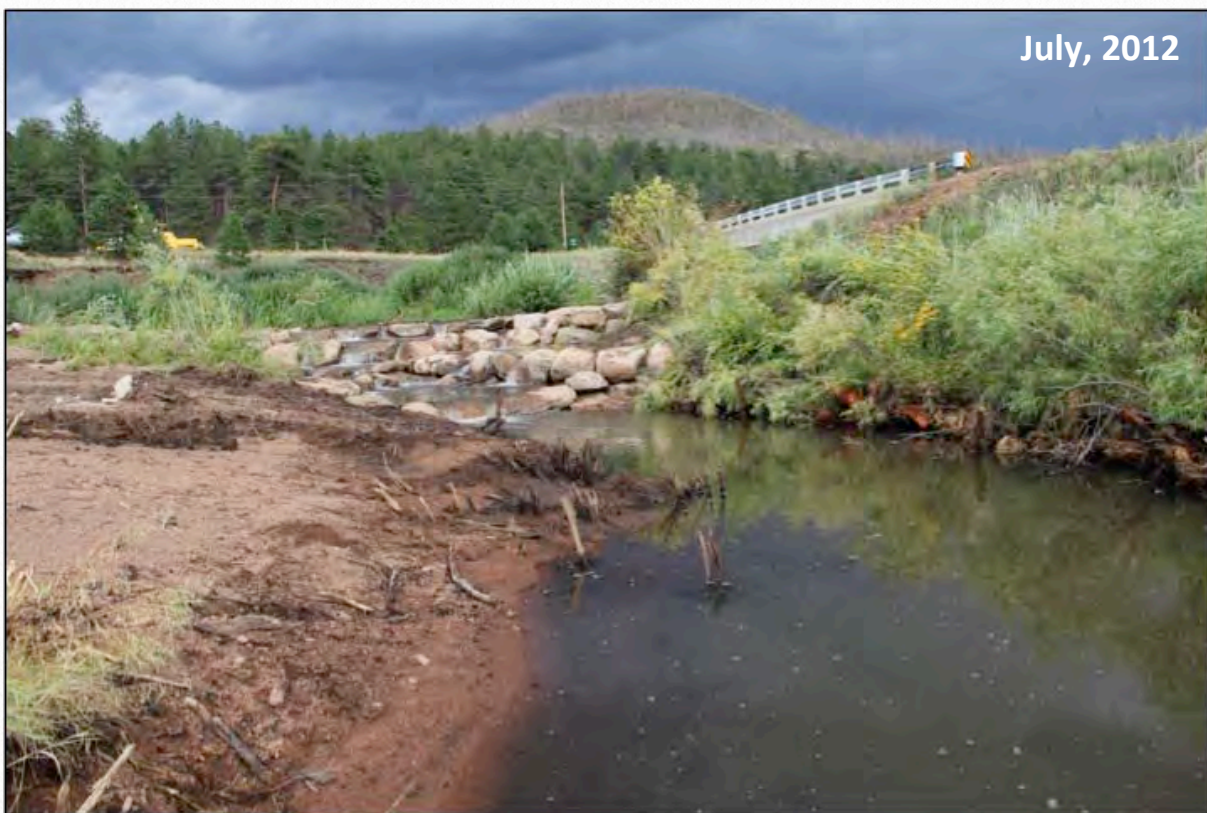
Before vs. After comparison of reach downstream of bridge on West Creek. Step-pool boulder structures were used to maintain beaver dam in place to prevent potential future headcut and breach. Toe wood was placed on bankfull bench in lateral scour pool created. Constructed in July, 2012.

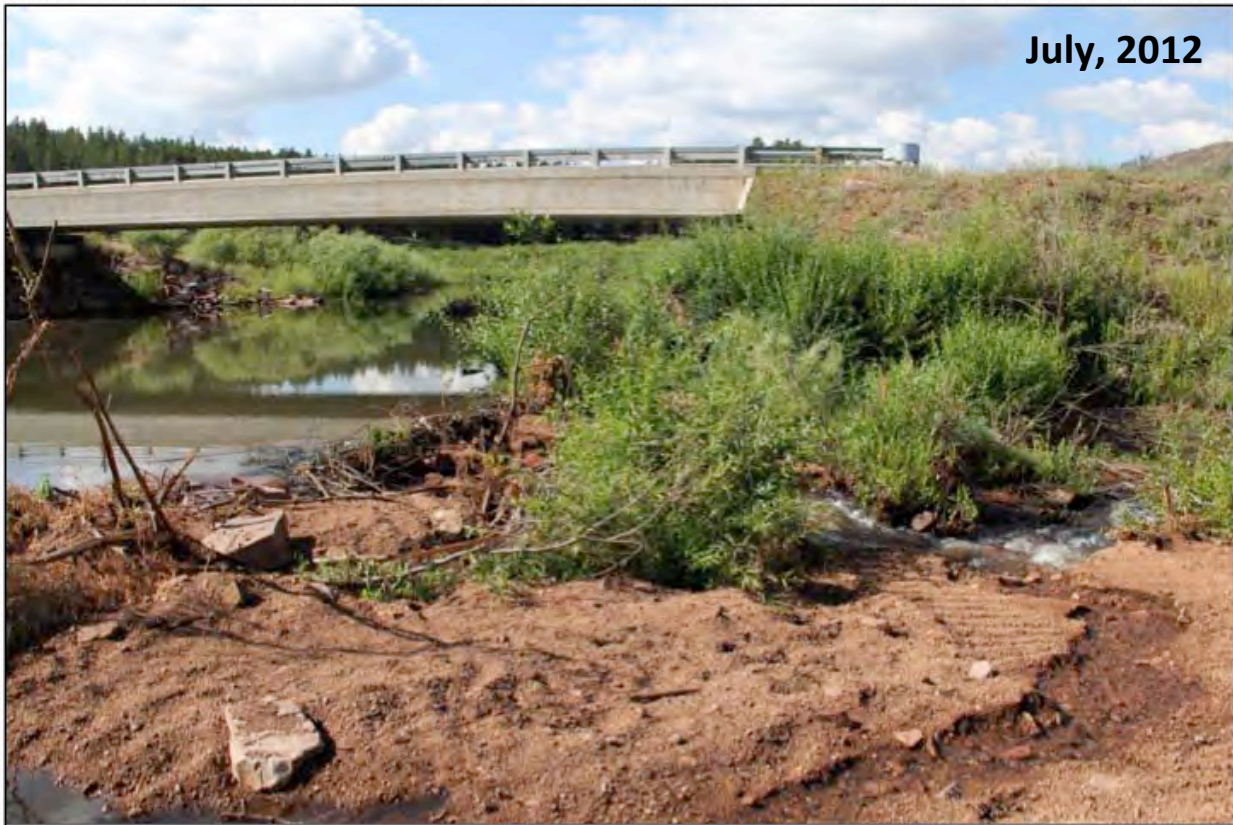
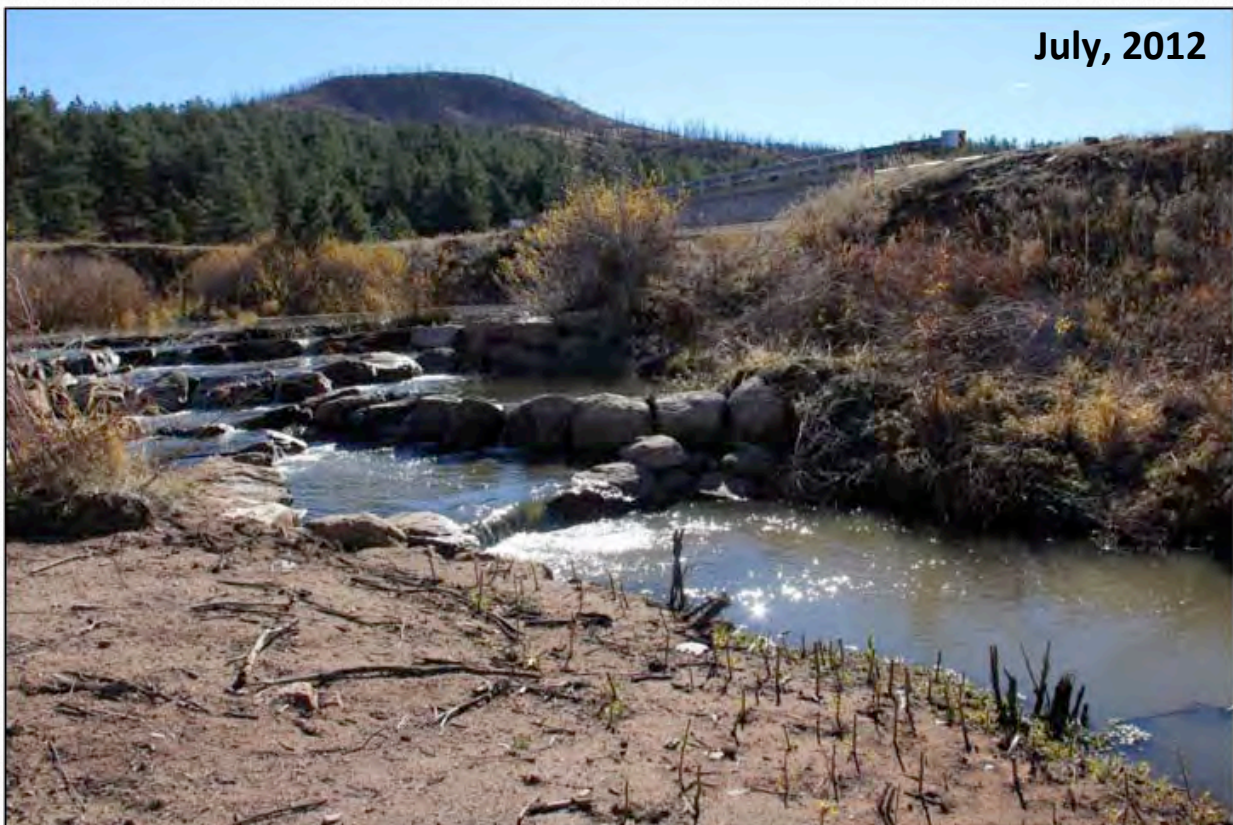
Before vs. After comparison of step-pool boulder structure on West Creek to prevent future breach of existing beaver dam. Note beaver dam immediately above invert of structure. A bankfull bench was constructed at the base of road fill. This reach was constructed in July, 2012.

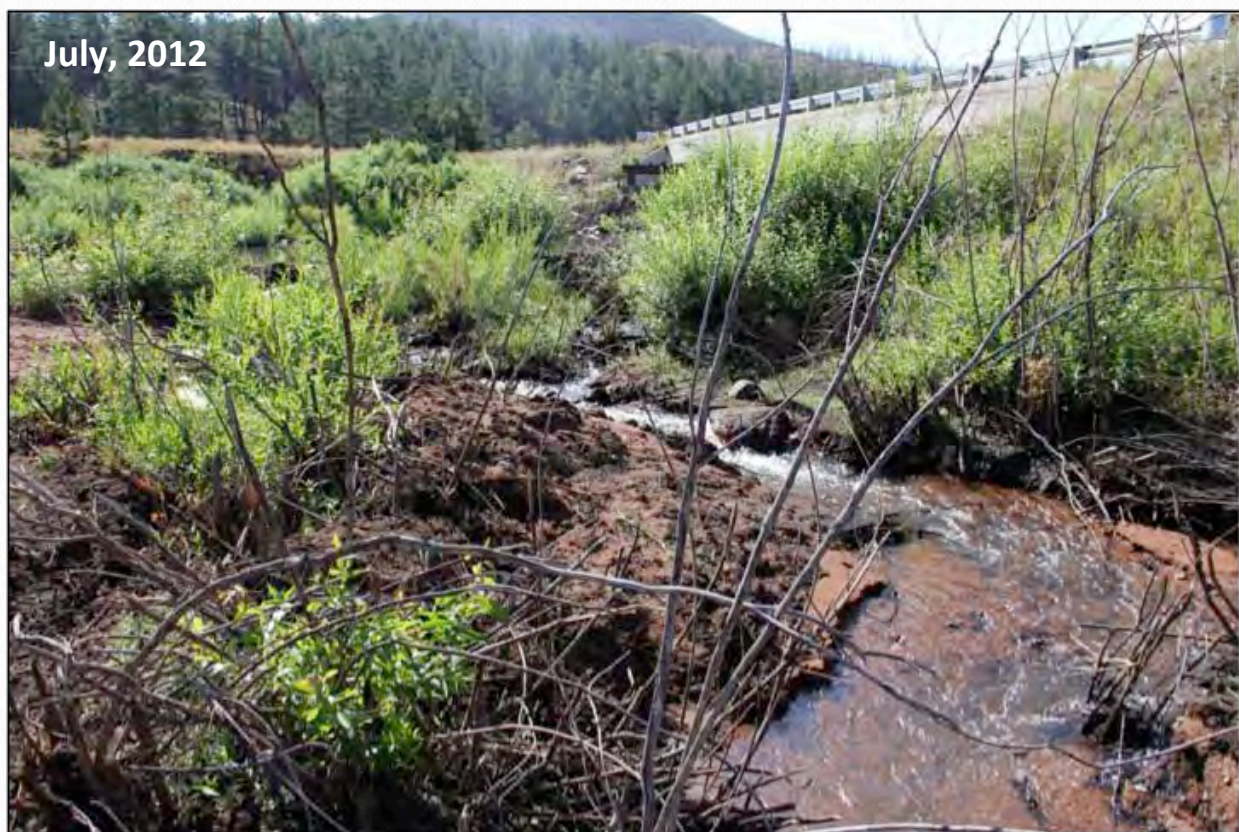
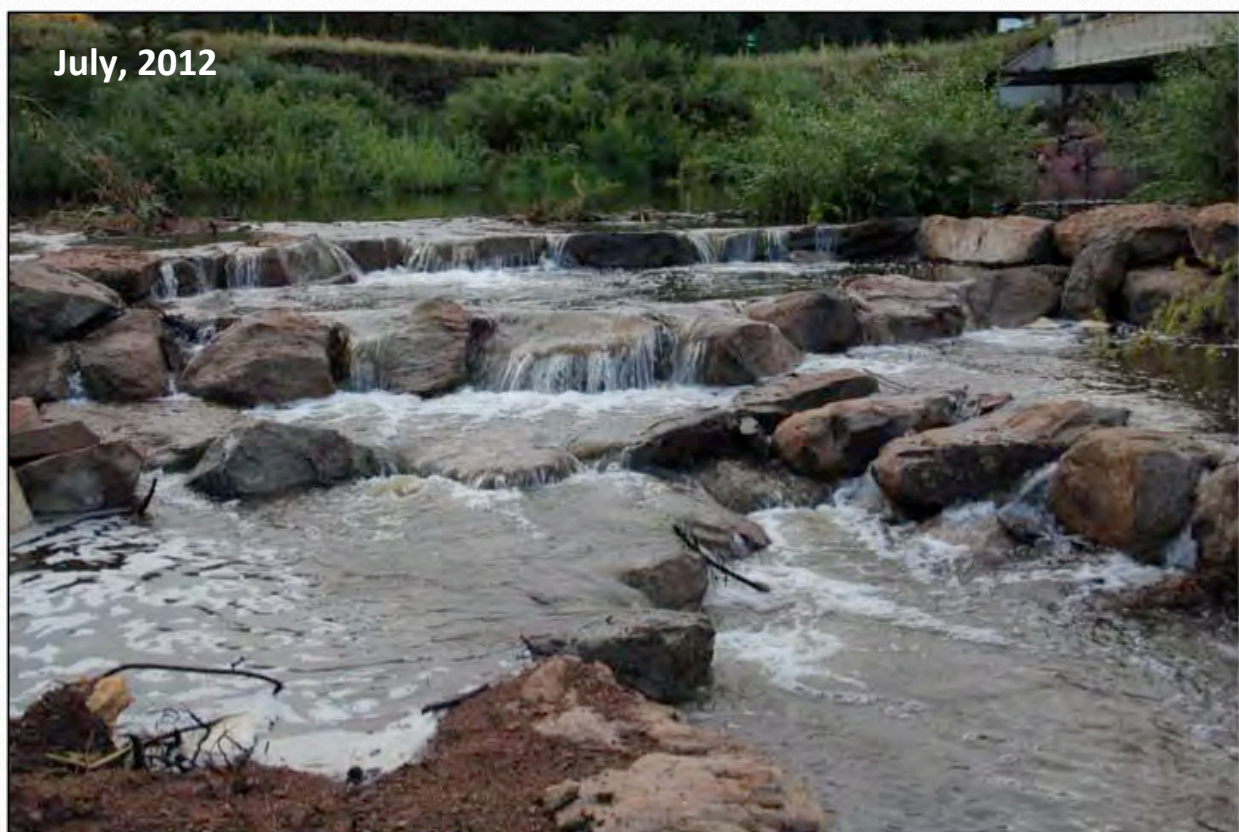
Before vs. After comparison below beaver dam on West Creek. A step-pool structure was used for fish migration, streambank erosion reduction, energy dissipation and grade control (constructed in July, 2012).

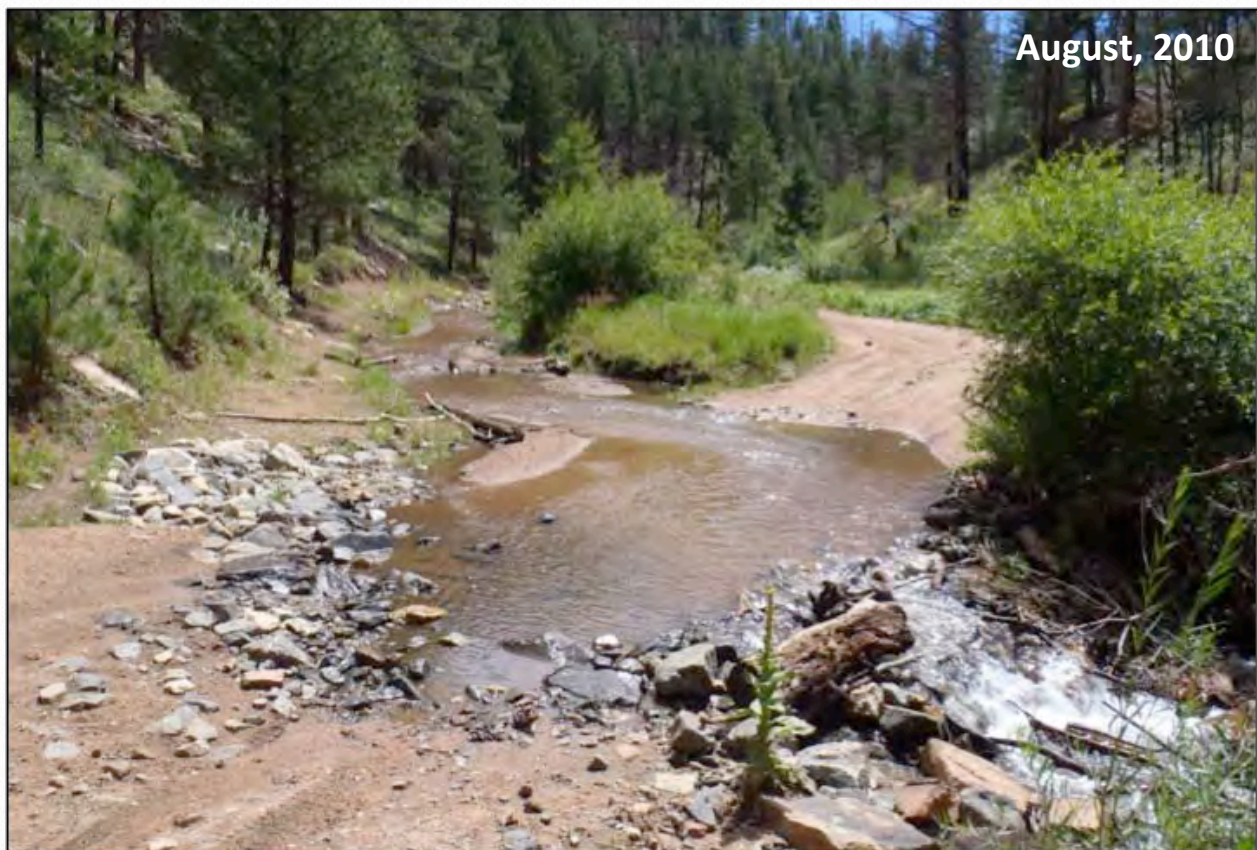
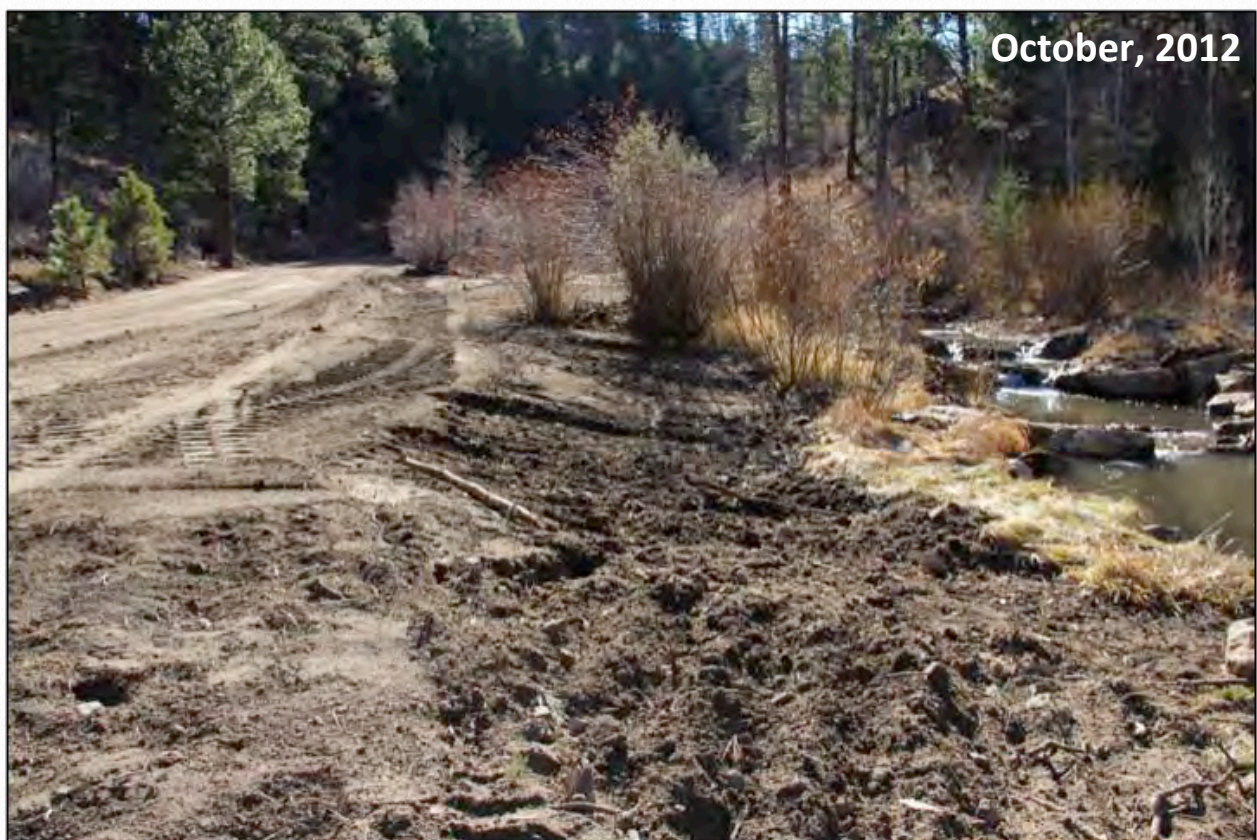
Before vs. After comparison of road and Trail Creek relocation that eliminated two ford crossings as constructed in October, 2012. Photographs are looking upstream.

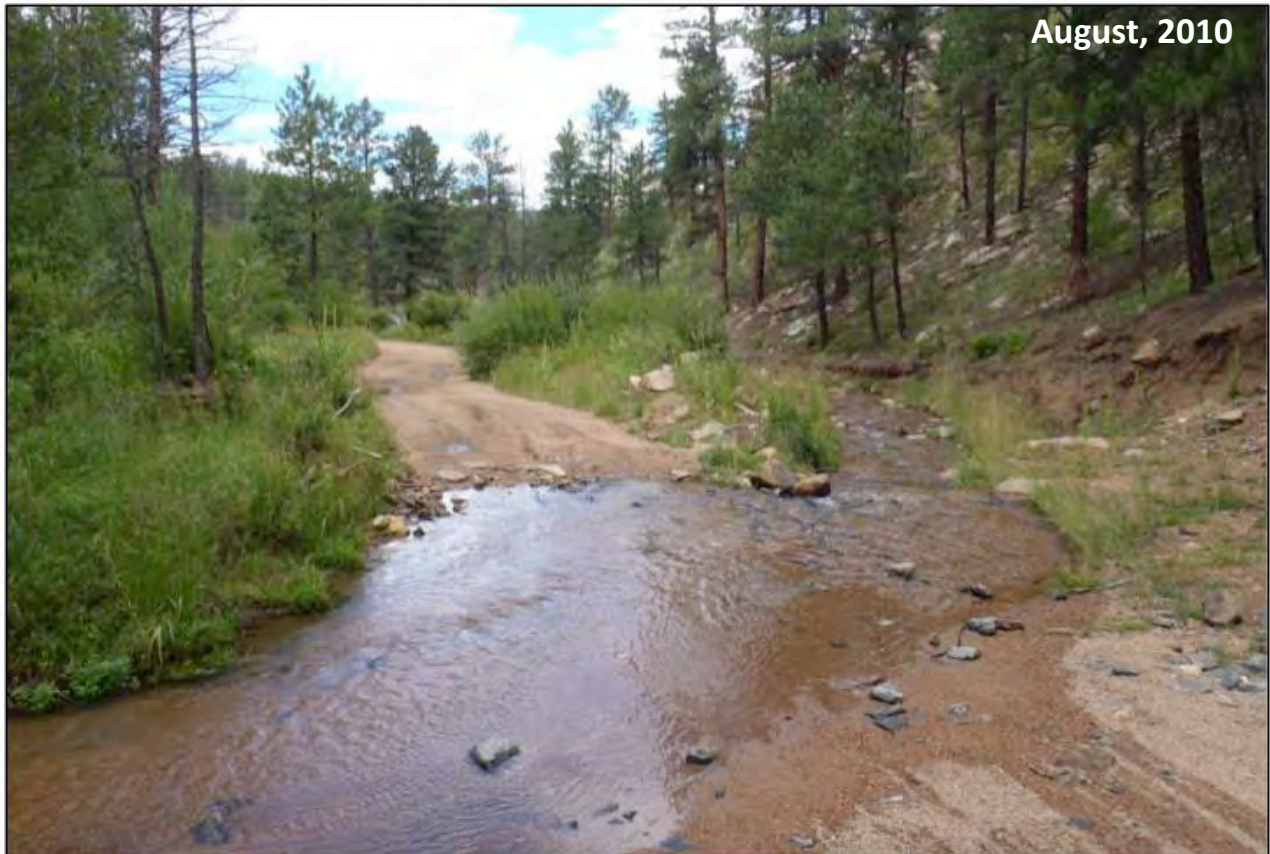
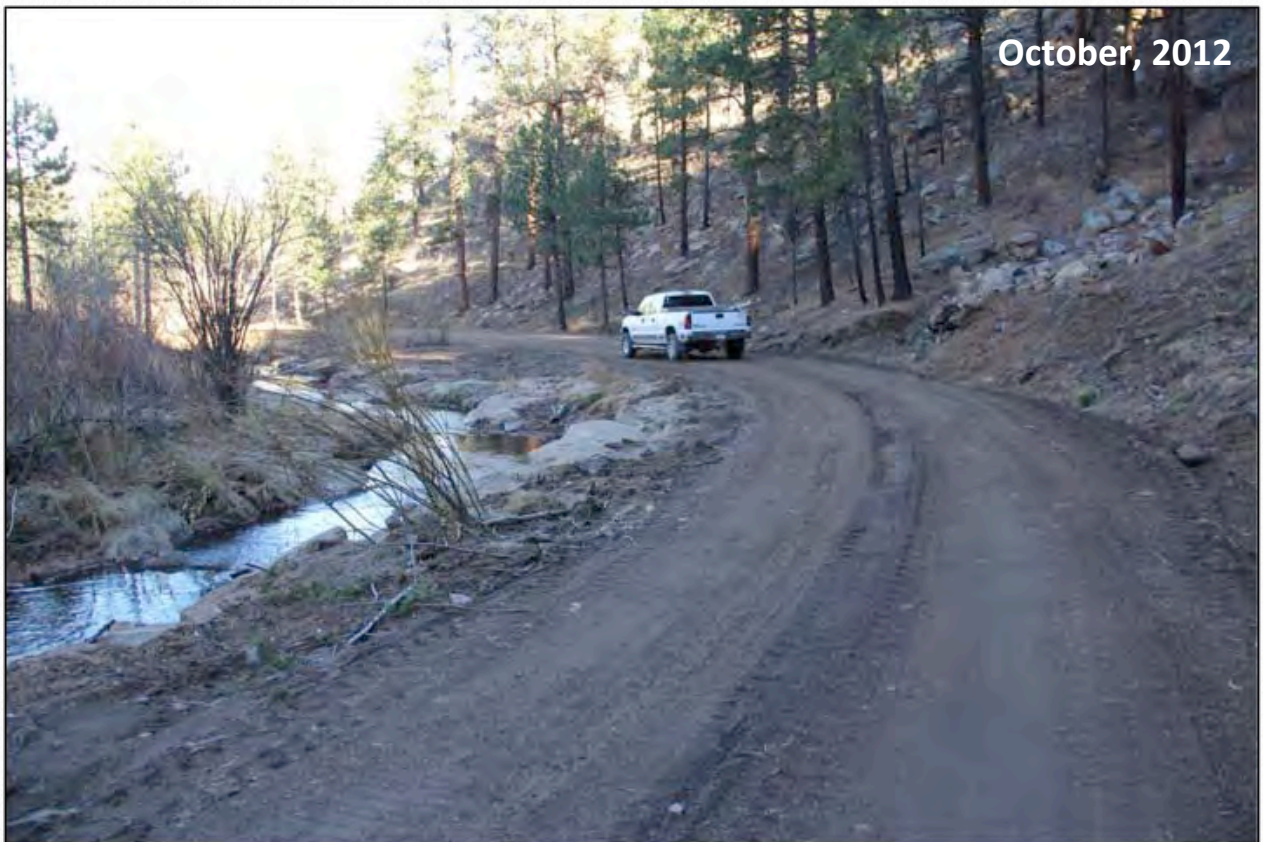
Before vs. After comparison of road and Trail Creek relocation that eliminated two ford crossings as constructed in October, 2012. Photographs are looking downstream.

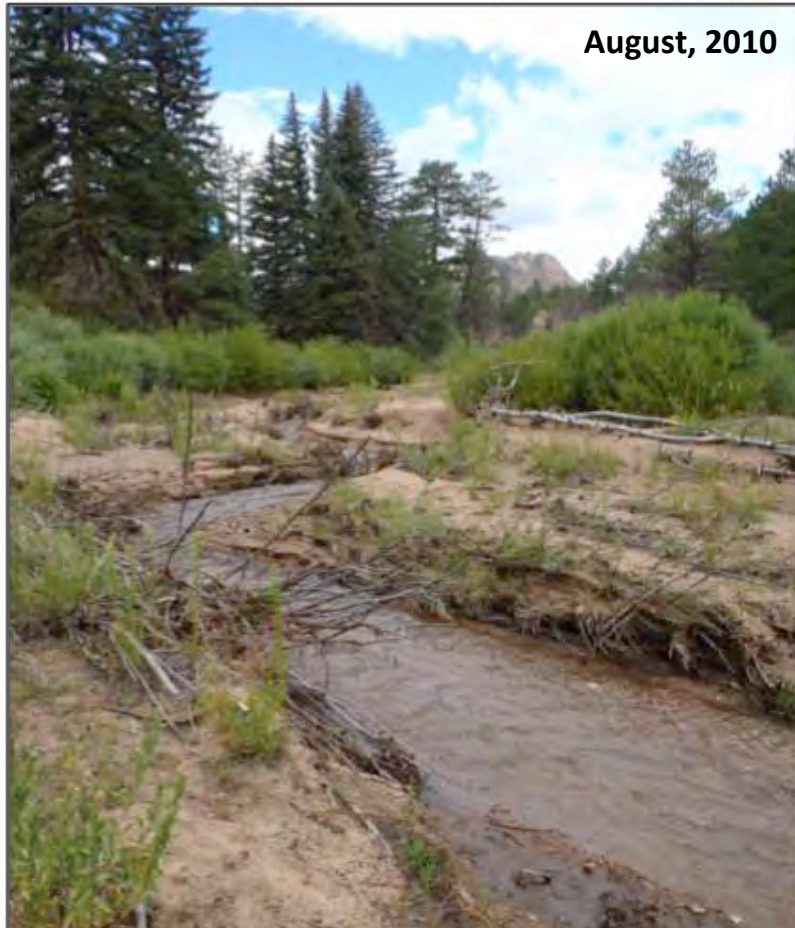
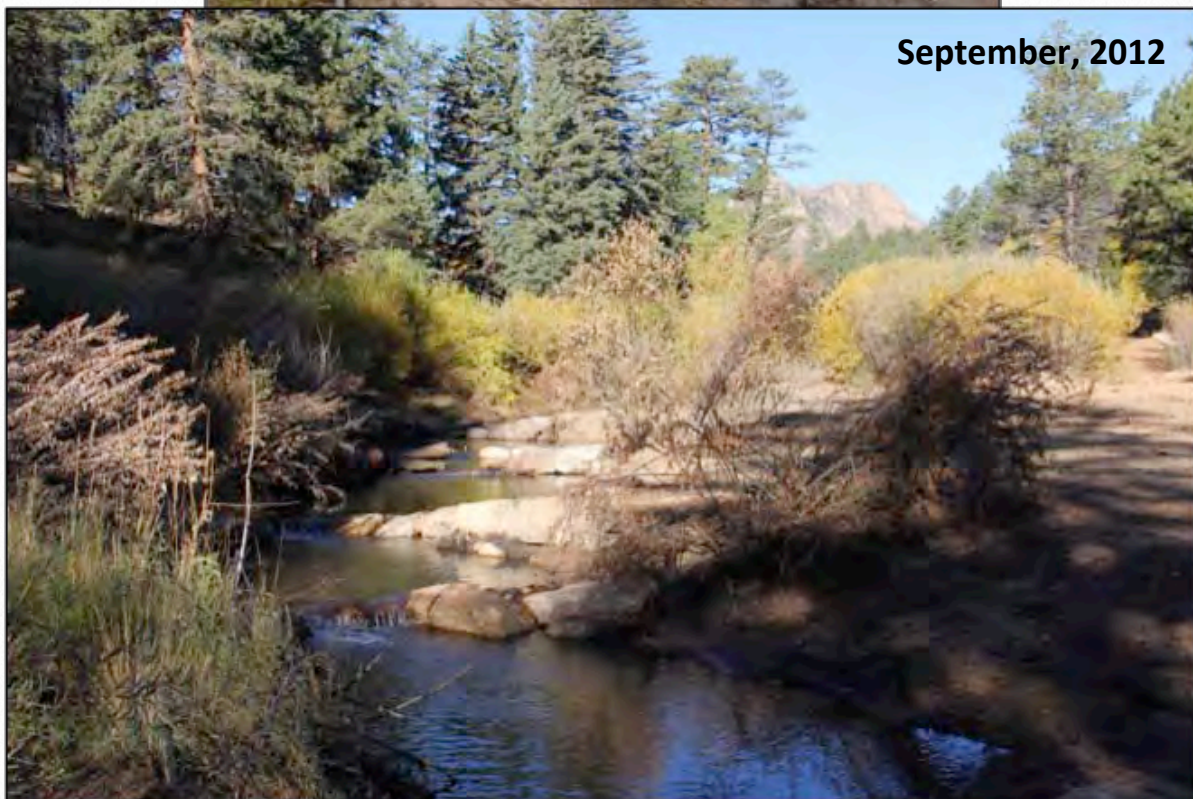
Before vs. After comparison of a reach on Trail Creek as constructed in September, 2012. Trail Creek was raised two feet in elevation to reconnect to previous floodplain at this location.
