# Trail Creek Restoration

## Final Report

April 30, 2015

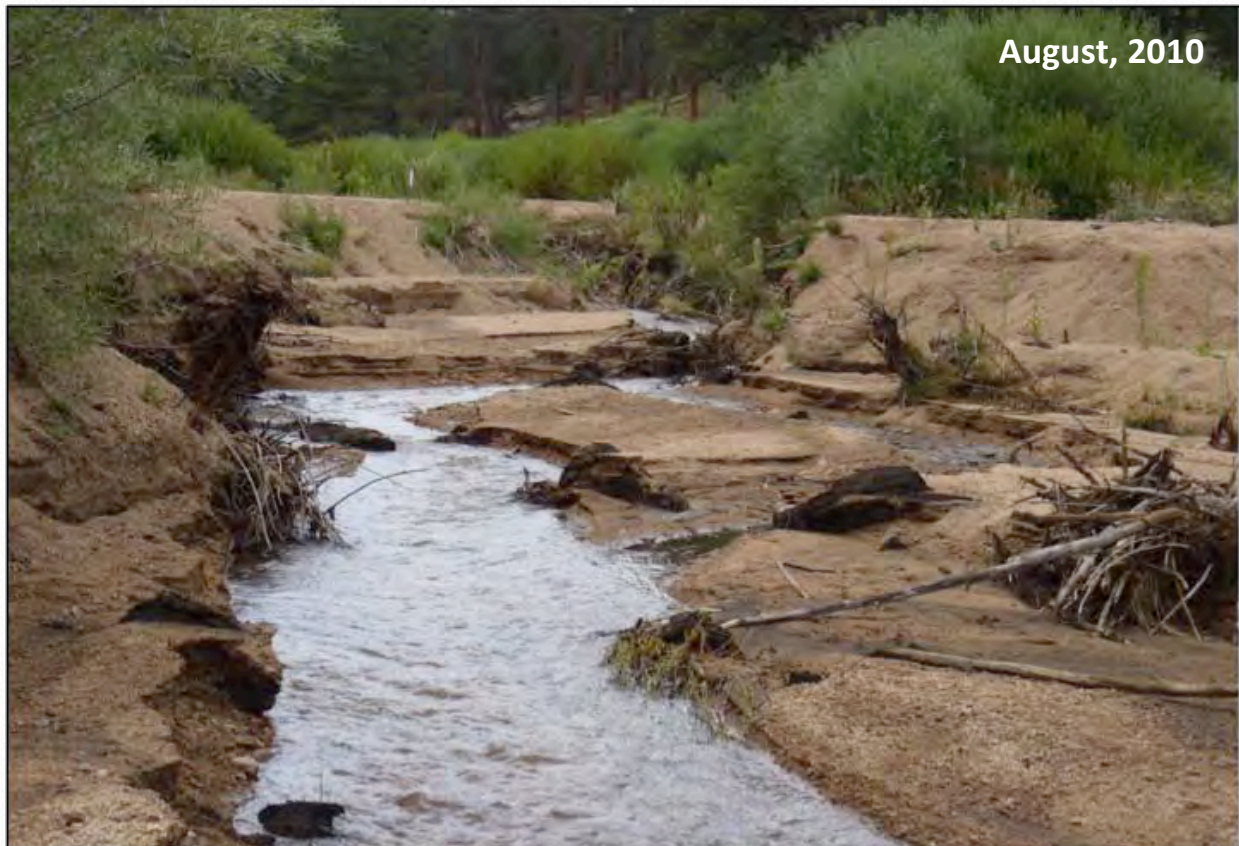
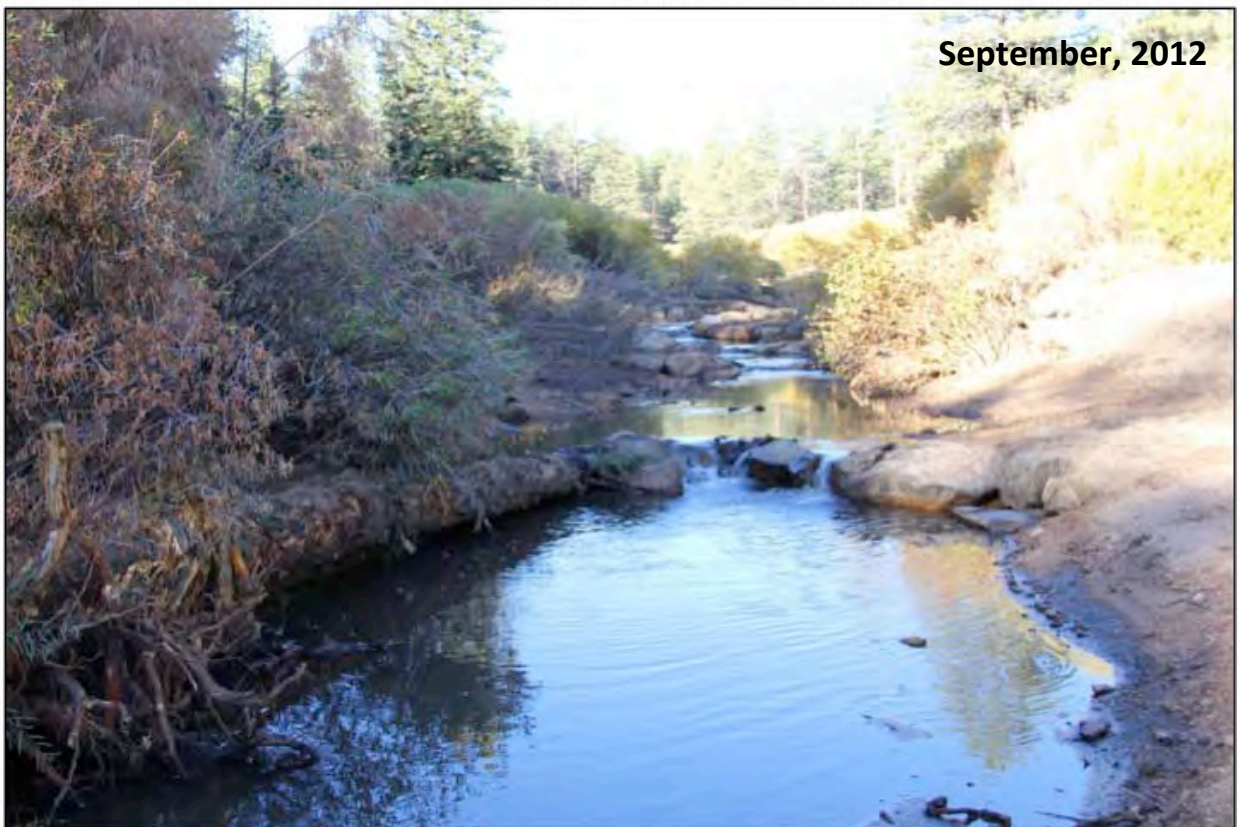
Before vs. After comparison of mainstem Trail Creek where the deeply entrenched stream type (G4 to F4) was converted to a stable B4, step-pool stream type as constructed in September, 2012.

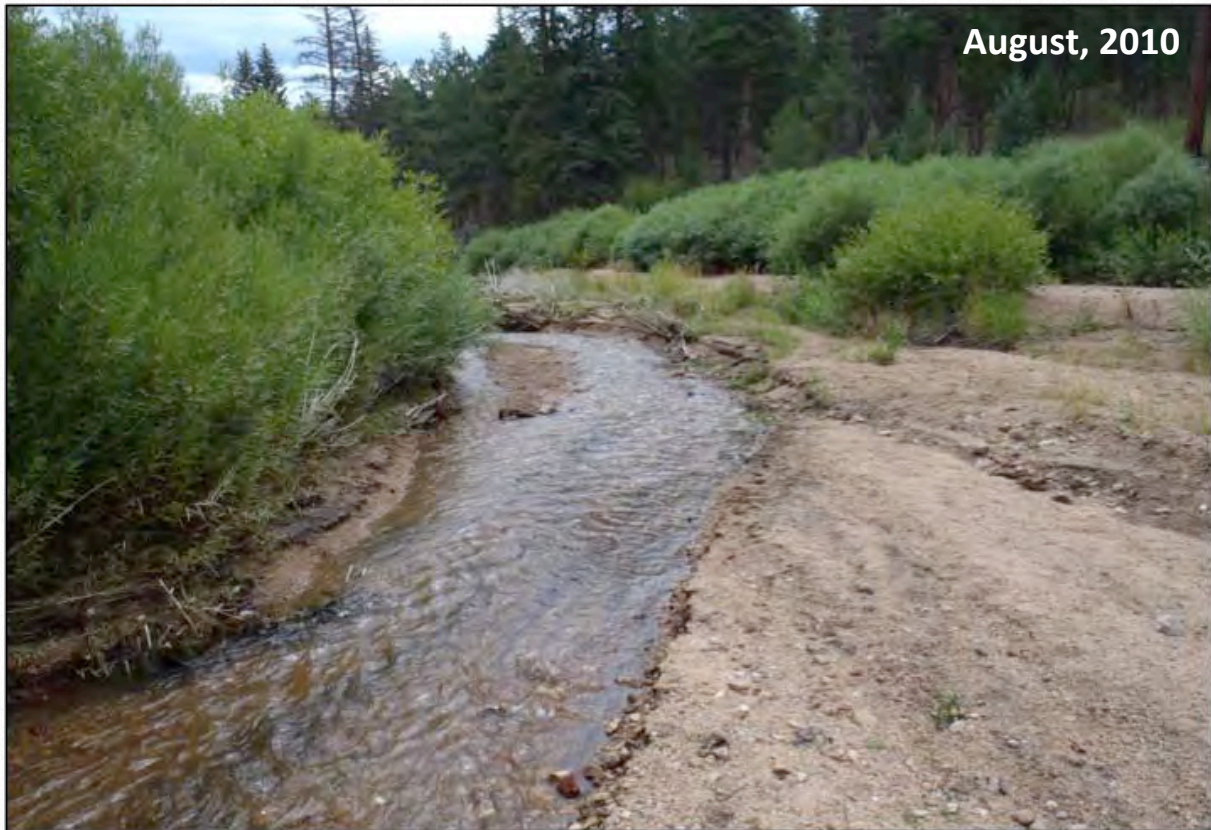
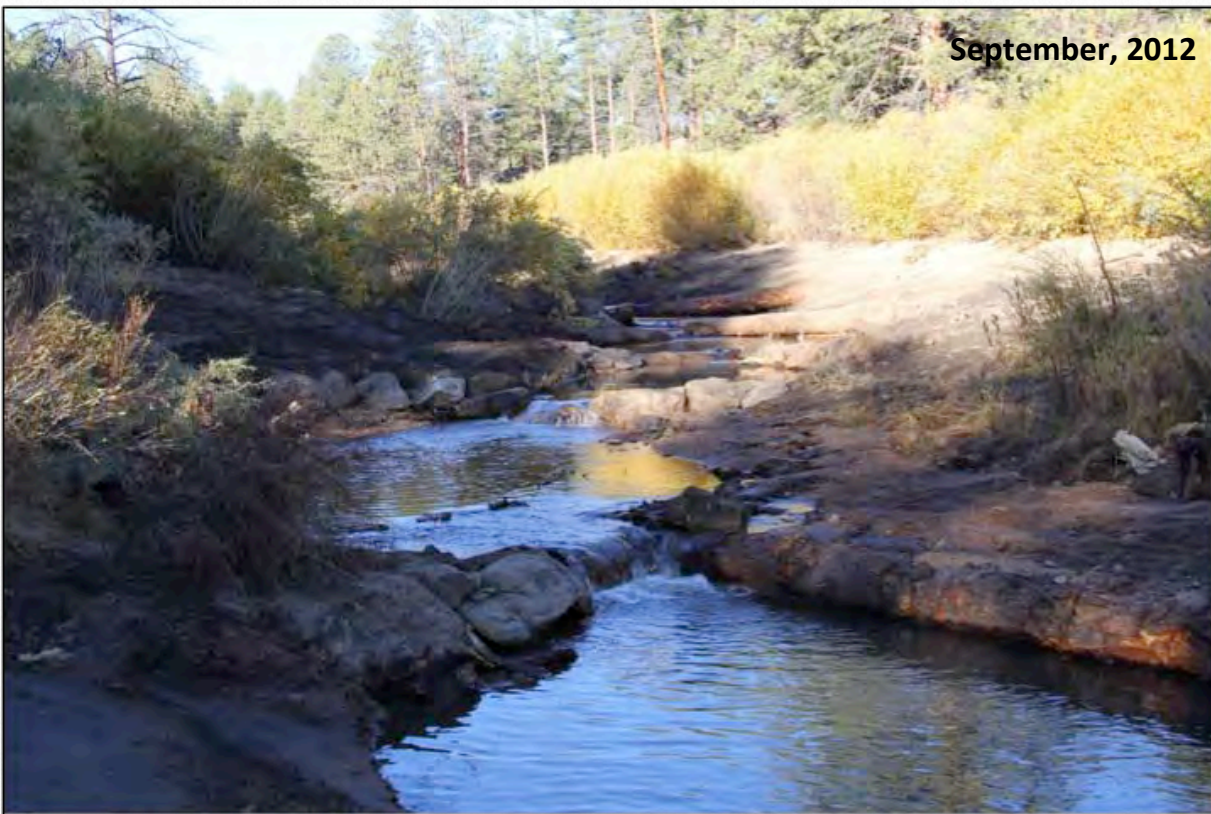
Before vs. After comparison of conversion from a high width/depth ratio, entrenched (F4) stream type on Trail Creek that was converted to a stable, step-pool B4 stream type as constructed in September, 2012.

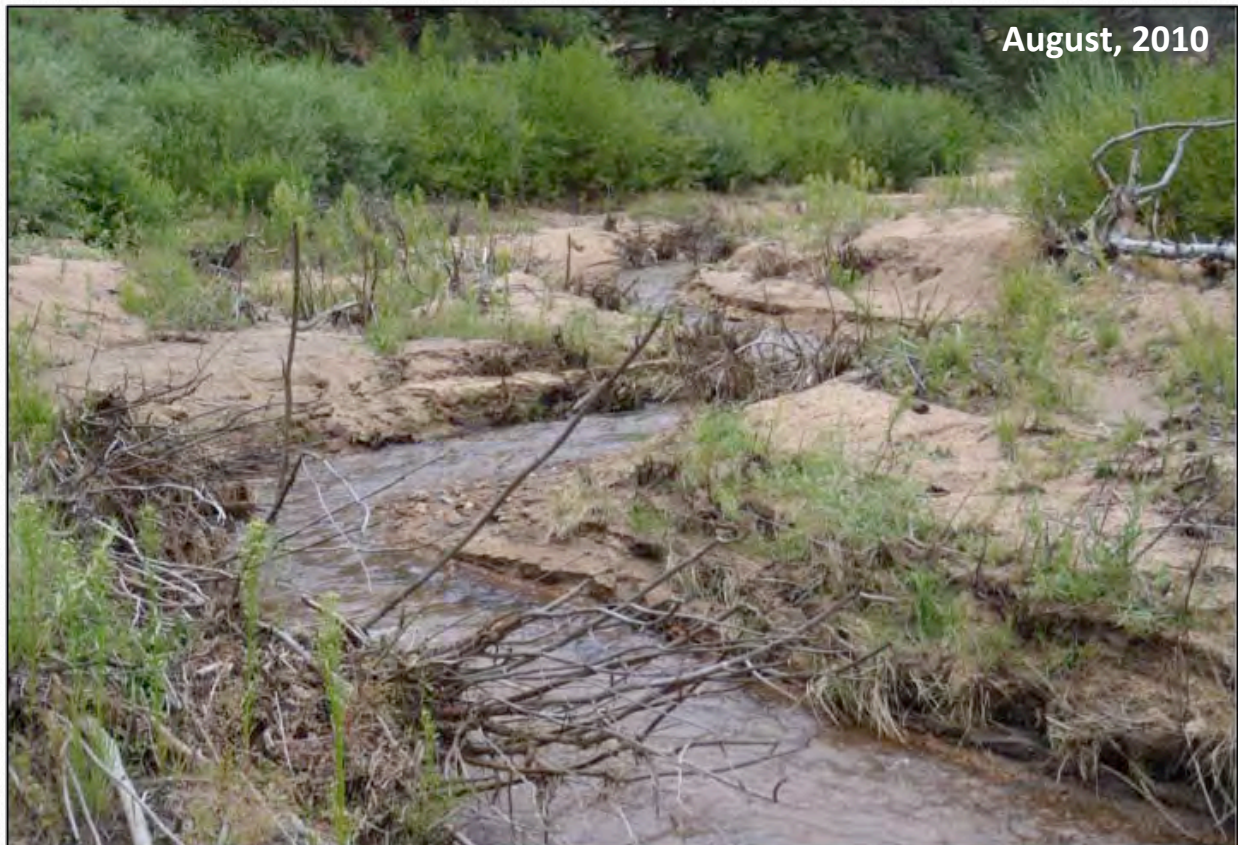
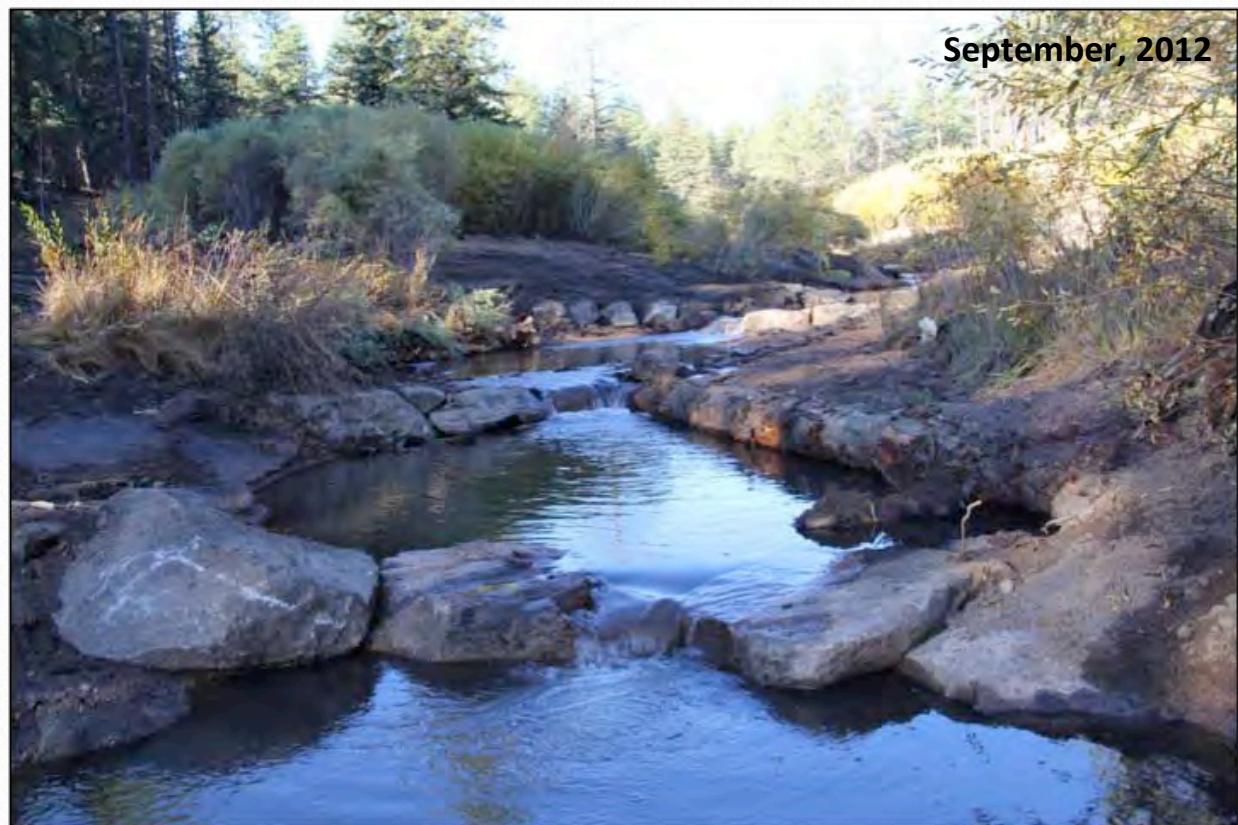
Before vs. After comparison of entrenched (F4) stream type converted to a step-pool B4 stream type as constructed in September, 2012. Note reduction in exposed streambanks and energy dissipation/grade control with use of a combination of log and rock structures.

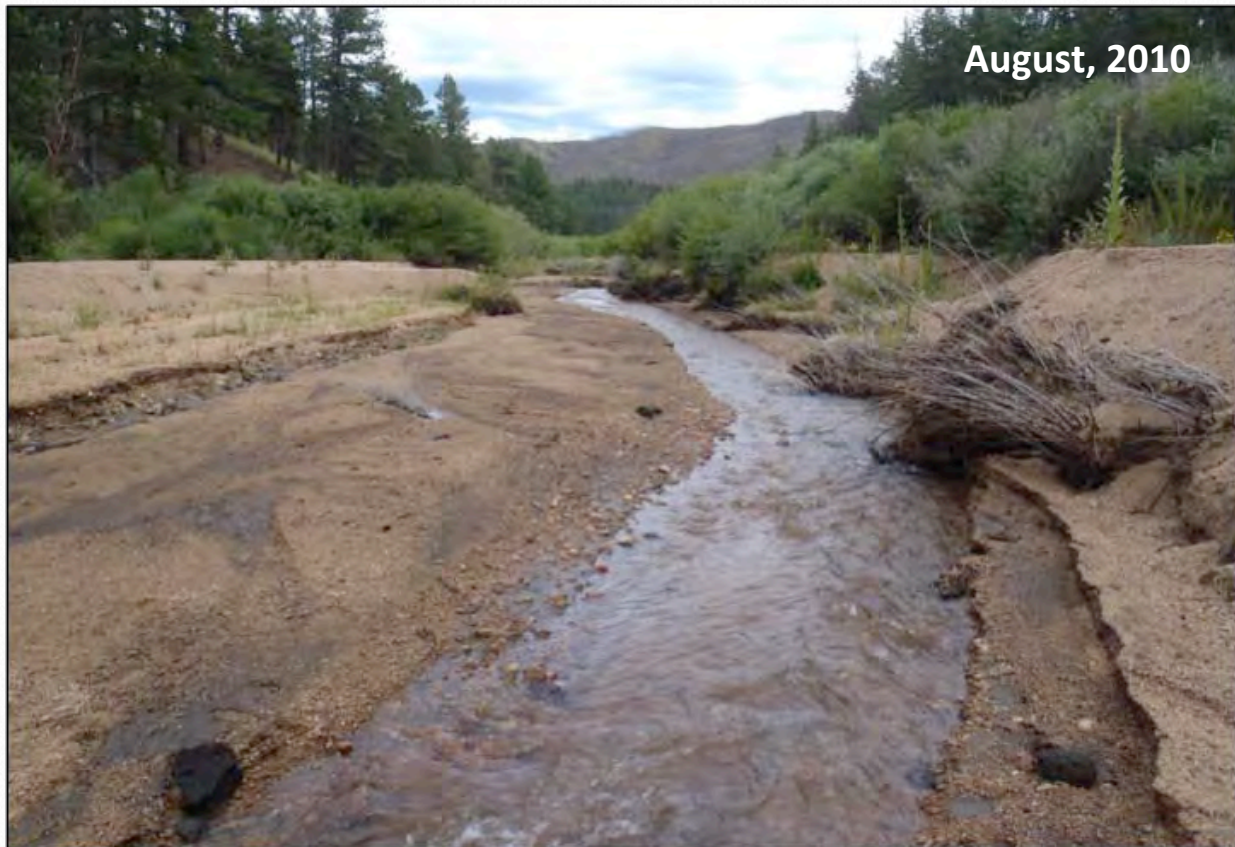
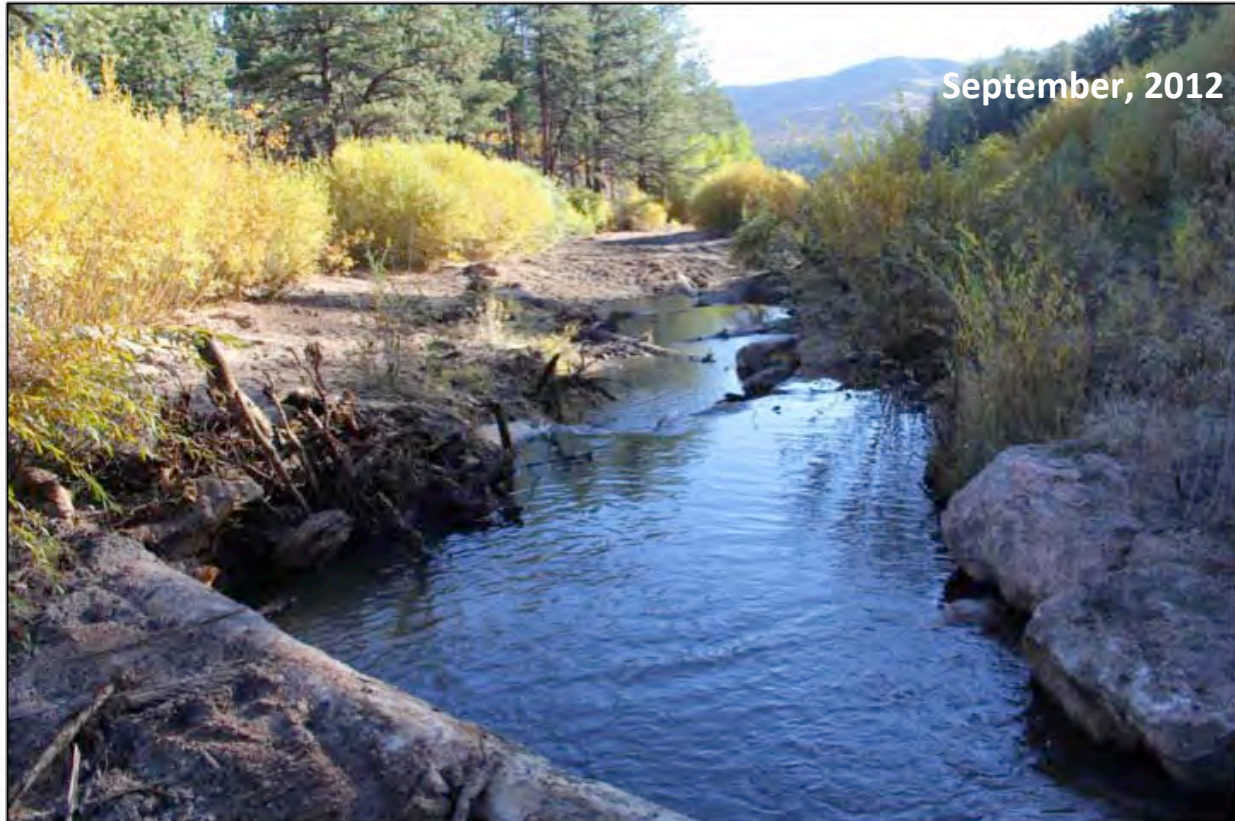
Before vs. After comparison of restoration on lower Trail Creek (looking downstream) as the entrenched (F4) stream type was converted to a meandering C4 type as constructed in September, 2012.

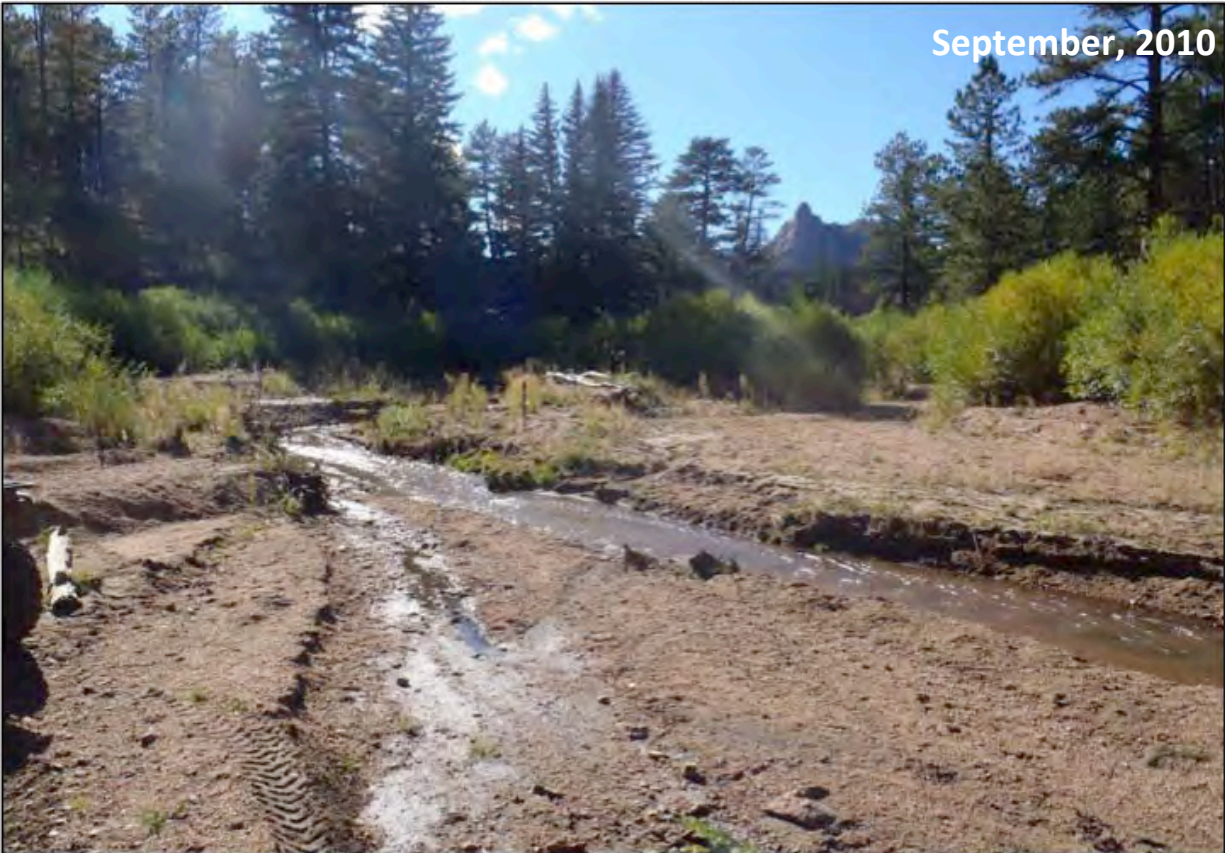
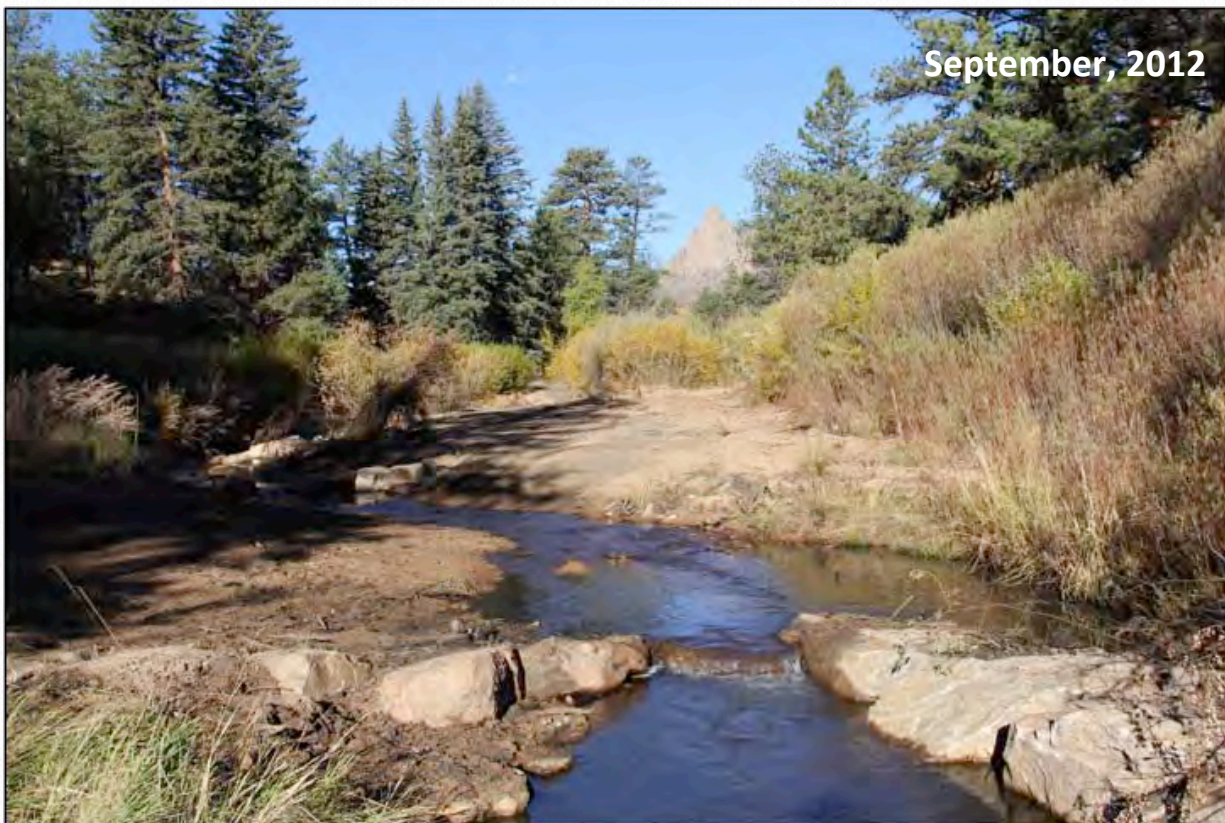
Before vs. After comparison of newly constructed, meandering C4 stream type (September, 2012).

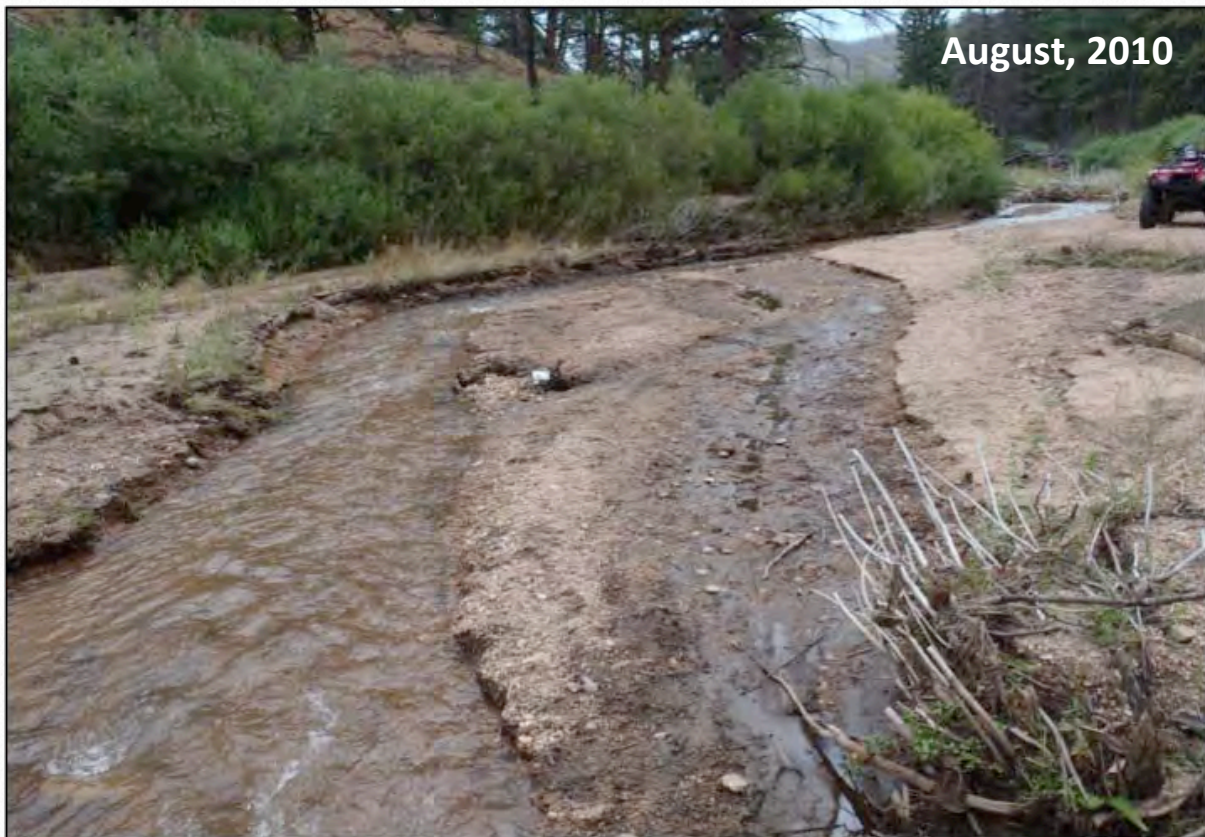
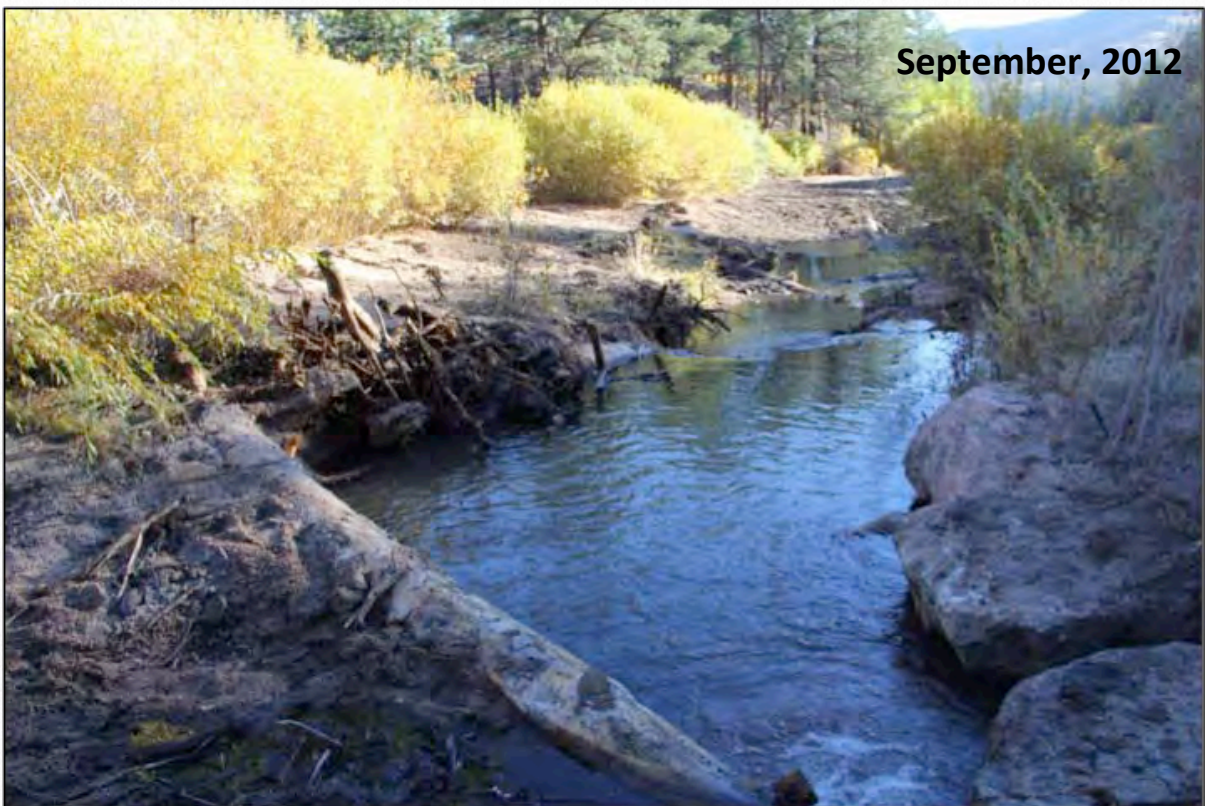
Before vs. After comparison looking downstream on Trail Creek showing log J-Hook Vane and Toe Wood structures as constructed in September, 2012.

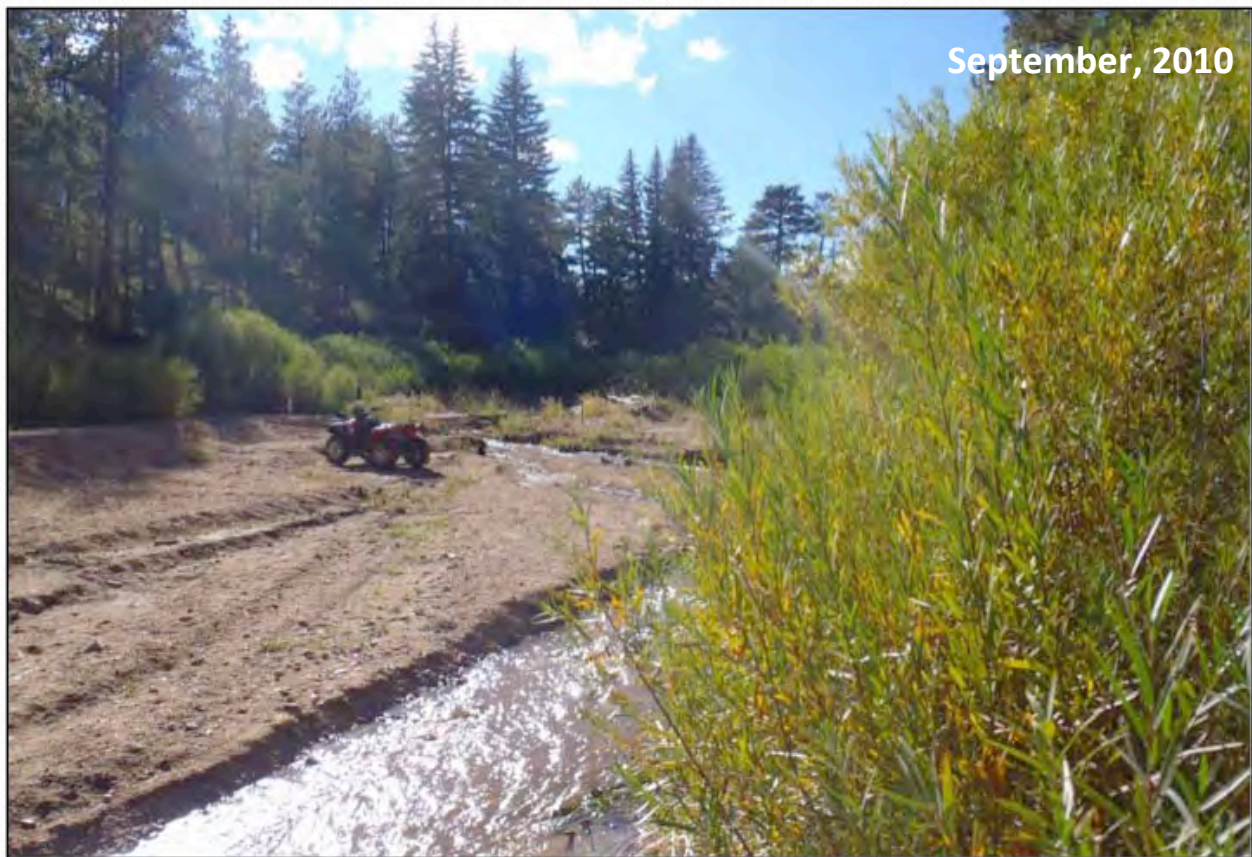
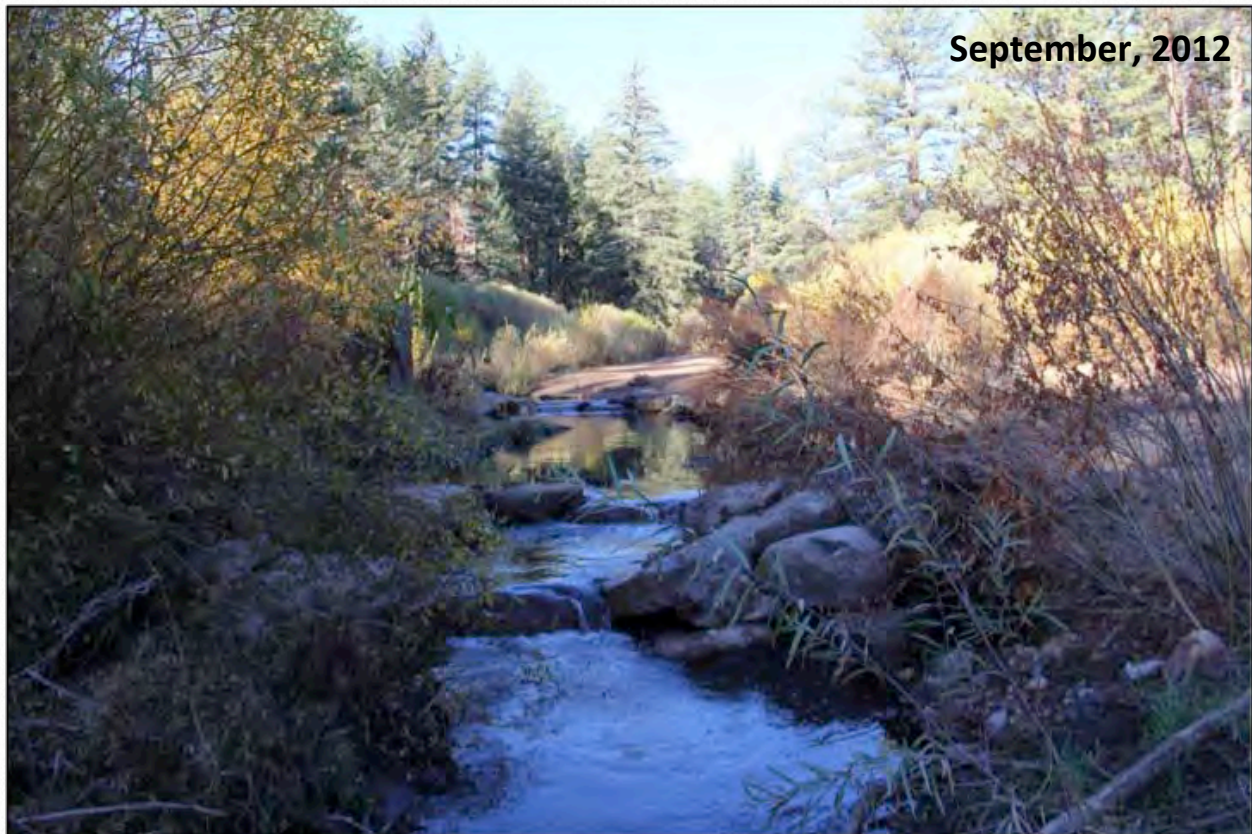
Before vs. After comparison of lower Trail Creek looking upstream transitioning from a C4 to B4 step-pool channel as constructed in September, 2012.
