Aquatic Habitat Assessment & Enhancement Plan Tarryall Creek - Landis Ranch Park County, Colorado

FIN-UP Habitat Consultants, Inc.

August 2015

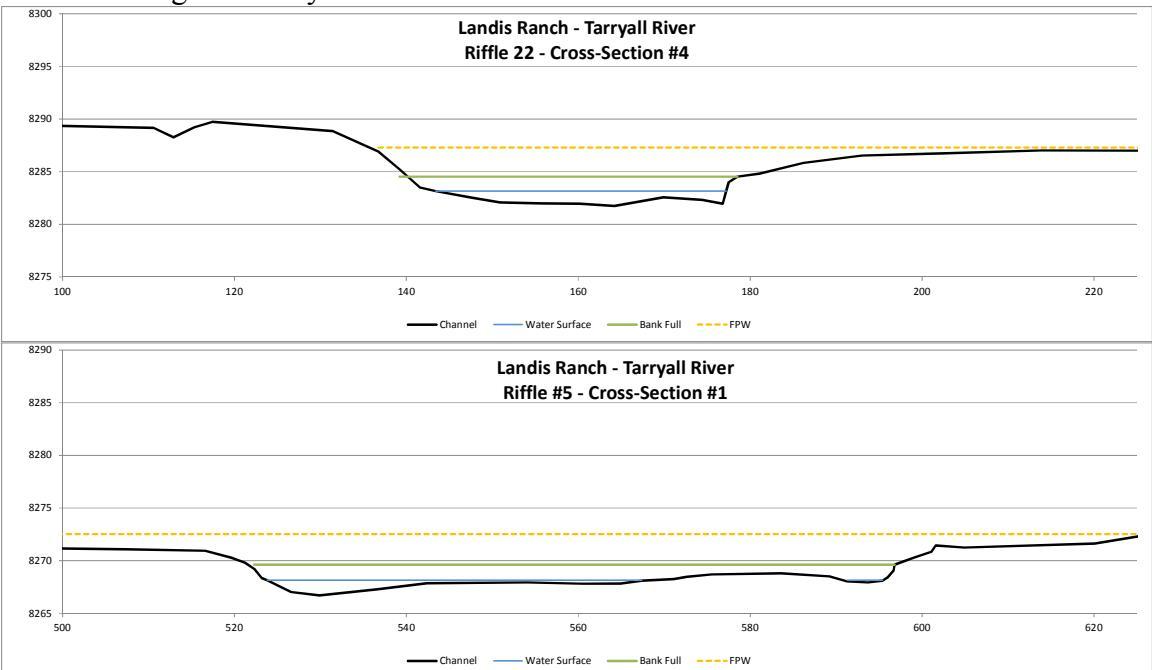
Chart 2: Comparison of cross section profiles in the Tarryall River study reach.

The chart below shows a comparison of channel cross sections through riffles in the study reach. The upper chart shows a typical channel cross section through Riffle 22. The lower chart shows the over-wide cross section through Riffle 5, upstream of the lower diversion structure. Width/depth ratios along this segment of the river were more than 2 times greater than in the other segments in the river, and appeared to be the result of river over-widening caused by the diversion structure itself.

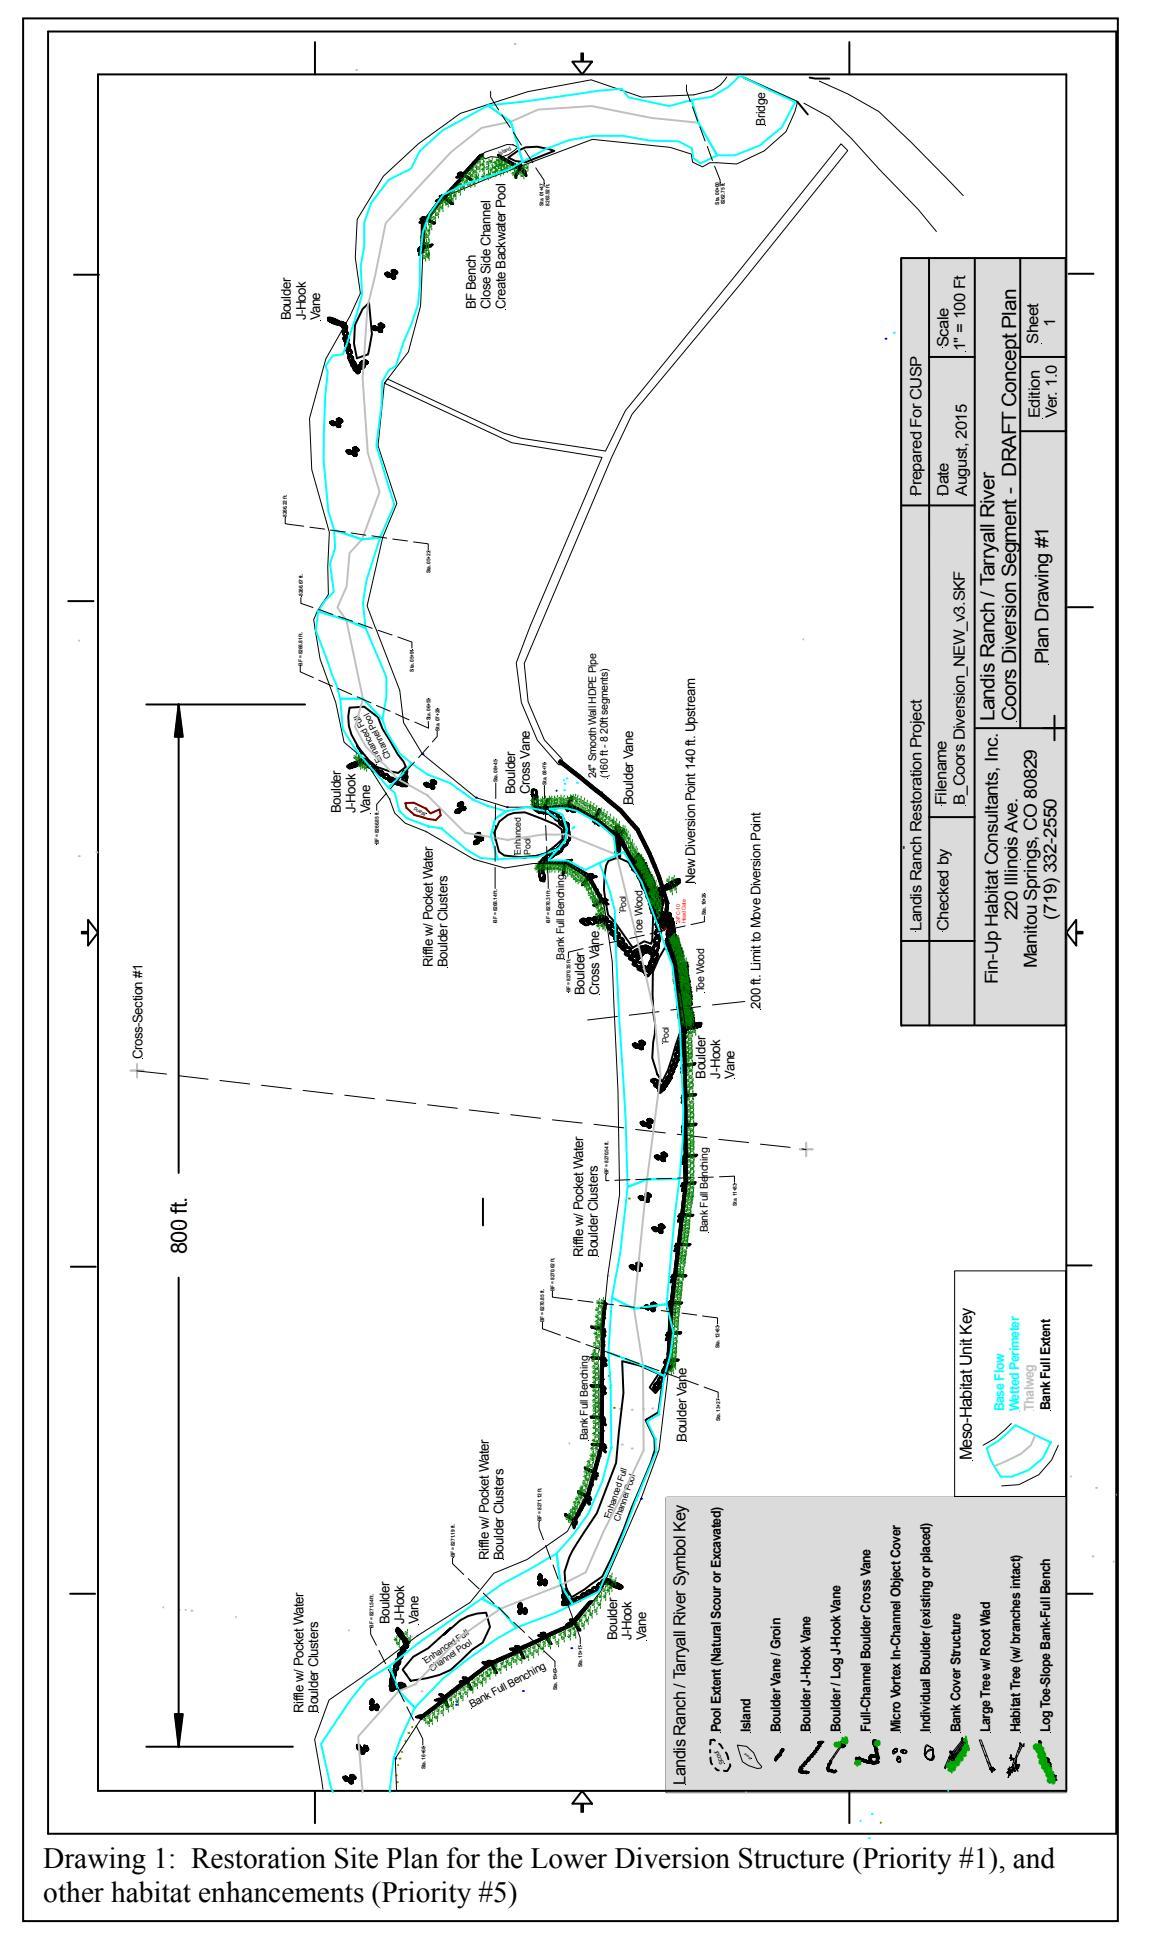
We identified the two irrigation diversion structures as the most significant threat to the long term health of the river in the study reach. The lower structure, which has mostly failed, has resulted in significant over-widening of the river channel for several hundred feet upstream. Subsequent deposition of sediment and further weakening of adjacent

The lower diversion structure, also known as the Coors Diversion, will need to be reconstructed before the beginning of the next irrigation season. At present, if the structure is replaced with a similar structure at the same diversion point, the channel upstream will continue to aggrade and over-widen. The rebuilt structure will continue to function at great risk of failure due to lateral migration of the channel on the north side of the feature, and will continue to require regular maintenance. There is an opportunity here that will soon close to relocate the diversion structure 140 feet upstream, at a location that is considerably less susceptible to lateral migration. A large boulder crossvane would be constructed at this new diversion point, maintaining a stage at the head gate to provide 11 cfs to the diversion point at base flows. A 24" Waterman C-10 head gate will be installed upstream of the south leg of the structure where it ties into the river bank. The head gate will be attached to 24" HDPE smooth wall plastic pipe, which will convey diverted flow to the existing ditch at the original diversion point. A second boulder cross vane will be constructed immediately downstream of the existing diversion point to provide a grade control, and to limit the hydraulic jump of the diversion to less than 18", enhancing aquatic organism passage through the diversion point. We have made a preliminary inquiry with the Colorado Division of Water Resources, and have confirmed that we may move the diversion point up to 200 feet without necessitating a re-adjudication of the water right.

The diversion and downstream cross vanes will provide a channel dimension control for additional toe-wood and bank full benching to significantly reduce the width/depth ratio of the river. We have established a target W/D ratio of 25 - 26 for this 800 foot segment, beginning at the old diversion point and extending upstream into Riffle 7. In addition to the cross vanes, four boulder J-Hook vanes and two smaller boulder vanes will be utilized to redirect the thalweg and reduce shear along the river bank. These features, combined with strategic placement of boulder pocket water clusters throughout the segment, will provide for enhanced habitat and complexity within this very limited segment.

A drawing of the proposed restoration is provided on the next page. A high resolution drawing may also be found in the appendices to this document. We have listed this project as the highest priority for the project due to the limited time available to accomplish the work. All necessary materials, including boulders and over 80 pieces of large wood are available on site. We estimate it would take approximately 10 days to complete at a cost of \$59,000.00. Timeline for construction would be fall/winter 2015.

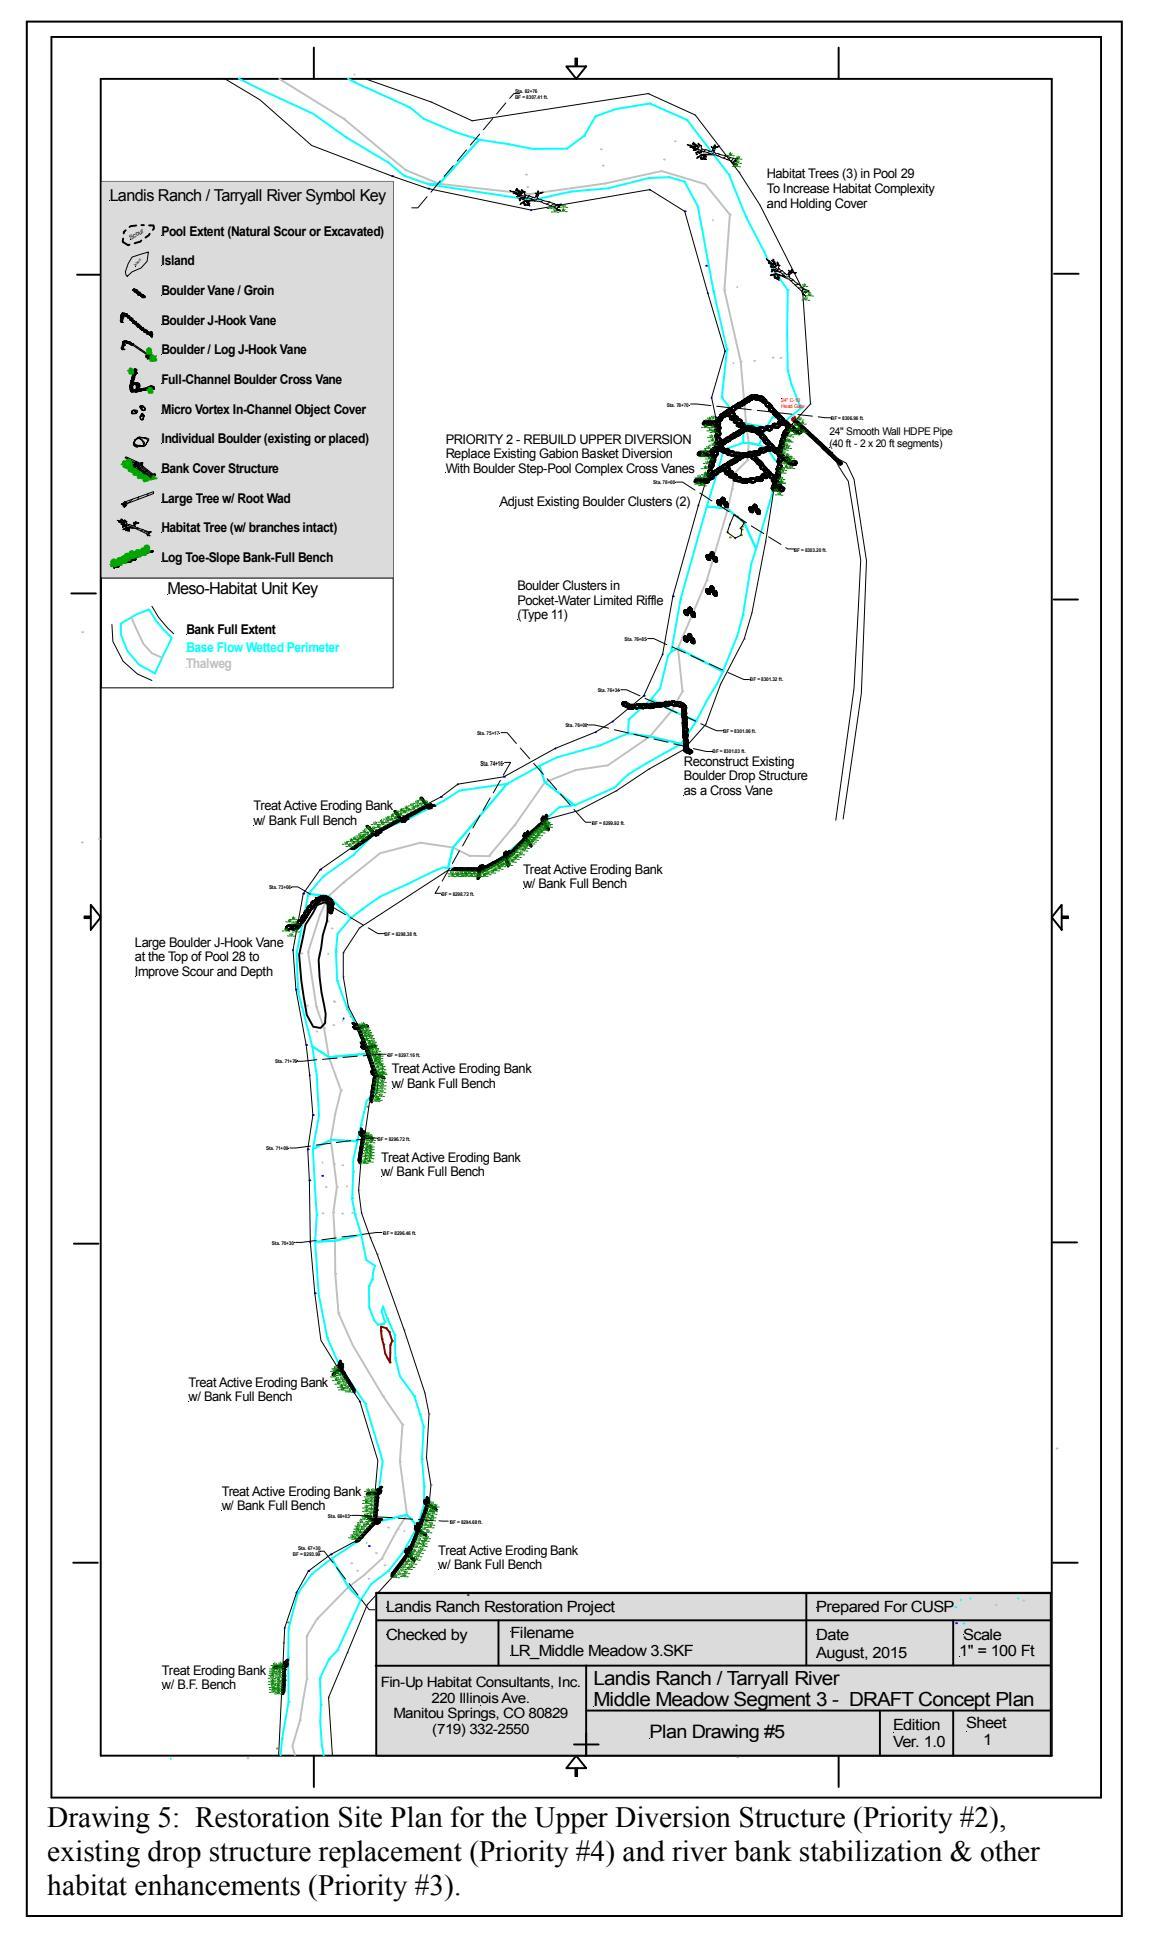
Priority #3: Hay Meadow River Bank Stabilization and Habitat Improvements.

The upper diversion structure is a significant barrier to fish migration, and is also at risk of failure over the long term due to the materials used in construction. The diversion drop structure consists of a series of wire gabion baskets stacked in the river channel perpendicular to the direction of flow, with a head gate and narrow sand-out channel on the northeast side of the structure. Gabion baskets for river control structures are notorious for failure due to corrosion of the containment wire, and are occasionally referred to as "time-release landslides", due in part to their short lifespan and high rate of failure. While frequently utilized in the past as a cost savings measure, or where adequate large rock was unavailable, these structures are generally not recommended any more for long term use in perennial rivers and streams.

The upper diversion structure may have already partially failed in the center, but the greatly accelerated flow through the center of the feature precluded a closer inspection. The longitudinal profile survey indicated that the feature has a hydraulic jump elevation of nearly 4 feet, with only a shallow and small pool feature below, severely limiting maximum burst velocity for fish attempting passage through the structure. The structure also presents a safety hazard for fishermen or other river recreationists in the large pool immediately upstream, who might be swept through the structure during high flows.

The priority #2 project would remove the existing structure, and replace it with a series of boulder cross vanes interlinked with each other to create a step pool cascade. The step pool cascade would tie together the existing channel slope above and below the diversion point while creating a "fish ladder" of sorts to allow for aquatic organism passage. The structure would begin approximately 75 feet downstream of the existing diversion, allowing the existing diversion point to be maintained. A considerable quantity of large boulders, of specific size and shape, will be required to successfully complete the new diversion, and we recommend that rock be imported from a nearby commercial quarry to ensure that properly sized materials are available for the work. We estimate it would take approximately 3 days to complete at a cost of \$40,250.00. Timeline for construction would be the fall of 2016.

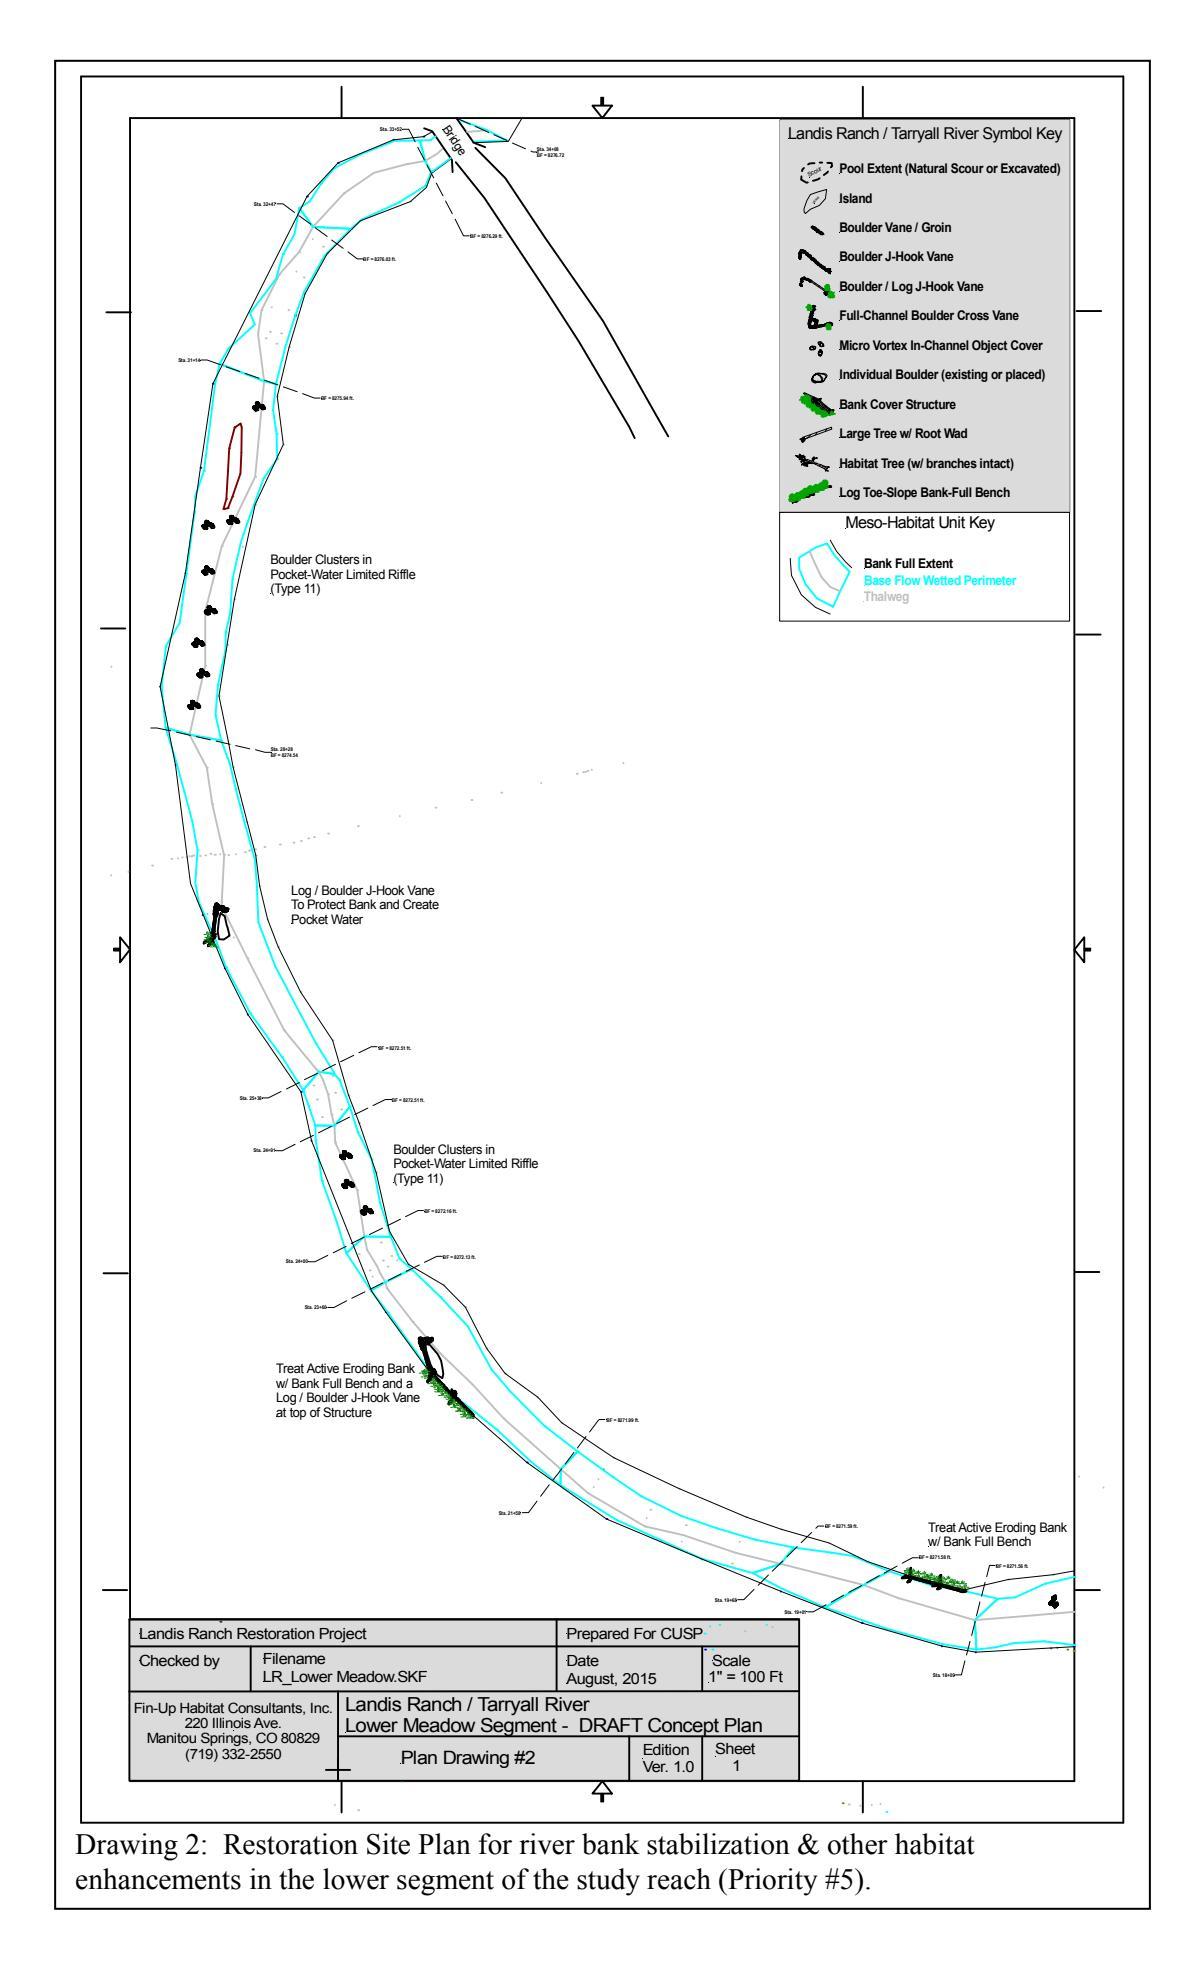
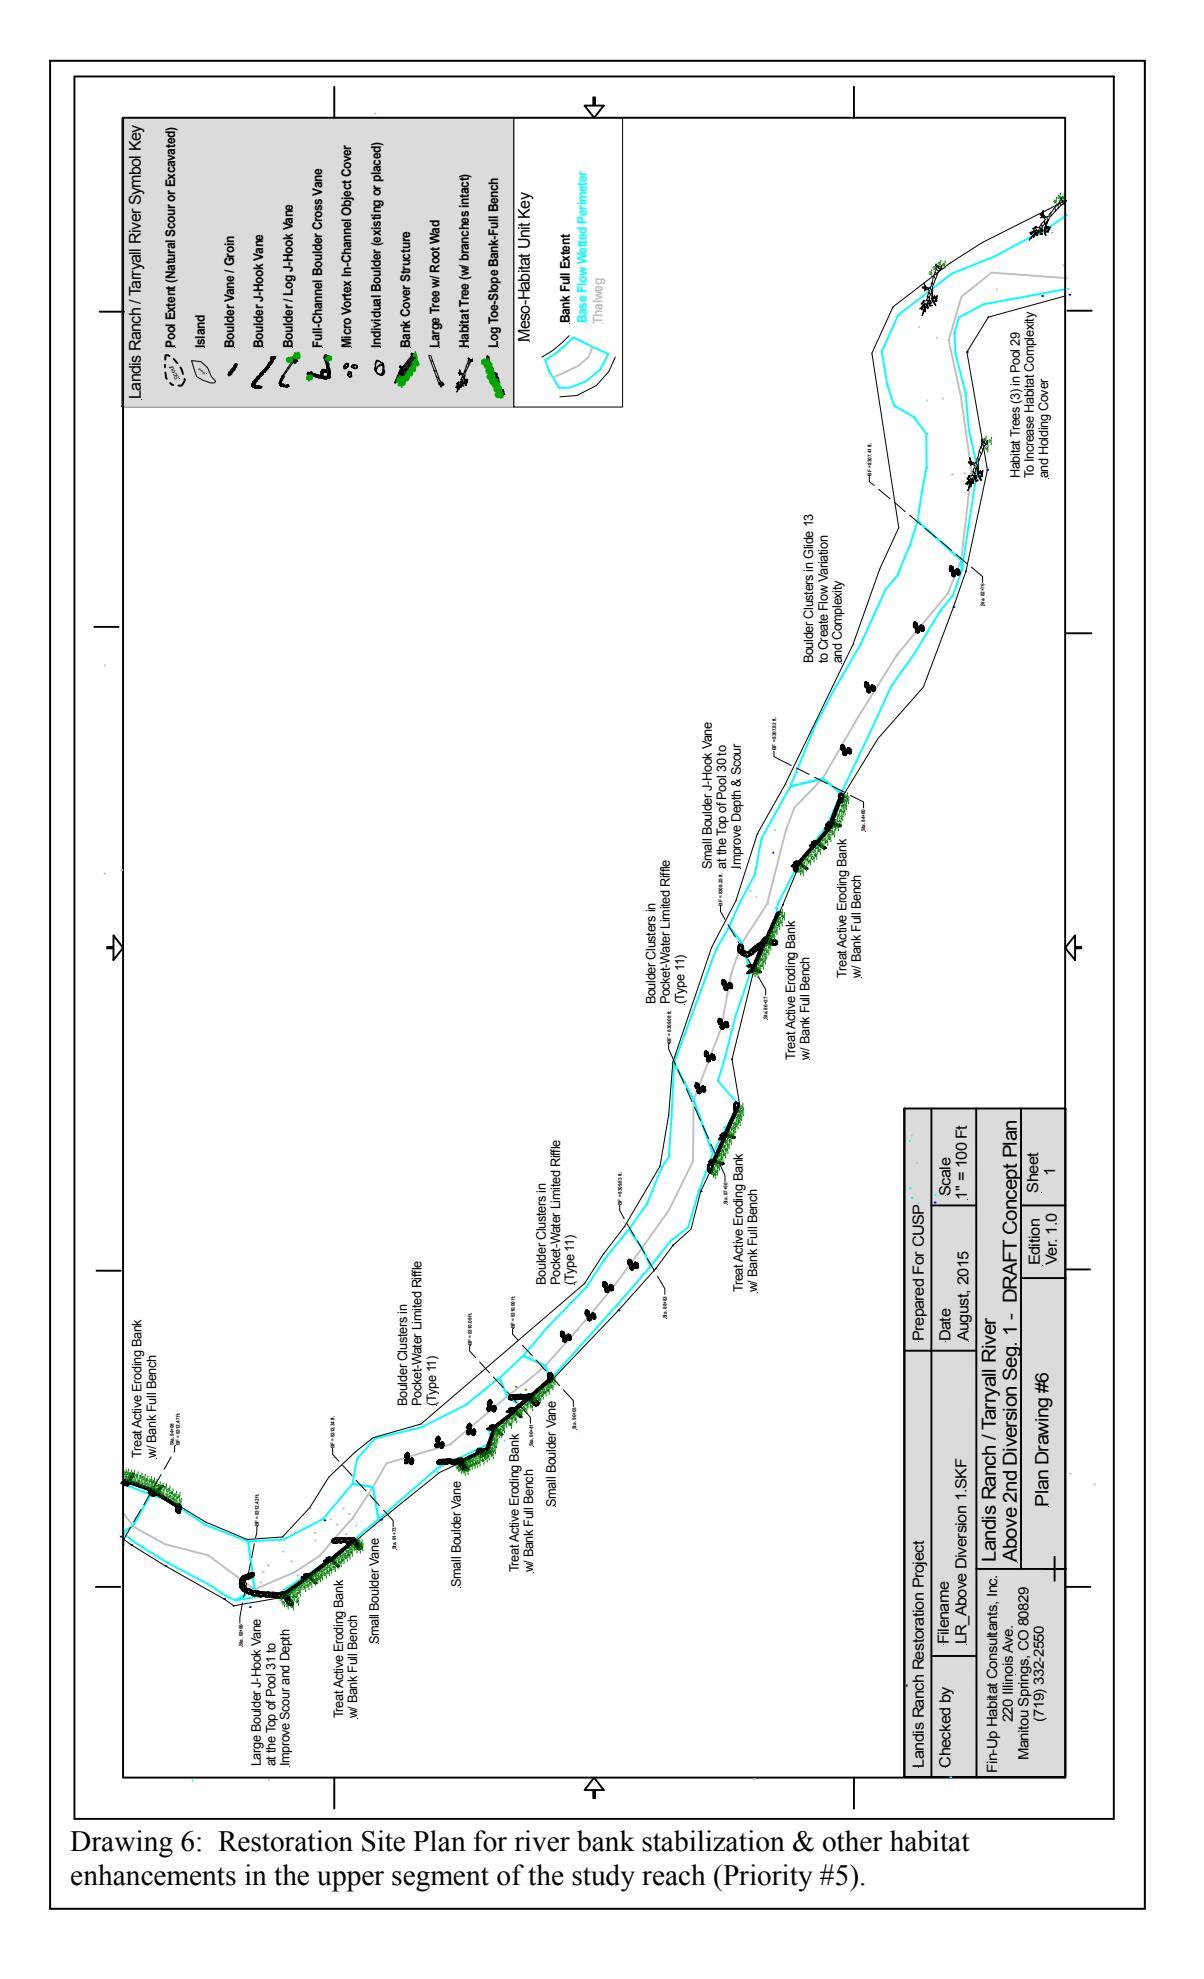
Much more extensive work will be necessary in the segment from the upstream diversion to the property boundary. Approximately 850 feet of actively eroding river banks will be treated with bank full benching. Two boulder J-Hook vanes and three smaller boulder vanes will be used to further protect these river banks and create additional in-channel cover for resident trout. A full channel cross vane will be installed immediately upstream of the 3rd bridge to direct the thalweg through the center of the bridge, and to provide fish viewing opportunity from the bridge itself. Eight Type 11 riffles will be enhanced for improved pocket water cover with the installation of up to 36 boulder clusters in this segment. Five additional habitat trees will also be anchored into the pool upstream of the diversion structure, and in the uppermost glide to create additional habitat complexity and velocity shelter. Details of these improvements are shown in Drawings #6 and #7.

We expect we can obtain necessary materials on site for this work, and we estimate that it would take up to 14 days to complete at a cost of \$60,000.00. Timeline for construction would likely be late 2017 or beyond.
