# Waldo Fire Recovery

## The Waldo Canyon Fire Master Plan for Watershed Restoration & Sediment Reduction

# Stream Segments

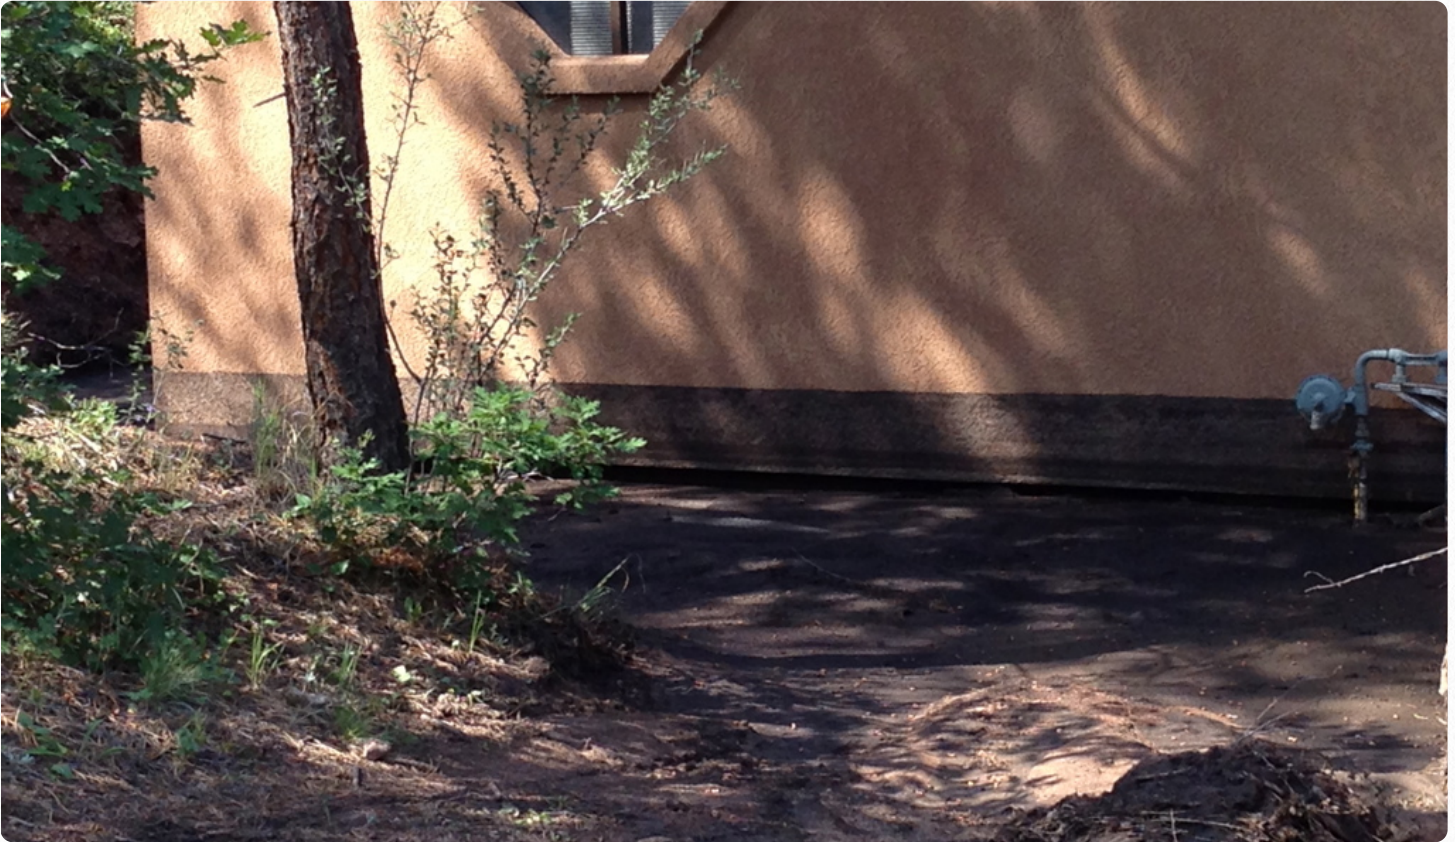
Mud flow line from a post-fire flood on a home in Cascade.

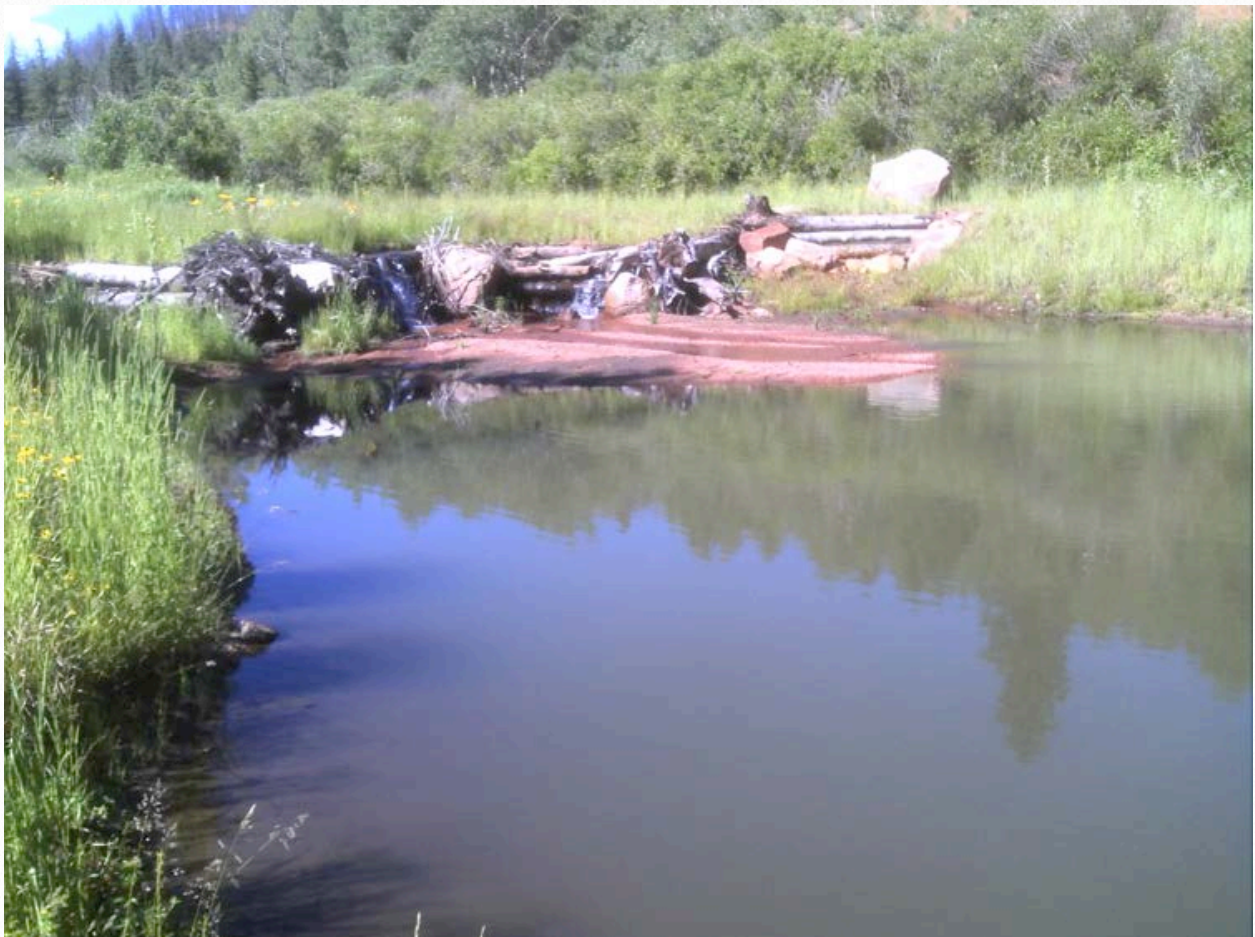
The boulder step pool channel constructed in 2014 is very stable, and is performing as expected. This feature has sufficiently stabilized the lower basin channel and is protecting CSU's infrastructure at the bottom of the draw. Log sills are the most common treatments in the upper part of the reach. Failure rates of these structures are slightly higher than in other basins at 75%. Log sills mostly failed due to flows undermining the log and geotextile fabric. The nine sediment basins in the reach are still providing storage for flood debris and sediment, although none of the log basin sills are completely intact. Several of the ba-

sin log crib walls have failed, typically the result of lateral migration of the channel around the structure. Basin crib walls in this reach are of an older design; typically straight, without wing walls or spur logs embedded into the adjacent banks. Straw waddles were installed along two segments in the middle of the basin, but neither of these features survived the floods in 2013.

Overall, only 25% of the treatments in the project reach were found to be fully functioning and 9% of the treatments were fully functioning but at risk. 60% of the work had failed completely, and 6% of the treatments were partially failed and not function at full potential. All of the treatment failures were in the upper and middle portions of the reach. The downstream boulder step pool channel constructed in 2014 is in good condition however, and is functioning to protect the basin from further unravelling. The sediment basins, although compromised, are still functioning to capture sediment and debris from the upper portion of the watershed. For these reasons, we concluded that the project is functioning as desired, but at risk to future failure as the capacity of the basins decreases over time.

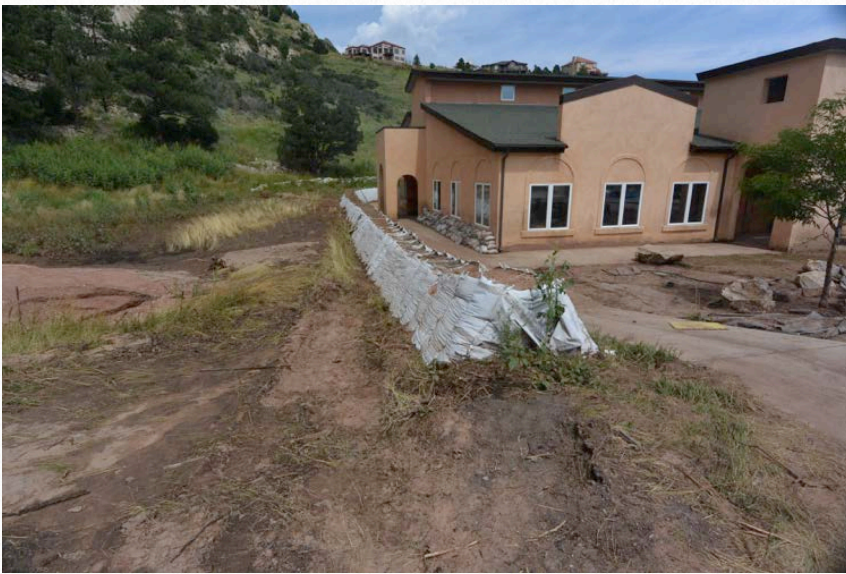
Autism school

The overall project reach sustained total failure of 44% of the treatments, mostly in the upper half of the reach. Critical structures, such as the sediment basin, are still functional, and continue to protect the school and neighborhoods downstream from catastrophic flooding. The sediment basin will continue to need periodic maintenance to ensure full function, therefore we considered the entire project reach as functioning at risk at this time.

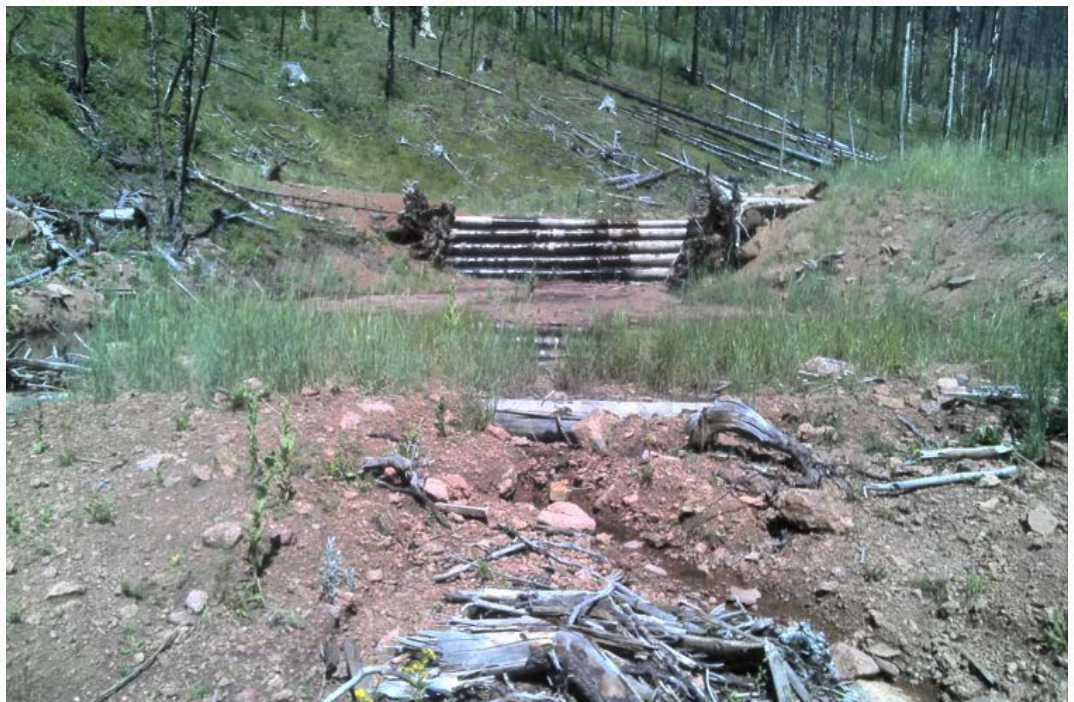
Seventy-five percent of the log sills in the project reach were in good condition, which represented some of the highest survival rates for log sills in the entire Waldo Canyon burn area.

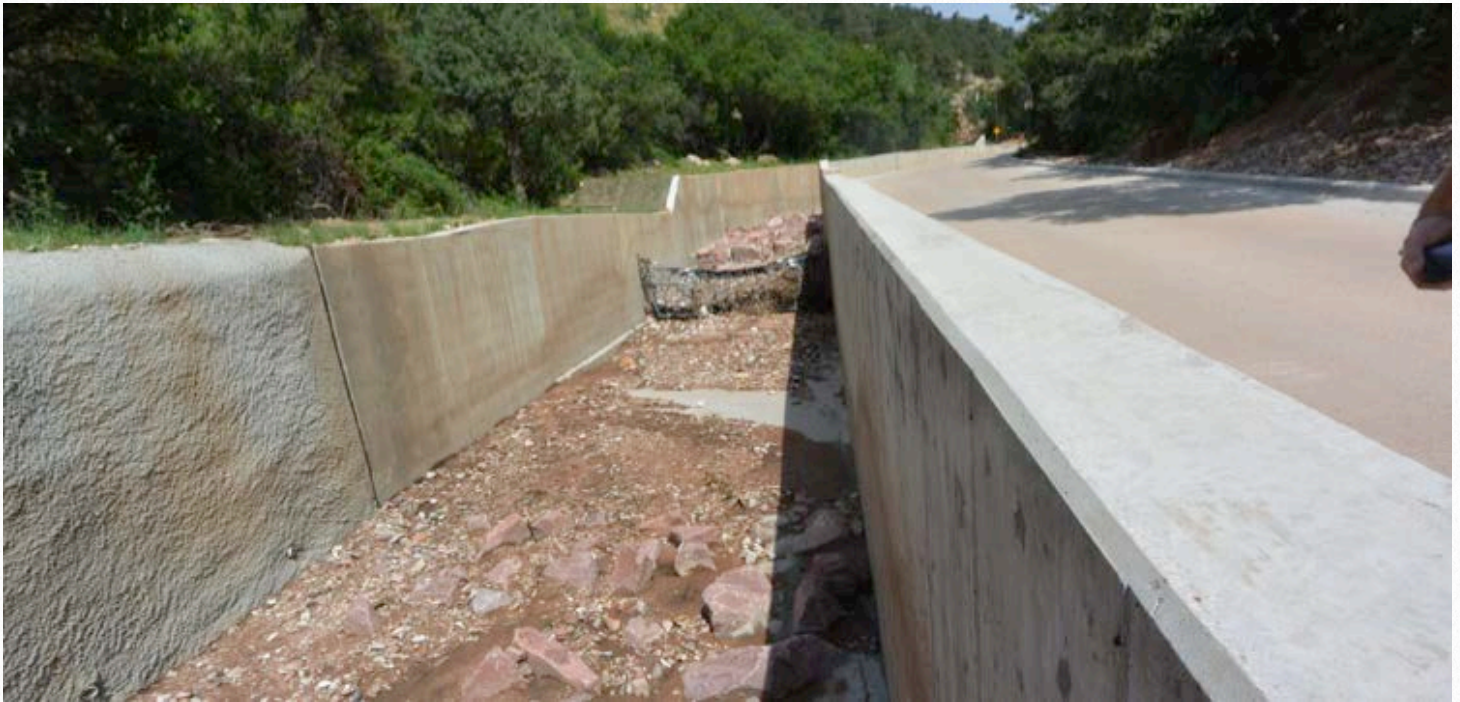
Following the 2013 flood, the 1,000 ft long box culvert was excavated and is now functional. The new concrete and grouted boulder flood channel is in excellent condition, but has yet to sustain a significant flood event. The debris nets were almost completely full at the time of our survey, and will require regular maintenance in order to be effective. The sediment detention basin in the middle of the project reach is also functioning at risk, and will require regular cleaning in order to function as designed. Overall, the project reach is very effective in terms of the original goals and objectives of the project, but at a cost, both in treasure, and in natural aquatic and hydrologic function in the project reach.

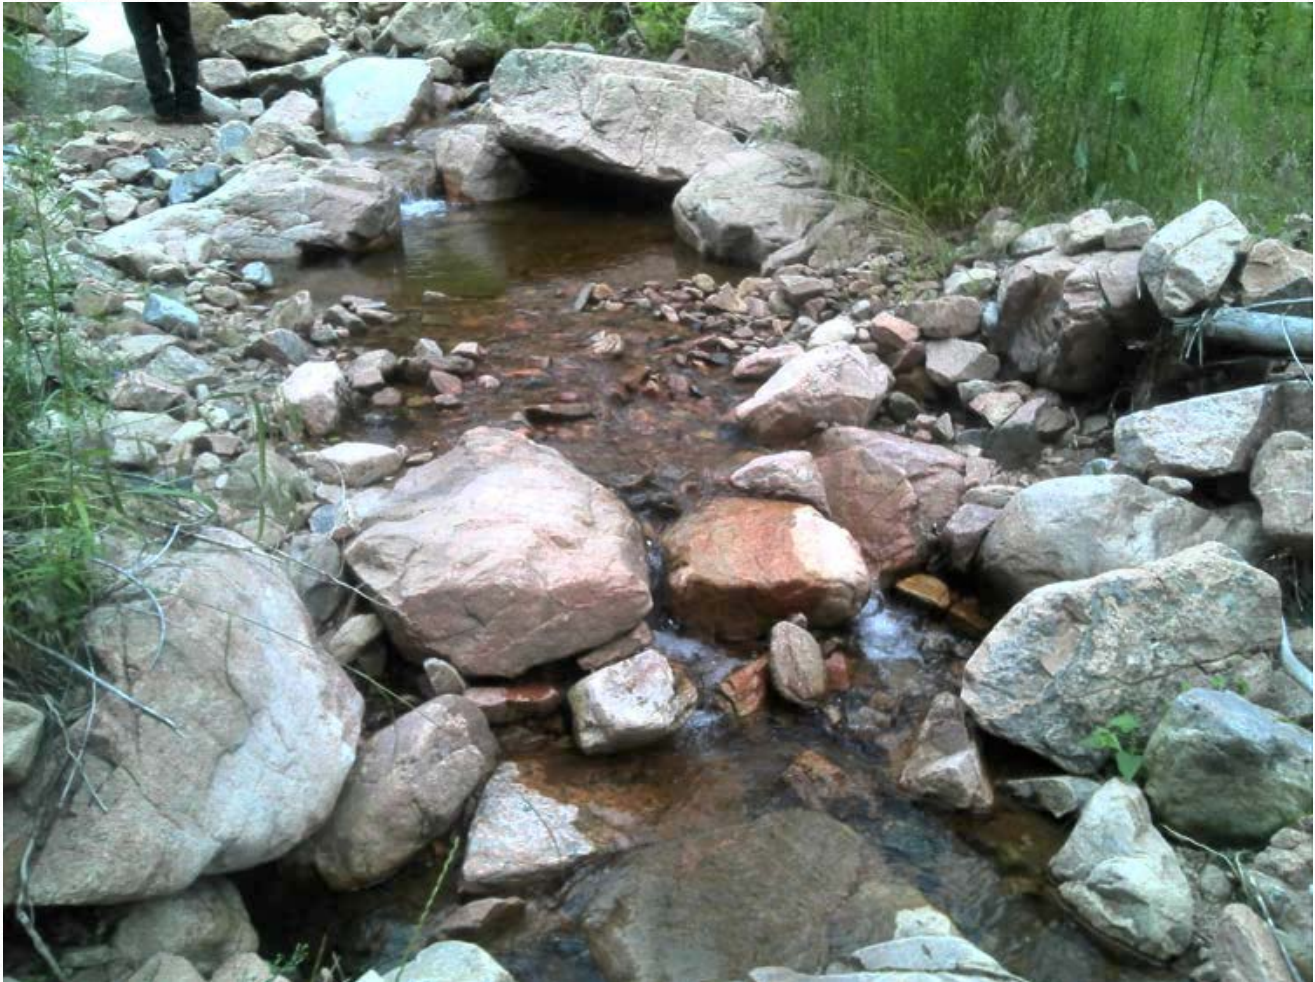
The sediment basin in the upper reach was functioning as designed, however, the basin crib wall appeared to be at risk of failure in a future large event. The basin sill log was intact and functioning to maintain the integrity of the basin and prevent down cutting below the structure. Two of the boulder drop structures were no longer functioning, however, all of the other channel grade control and bank features were in good condition functioning as designed. The work on the upper reach represented some of the most stable and effective natural treatments in the entire Waldo Canyon burn area.

Overall, 95% of the treatments in the project reach were found to be functioning as designed. The two boulder drop structures that failed completely did not appear to threaten the integrity of other structures in the immediate vicinity. In total, the work is performing as designed and is considered successful.

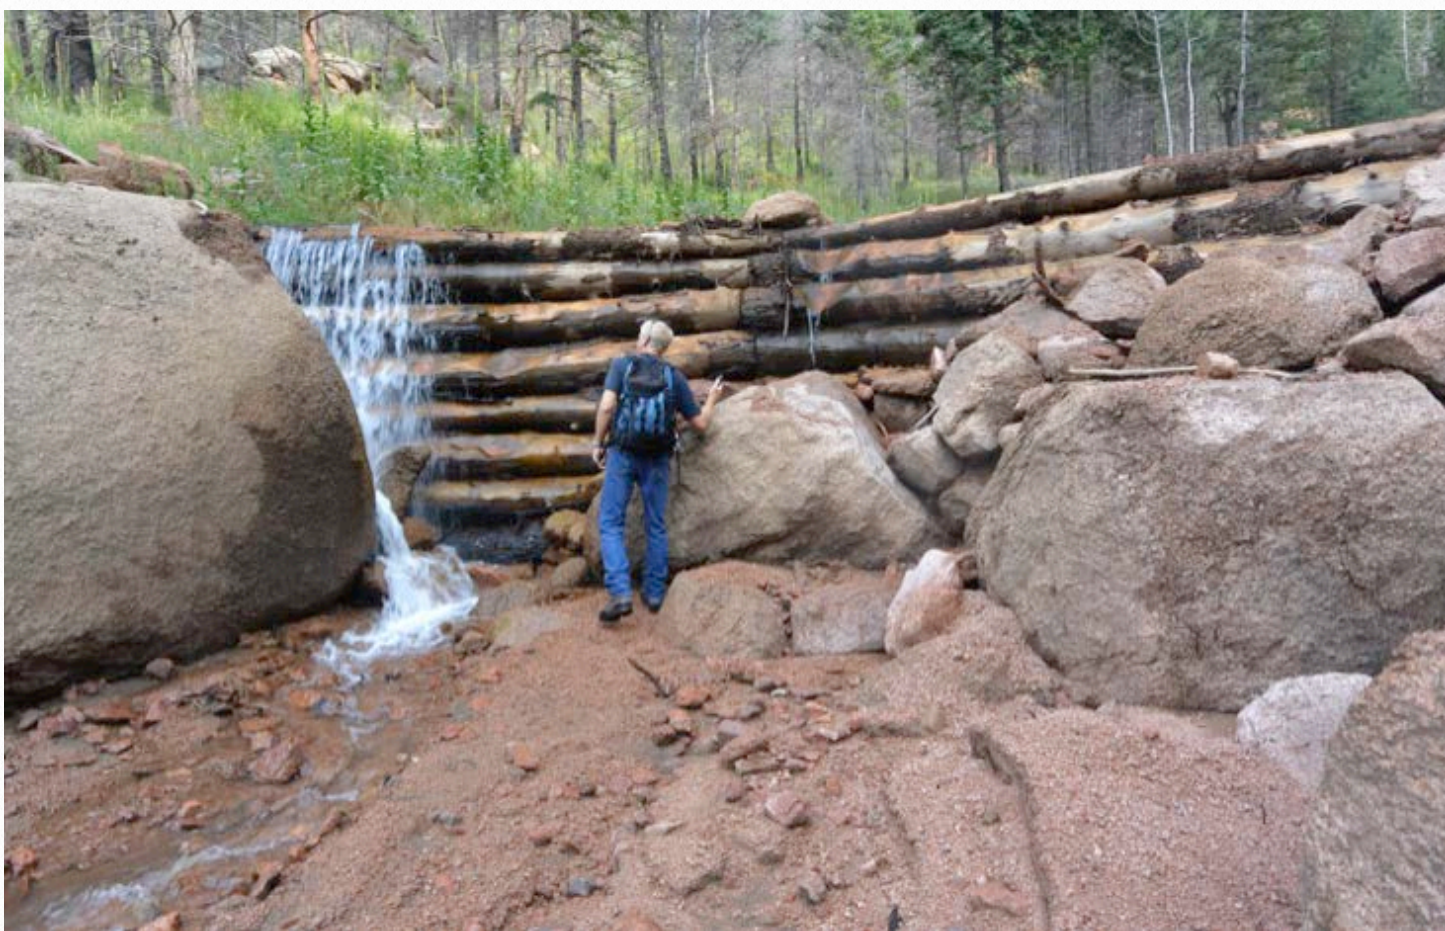
Log basin crib wall failures were relatively high in the Waldo Burn with 47% of these structures being at least partially failed. All of the completely failed structures were of the original design. All of the boulder crib walls were functioning at full potential, however half of these appeared to be at risk, primarily due to failure of the fabric behind the structure, or risk of lateral migration.

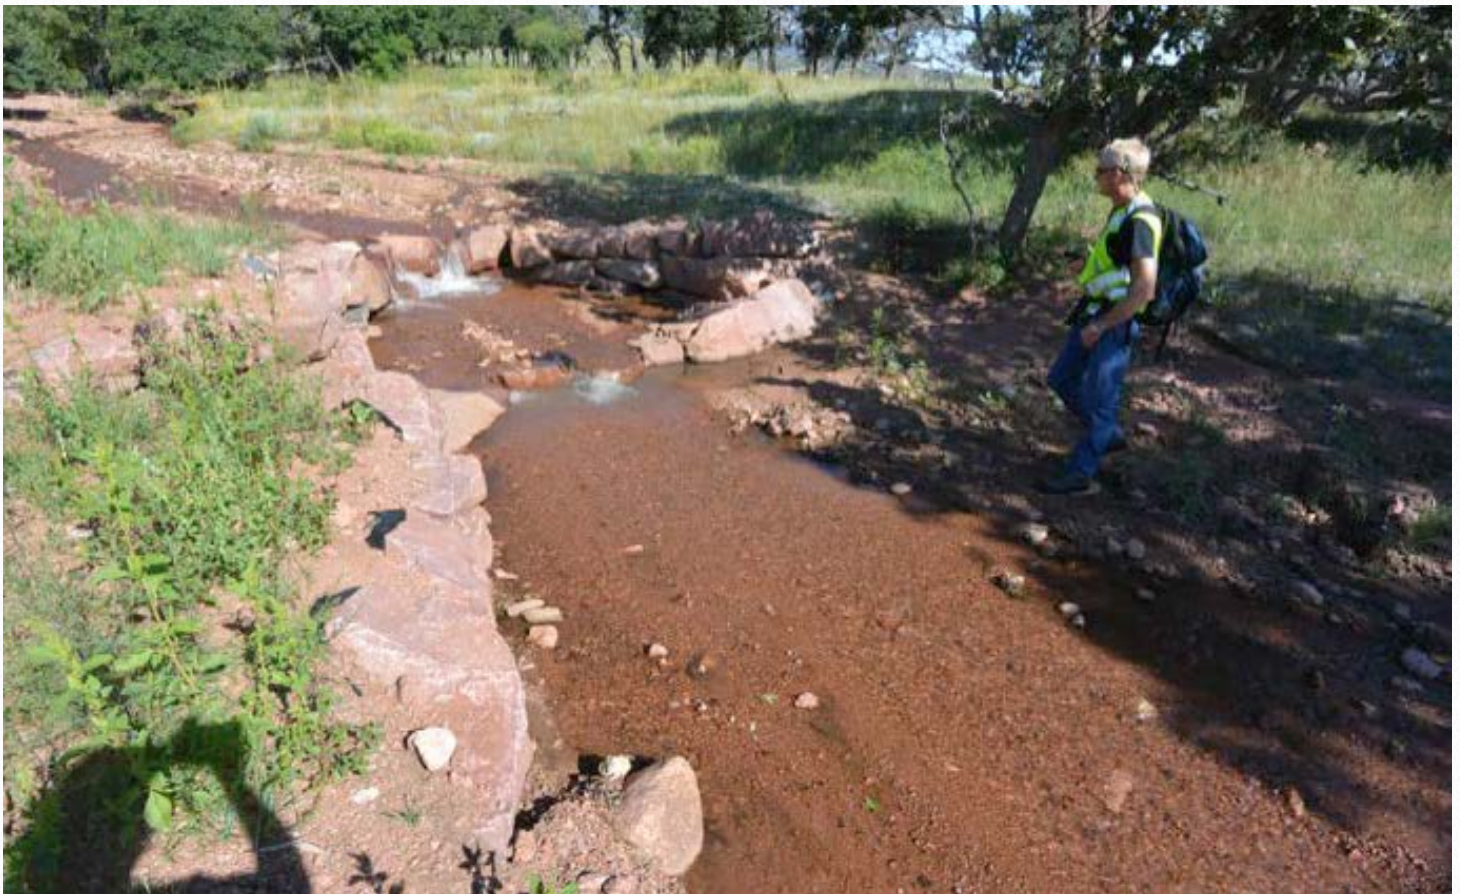
Of the one hundred and thirty-two boulder drop structures assessed in 2015, 73% were still in good condition and fully functioning. 14% of the boulder drop structures had either partially failed, or failed completely. Boulder drop structures typically failed due to tearing of the fabric behind the structure, or lack of adequate footer boulders causing the center of the structure to collapse. We should note here that we commonly observed that drop structure failures occurred at the critical downstream structure, resulting in formation of a head cut that would migrate upstream through the project reach, compromising the other structures. This was likely due to the use of smaller materials as the stockpile of more suitable rock was consumed during the course of construction.

Typical boulder drop structure

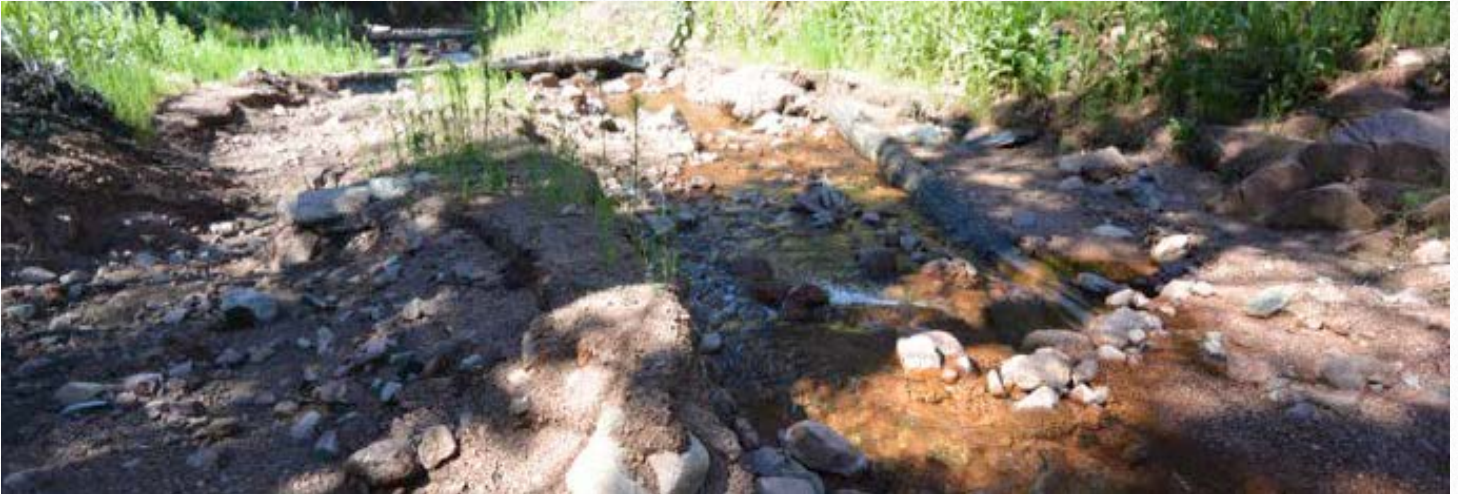
water surface slope along the stream bank through various flow stages, reducing velocity and shear along the bank. Boulder and log vanes can be very effective in reducing stream bank erosion, but their use is limited in highly erosive channel beds such as found in the Waldo Canyon burn. For this reason, very few of this treatment type were used in Waldo Canyon project reaches. Where this technique was employed, success was limited, with 75% of the log vanes and 50% of the boulder vanes completely failing.

Boulder Log Veins

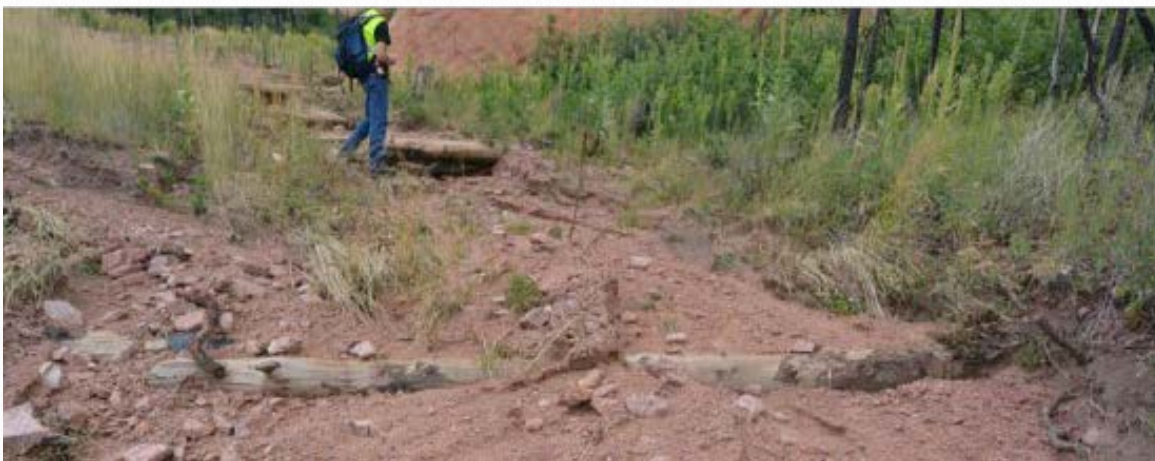
Concrete sills, as expected were found to be extremely effective, but at too high a cost to be employed universally. Boulder sills were found to be effective in more than 50% of the project reaches. The 31% total failure rate of boulder sills was typically the result of faulty construction, lack of fabric, and no footings. Log Sills were the most common of all treatments in the project reach, and over three hundred of these structures were assessed in the 2015 study. Log sills typically consisted a single log spanning the channel, with fabric attached to the upstream side of the log and buried under the channel surface. Inevitably, the fabric would tear or otherwise be compromised along some point on the sill, allowing flows to cut beneath the structure. Once the log was undercut, the fabric on either side of the failure point would fail, resulting in the log suspended above the new down cut channel. Within the project reaches, 47% of the log sills have completely failed. As a result, the log sill design has been modified over time, and later sills have incorporated two or even three rows of logs, staggered and stacked on top of each other, and completely wrapped on both sides by geotextile fabric (cigar roll). This newer design was observed to be far more resistant to failure. Additionally, some newer log sills have included boulder footings to project against undermining of the structure.

An experimental sill design, named a “whisker” sill, was employed in one project reach on the burn. This treatment consists of a PVC pipe embedded across the channel. This pipe has numerous smaller protrusions (whiskers) extending above the channel bed to create additional channel roughness and to capture smaller debris and sediment. Unfortunately, the basin where these were installed experienced a significant flood event immediately following construction resulting in significant damage to the treatments and a 70% catastrophic failure rate. It is likely that this event mobilized so much larger materials (cobble and boulder) that the PVC pipes were shattered when exposed during the flood.

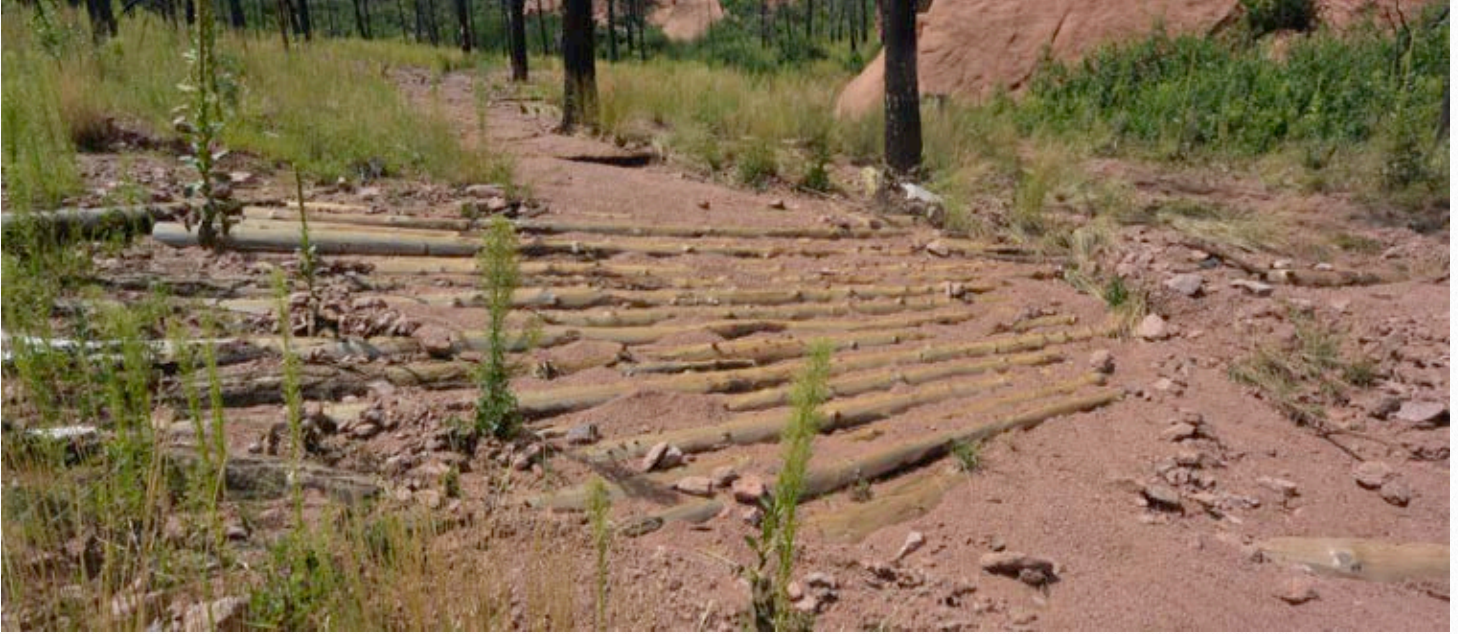
equipment. Unfortunately, the log corduroy treatments we assessed in the Waldo Canyon project reaches were, for the most part, being used in segments of channel that were inappropriate for the technique.
