Horse Creek Watershed Assessment & Conceptual Restoration Plan

*The Prediction Level Assessment
Results of the Hayman Fire*

Dana Butler, Leah Lessard – U.S. Forest Service

March 4th, 2015

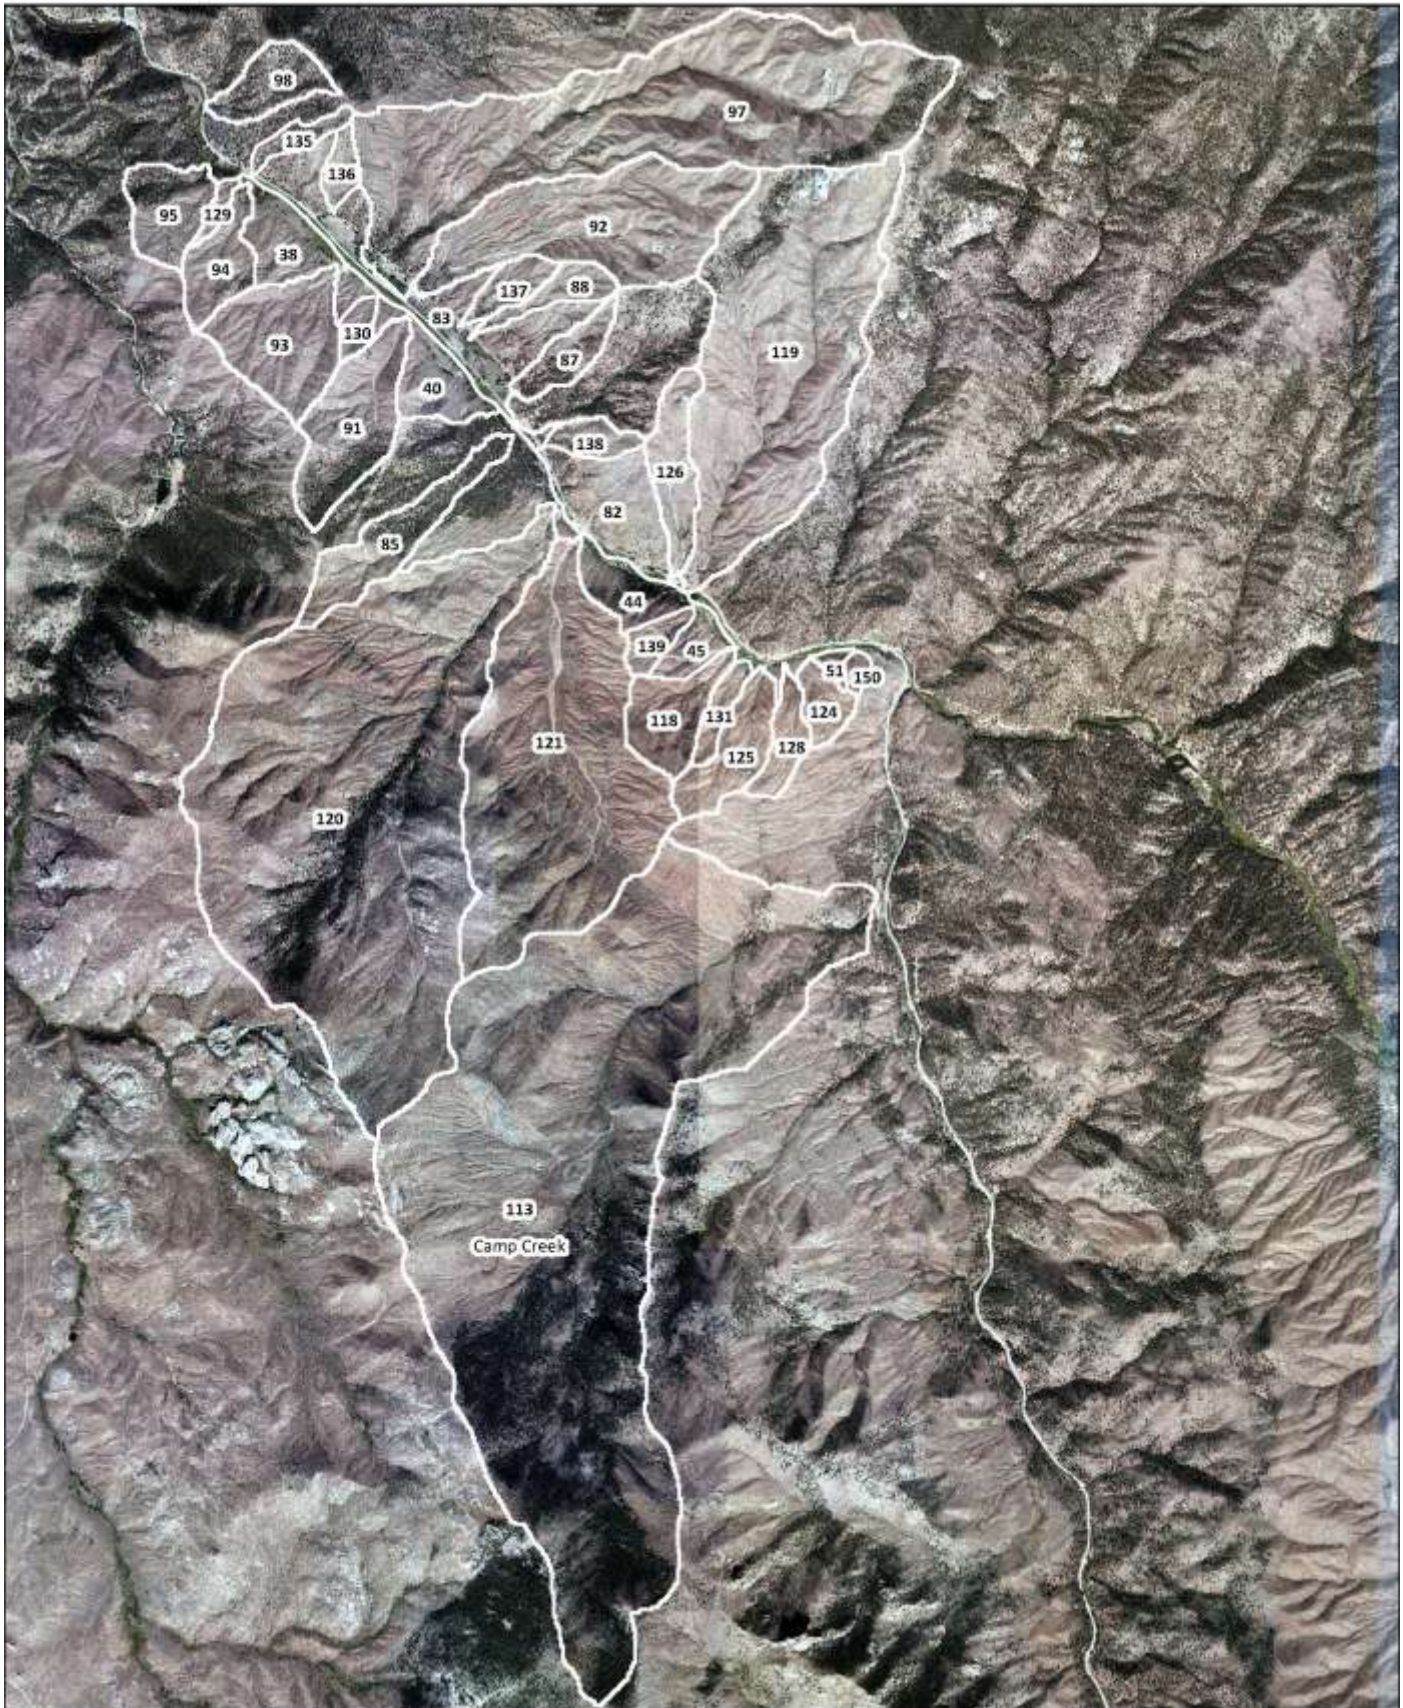
Figure 2. Horse Creek project area sub-watersheds

Horse Creek Sub-Watersheds

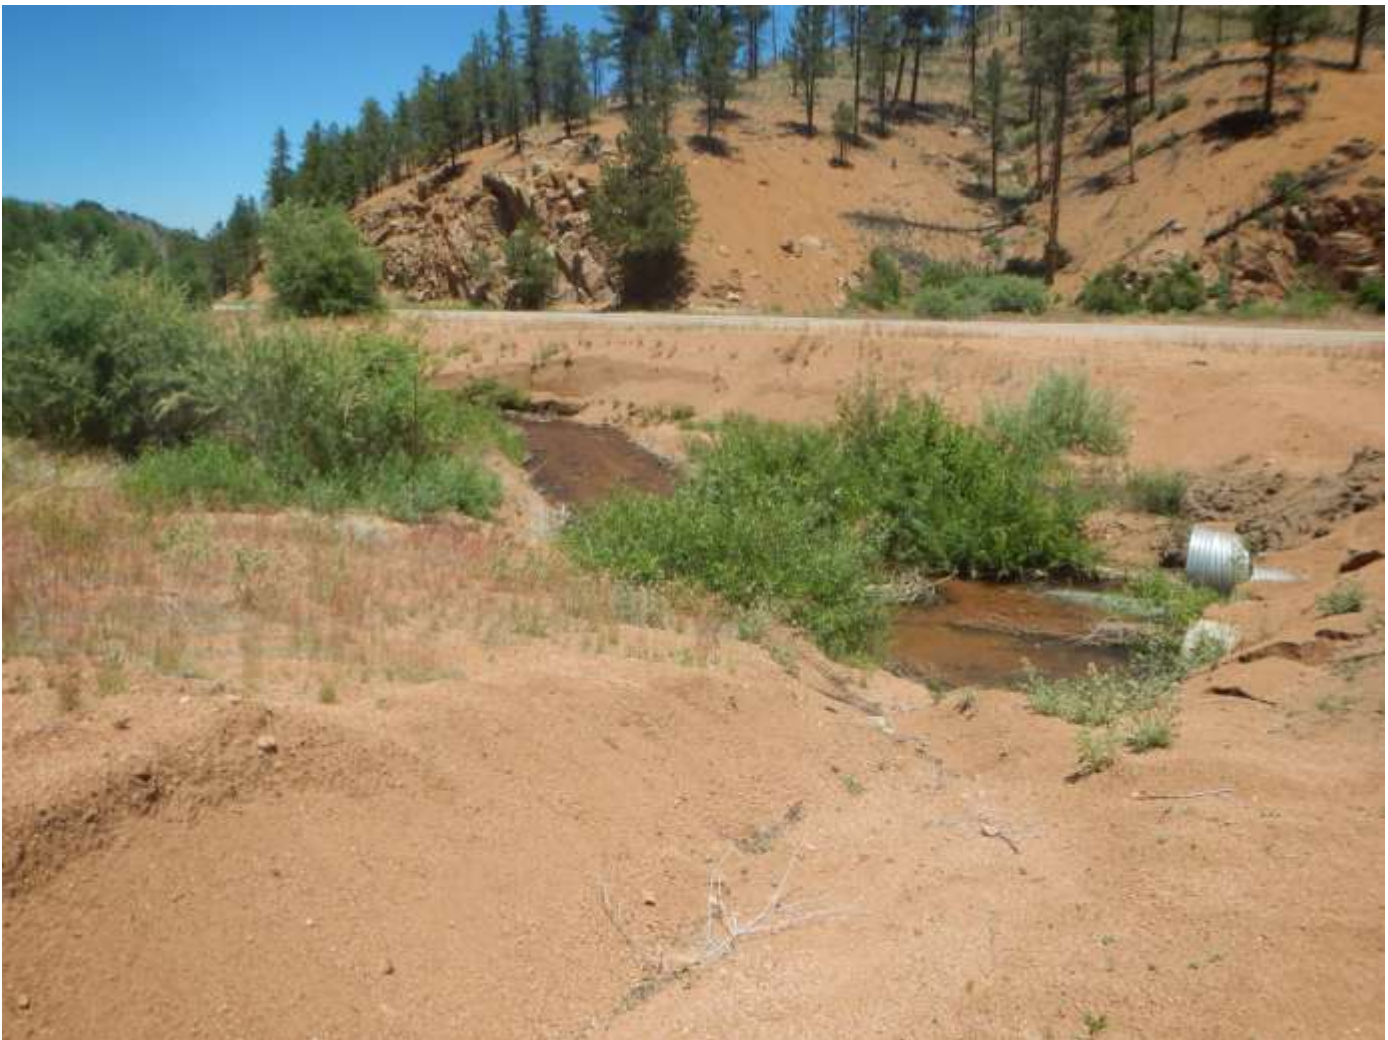
Figure 6. Image of sediment deposition from a driveway crossing Horse Creek to access Hwy 67.

Several driveways with multiple culverts cross the mainstem of Horse Creek. Many of these driveways and culverts were installed during the post flooding, emergency response with the number one goal being access to private property. During large flood events, driveway failures have drastically altered stream channel morphology in the downstream reaches. Driveways with culverts have failed when the culvert capacity was exceeded and the driveway acted like a dam and catastrophically failed or when the culvert inlet was plugged and storm water flowed overtop of the driveway fill. Most of the driveway fill is made of the highly erosive Pikes Peak granitic native material. Driveway failures and poor design have created a sediment input that exceeds the bedload carrying capacities of the channel. Excess sediment and a lack of sediment transport leads to infilling of pools and unstable braided channels. During annual flood events, undersized culverts have resulted in an increased stream power causing downcutting and channel enlargement in the immediate downstream reaches. Water quality, fish and riparian habitat have all been affected due to increased turbidity and the creation of new cut-bank sediment sources. Driveway improvements should include proper culvert and bridge designs that drain the floodplain and also accommodate base flow without aggradation. New culverts should be designed and installed with a professional engineer's stamp of approval to ensure proper function and to protect the investment. Driveway improvements should be focused on proper culvert sizing, and reducing sediment delivery into Horse Creek. The hillslopes and tributary drainages are recovering on an upward trend, but the undersized, poorly designed driveway crossings are a permanent source of sediment and are a high risk for failure.

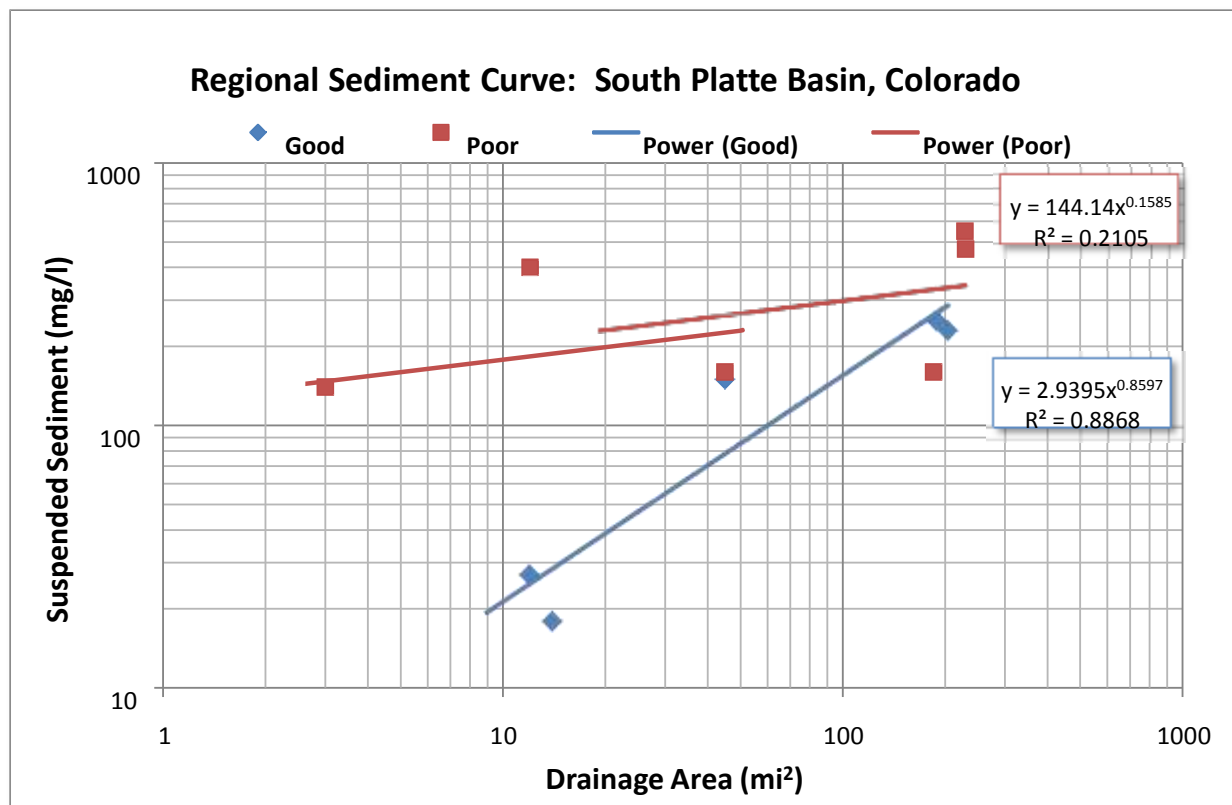
Figure 10. Regional suspended sediment curve: South Platte Basin, Colorado. (Rosgen, 2013)

The bankfull discharge, as discussed previously, is determined from a regional curve of bankfull discharge vs. drainage area (see **Figure 3**). In the absence of measured bankfull sediment data, an approach similar to that used to estimate bankfull discharge is used to estimate bankfull bedload and suspended sediment data by drainage area based on geological characteristics. Thus, regional sediment curves were developed by stability type for the local batholith geology (Pikes Peak, gneissic granite geology) as shown in **Figure 9** and **Figure 10**. The bankfull sediment values from the regional curves can then be used to convert the dimensionless sediment rating curves to dimensional curves that are unique and scaled for each sub-watershed.

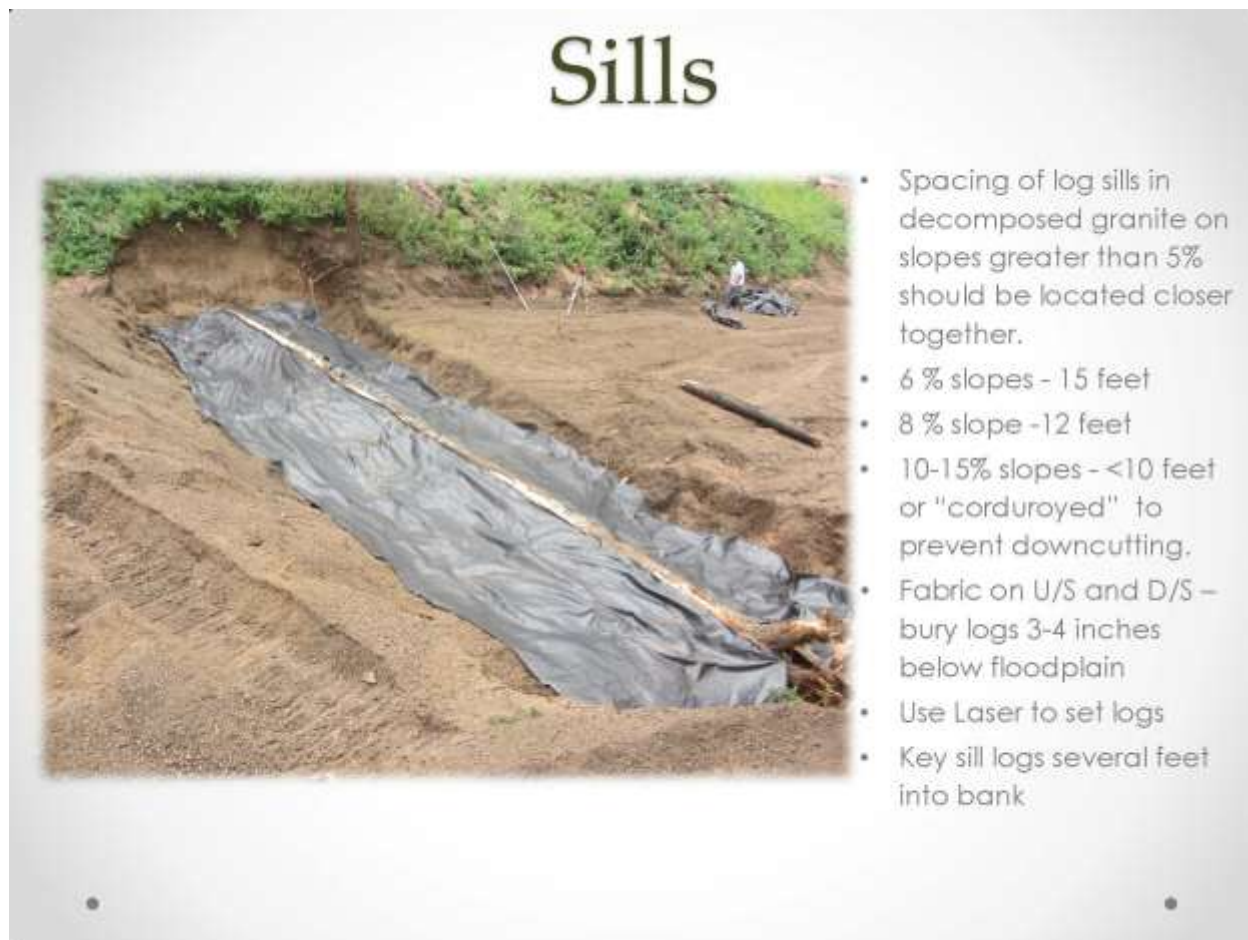
Figure 22. Log Sill Description

When used in combination with basins and cross-channel structures (cross-vanes, J-hooks and log rollers), the end of the log should be tied into the end of the structure and extend past bankfull and tie into a stable location (hillslopes, rock outcrops, and existing or transplanted vegetation). Sills should be used in existing, D stream types in Valley Types II, III, and VIII to prevent headcuts advancing through depositional surfaces. In these situations, the sills should be buried across the entire channel width and tied into stable features (See **Figure 22**). Sills are incorporated into sediment detention basin and D channel restoration. Sills are installed upstream and downstream of sediment detention basins to prevent downcutting and to spread flows across the channel.
