Roads to Rivers Assessment Eleven Mile Canyon, Happy Meadows, and Sportsmen's Paradise Roads

September 2015

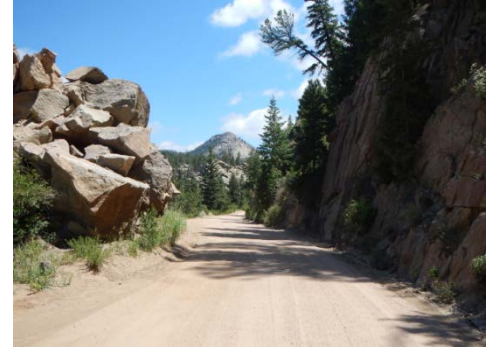
The AASHTO Guidelines for Very Low Volume Roads specify a minimum width of 18 feet for two-way traffic. The existing roadway widths generally vary from 14 to 28 feet. In some areas, the roadway widens to accommodate parking pullouts. The narrowest sections of road are in tunnels, which were designed to meet railroad standards of 14 feet wide and 17 feet high. Several areas do not meet the 18-foot minimum width criteria because of railroad tunnels, rock cuts on one or both sides of the road, or river encroachment. Often on days with high public use, uncontrolled parking impedes the roadway width to the point where only one-way traffic is possible in those areas.

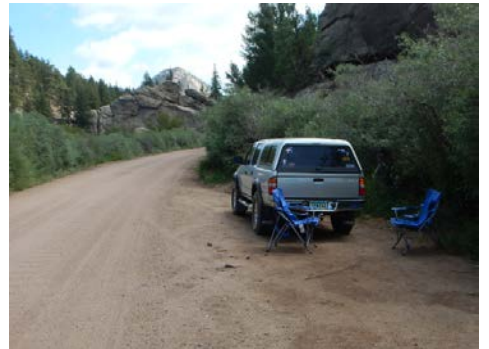
The roadway has many curves, and it is estimated that all of the curves meet the minimum radius criteria for the design speed of 20 mph. However, limited sight distances resulting from the topography, vegetation, and narrow road widths create a traffic calming environment that naturally reduces and controls speeds. These conditions are exaggerated when visitors park along the road, making the road width seem narrower.

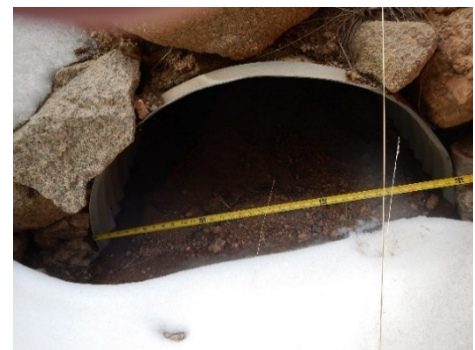
During the site assessments, multiple culverts were discovered to be partially or completely filled with sediment. It is possible that some culverts were not identified or located during the site assessments because they were buried by excessive sediment deposition. Additionally, multiple culverts were found to be damaged. Because of the reduction of flow area at either the upstream or downstream end of the culvert, the original flow capacity of those culverts had been reduced. The culverts presented in **Table 3** have been identified as either buried or damaged. Existing culvert locations are shown in the Map Book in **Appendix C**.

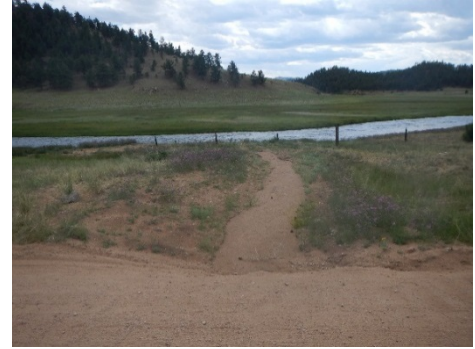
Loose sediment from the roadway and uphill slopes is conveyed into roadside ditches and eventually into the cross culverts. The sediment is carried through the culverts to the river side of the roadway or becomes trapped and plugs the culvert. The runoff and sediment then either discharge into the river or onto the river overbank or are conveyed down a rundown or swale to the river. These rundowns are not stabilized or protected and rundown erosion is often present. The majority of the rundowns along the South Platte River within the study area have undergone significant erosion because of the lack of protective measures.

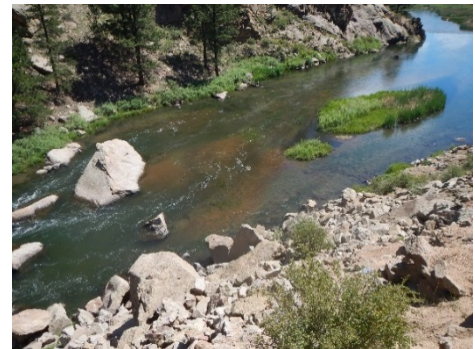
Throughout the study area, a clear correlation can be seen between sediment deposition areas and the roadway's proximity to the South Platte River. In certain sections of Eleven Mile Canyon, the difference in elevation between the roadway elevation and river exceeds 20 feet. This vertical elevation difference often results in a steep slope with limited established vegetation. The erosion and deposition areas continually add to the sediment loading in the South Platte River.

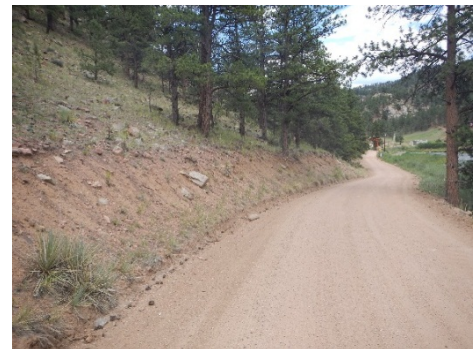
In June 2002, the Hayman fire engulfed a significant portion of the tributary area that contributes flow to the South Platte River through the Sportsmen's Paradise reach. Although this assessment primarily focuses on roadways alongside the river, the tributary areas affected by the fire are contributing increased runoff and sediment load to the South Platte River. Along Vermillion Creek and Crystal Creek, manmade fishing ponds are effectively acting as retention ponds and removing sediment from runoff. However, over time, it is essential that these ponds be cleaned to maintain the pond's effectiveness in retaining sediment. In the watersheds contributing to these creeks, frequent runoff has caused a significant impact on the unprotected topography. Within the Sportsmen's Paradise reach, the Hayman fire has caused an increase in runoff and sediment load from hillslopes and drainages. Improvements to hill slopes and drainages within the Hayman fire burn area are recommended to reestablish vegetation and stabilize the existing slopes and drainages.

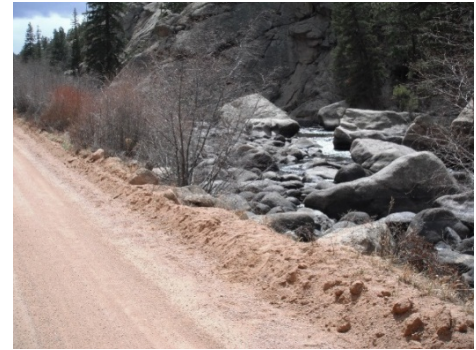
In some locations, roadway berms have developed on the river side of the road as a result of roadway grading operations where excess material has been pushed to that side. These berms have a tendency to fail where the roadway cross slope is toward the river and runoff concentrates alongside the berms. The failure of the roadway berms can result in erosion cutting back into the travel lane and significant sediment deposition into the South Platte River.

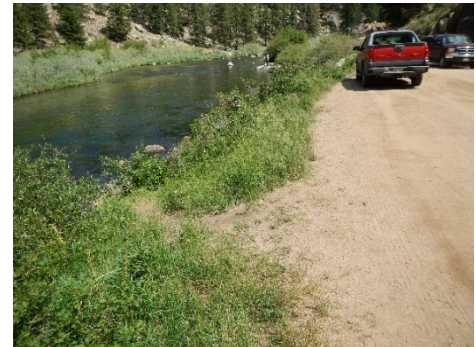
Numerous pedestrian rundowns are seen throughout the Eleven Mile Canyon and Happy Meadows study areas. These rundowns are caused by pedestrians moving to and from the river, creating paths with limited to no vegetation. Because of the heavy pedestrian traffic, these locations are a source of sediment to the river.

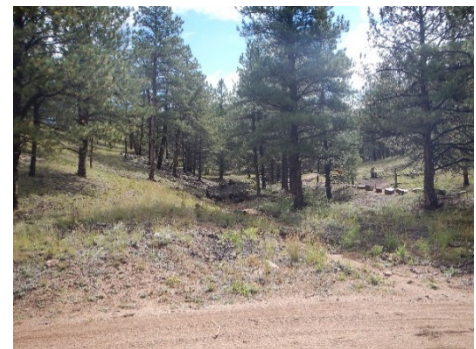
The natural hill slopes and drainages in the Eleven Mile Canyon, Happy Meadows, and Sportsmen's Paradise sections of the South Platte River corridor are a source of sediment. However, the human-caused sources of sediment are the focus of this assessment. It is assumed that the South Platte River, through natural processes of storm runoff and sediment transport, could adequately convey natural levels of sediment to sustain the natural populations of trout and other aquatic species. Therefore, although natural processes are introducing sediment into the river, the human-caused sources are increasing the sediment load on the South Platte River beyond the natural condition. The majority of the supply of sediment to the system has come from the unpaved roadways throughout the study area.

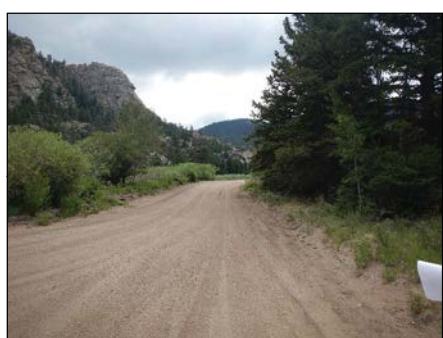
Photo 1
Start of Eleven Mile Road

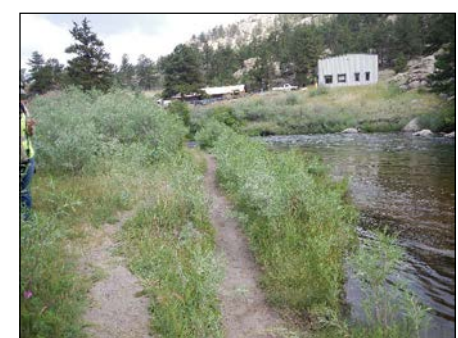
Photo 2
Pedestrian Trail

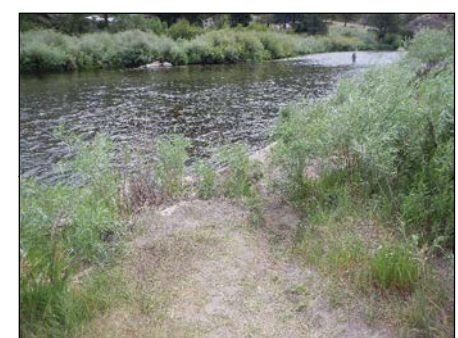
Photo 3
Pedestrian Rundown to River

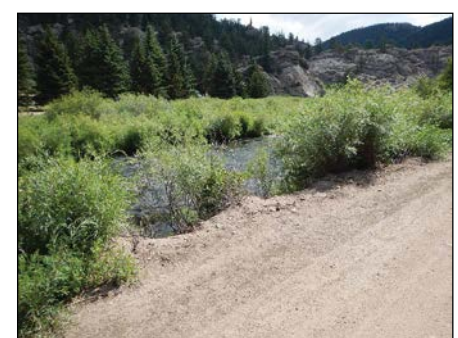
Photo 4
Limited Buffer Next to River

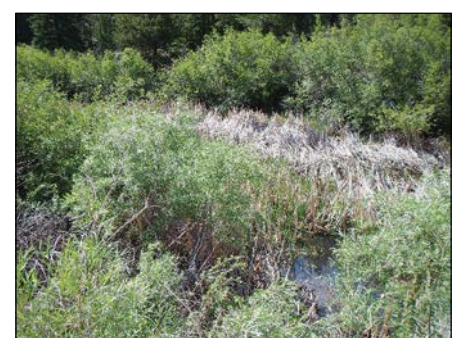
Photo 5
Wetland - Old Oxbow

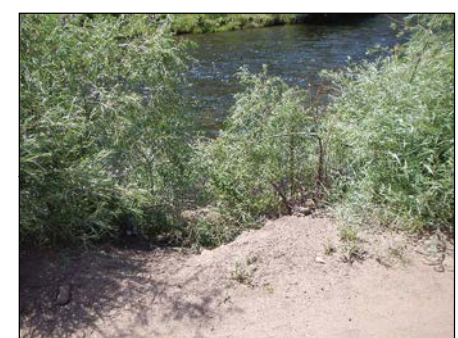
Photo 3
Pedestrian Rundown to River

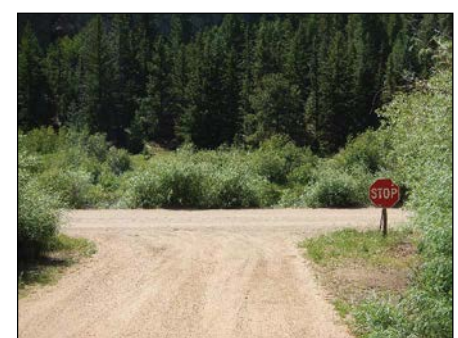
Photo 4
Intersection Approach

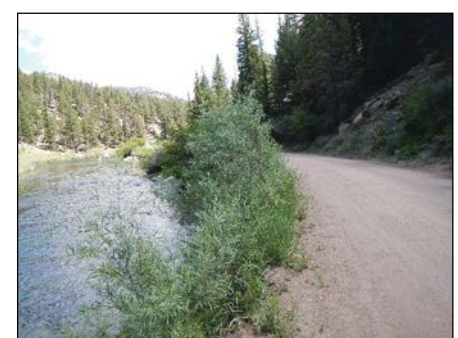
Photo 4
Thin but Stable Riparian Edge

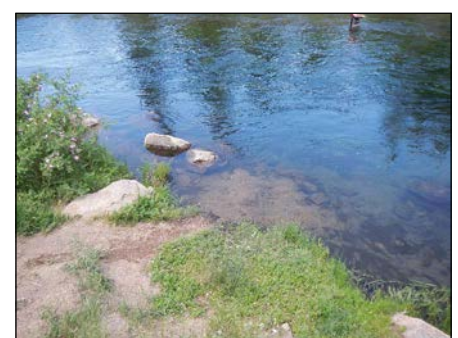
Photo 5
Sediment Deposition Location

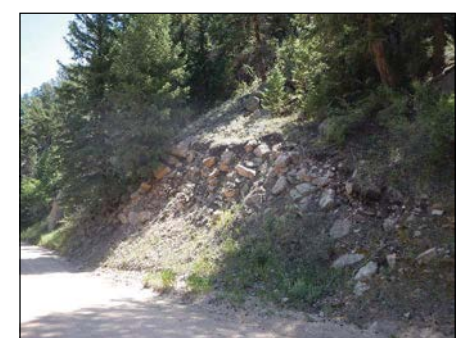
Photo 2
Hillside Erosion

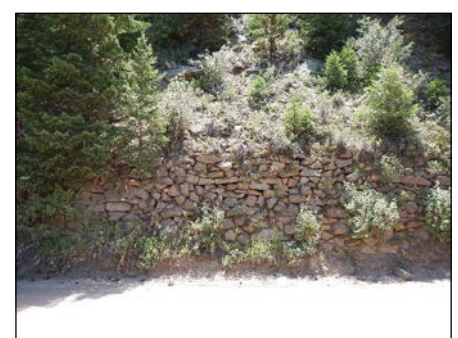
Photo 5
Old Rock Wall - Cultural Resource

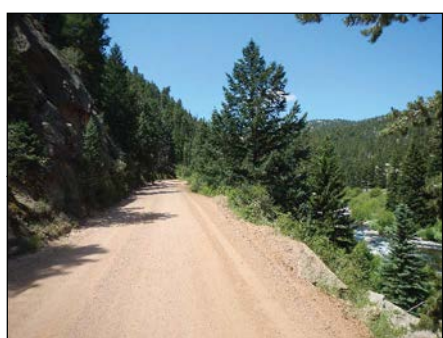
Photo 1
Well Vegetated Along River Terrace

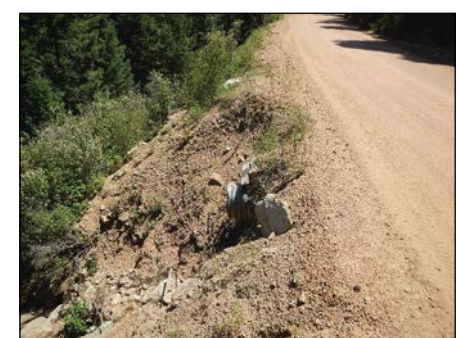
Photo 2
Culvert Outlet

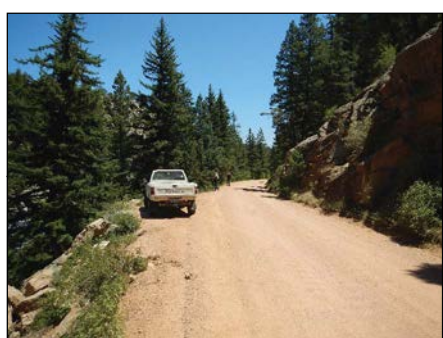
Photo 1
Car Parking in Pullout

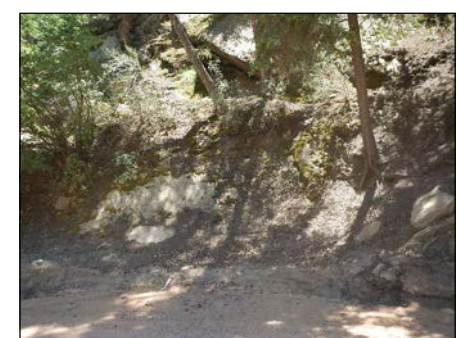
Photo 2
Hillside Erosion

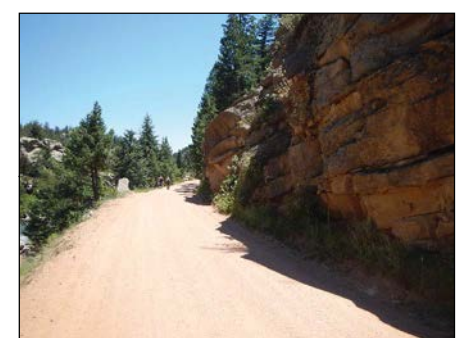
Photo 3
Rock Cut

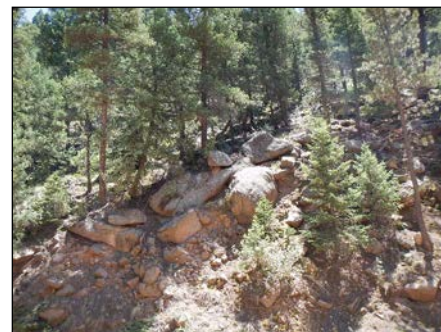
Photo 3
Representative Upland Hillslope

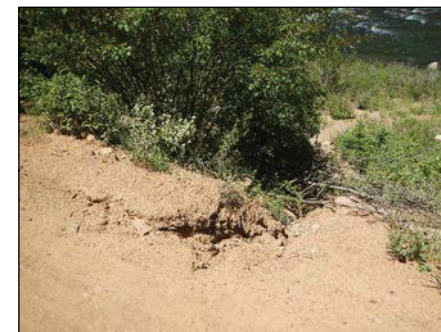
Photo 5
Drainage Rundown

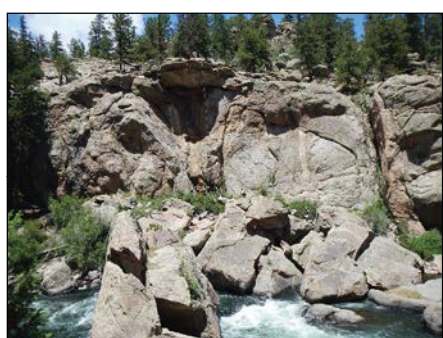
Photo 1
Popular Mountain Climbing Location

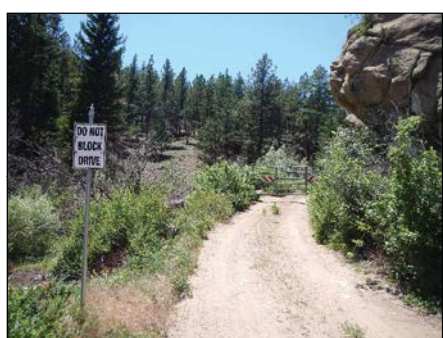
Photo 1
Typical Side Road

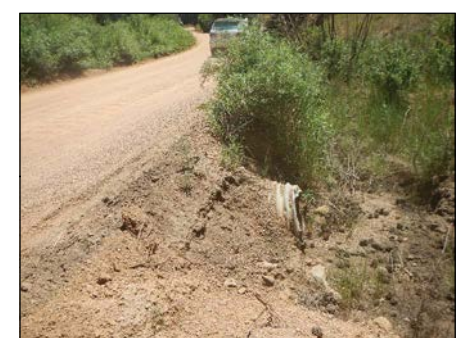
Photo 2
Culvert Outlet

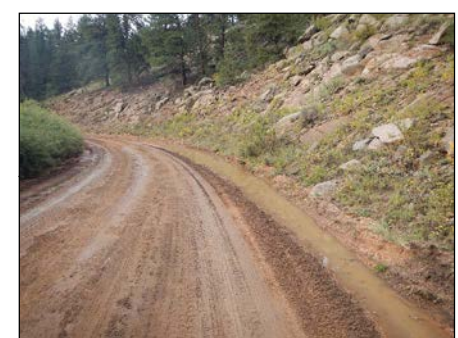
Photo 3
Roadway Drainage

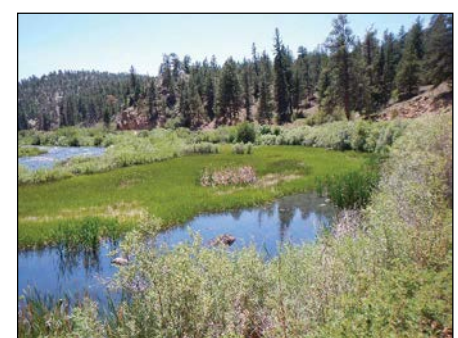
Photo 4
Nice Backwater Habitat

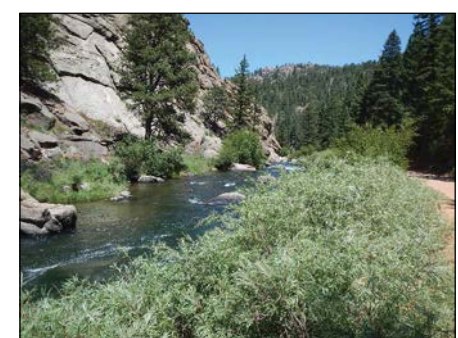
Photo 1
Limited Buffer Next to River

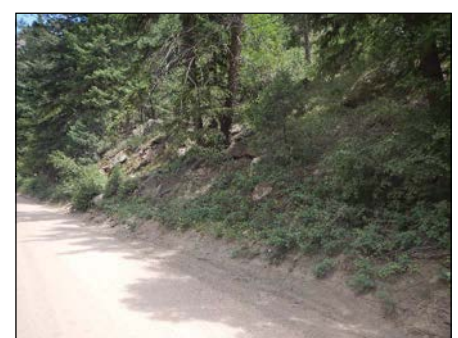
Photo 4
Trees Within Clear Zone

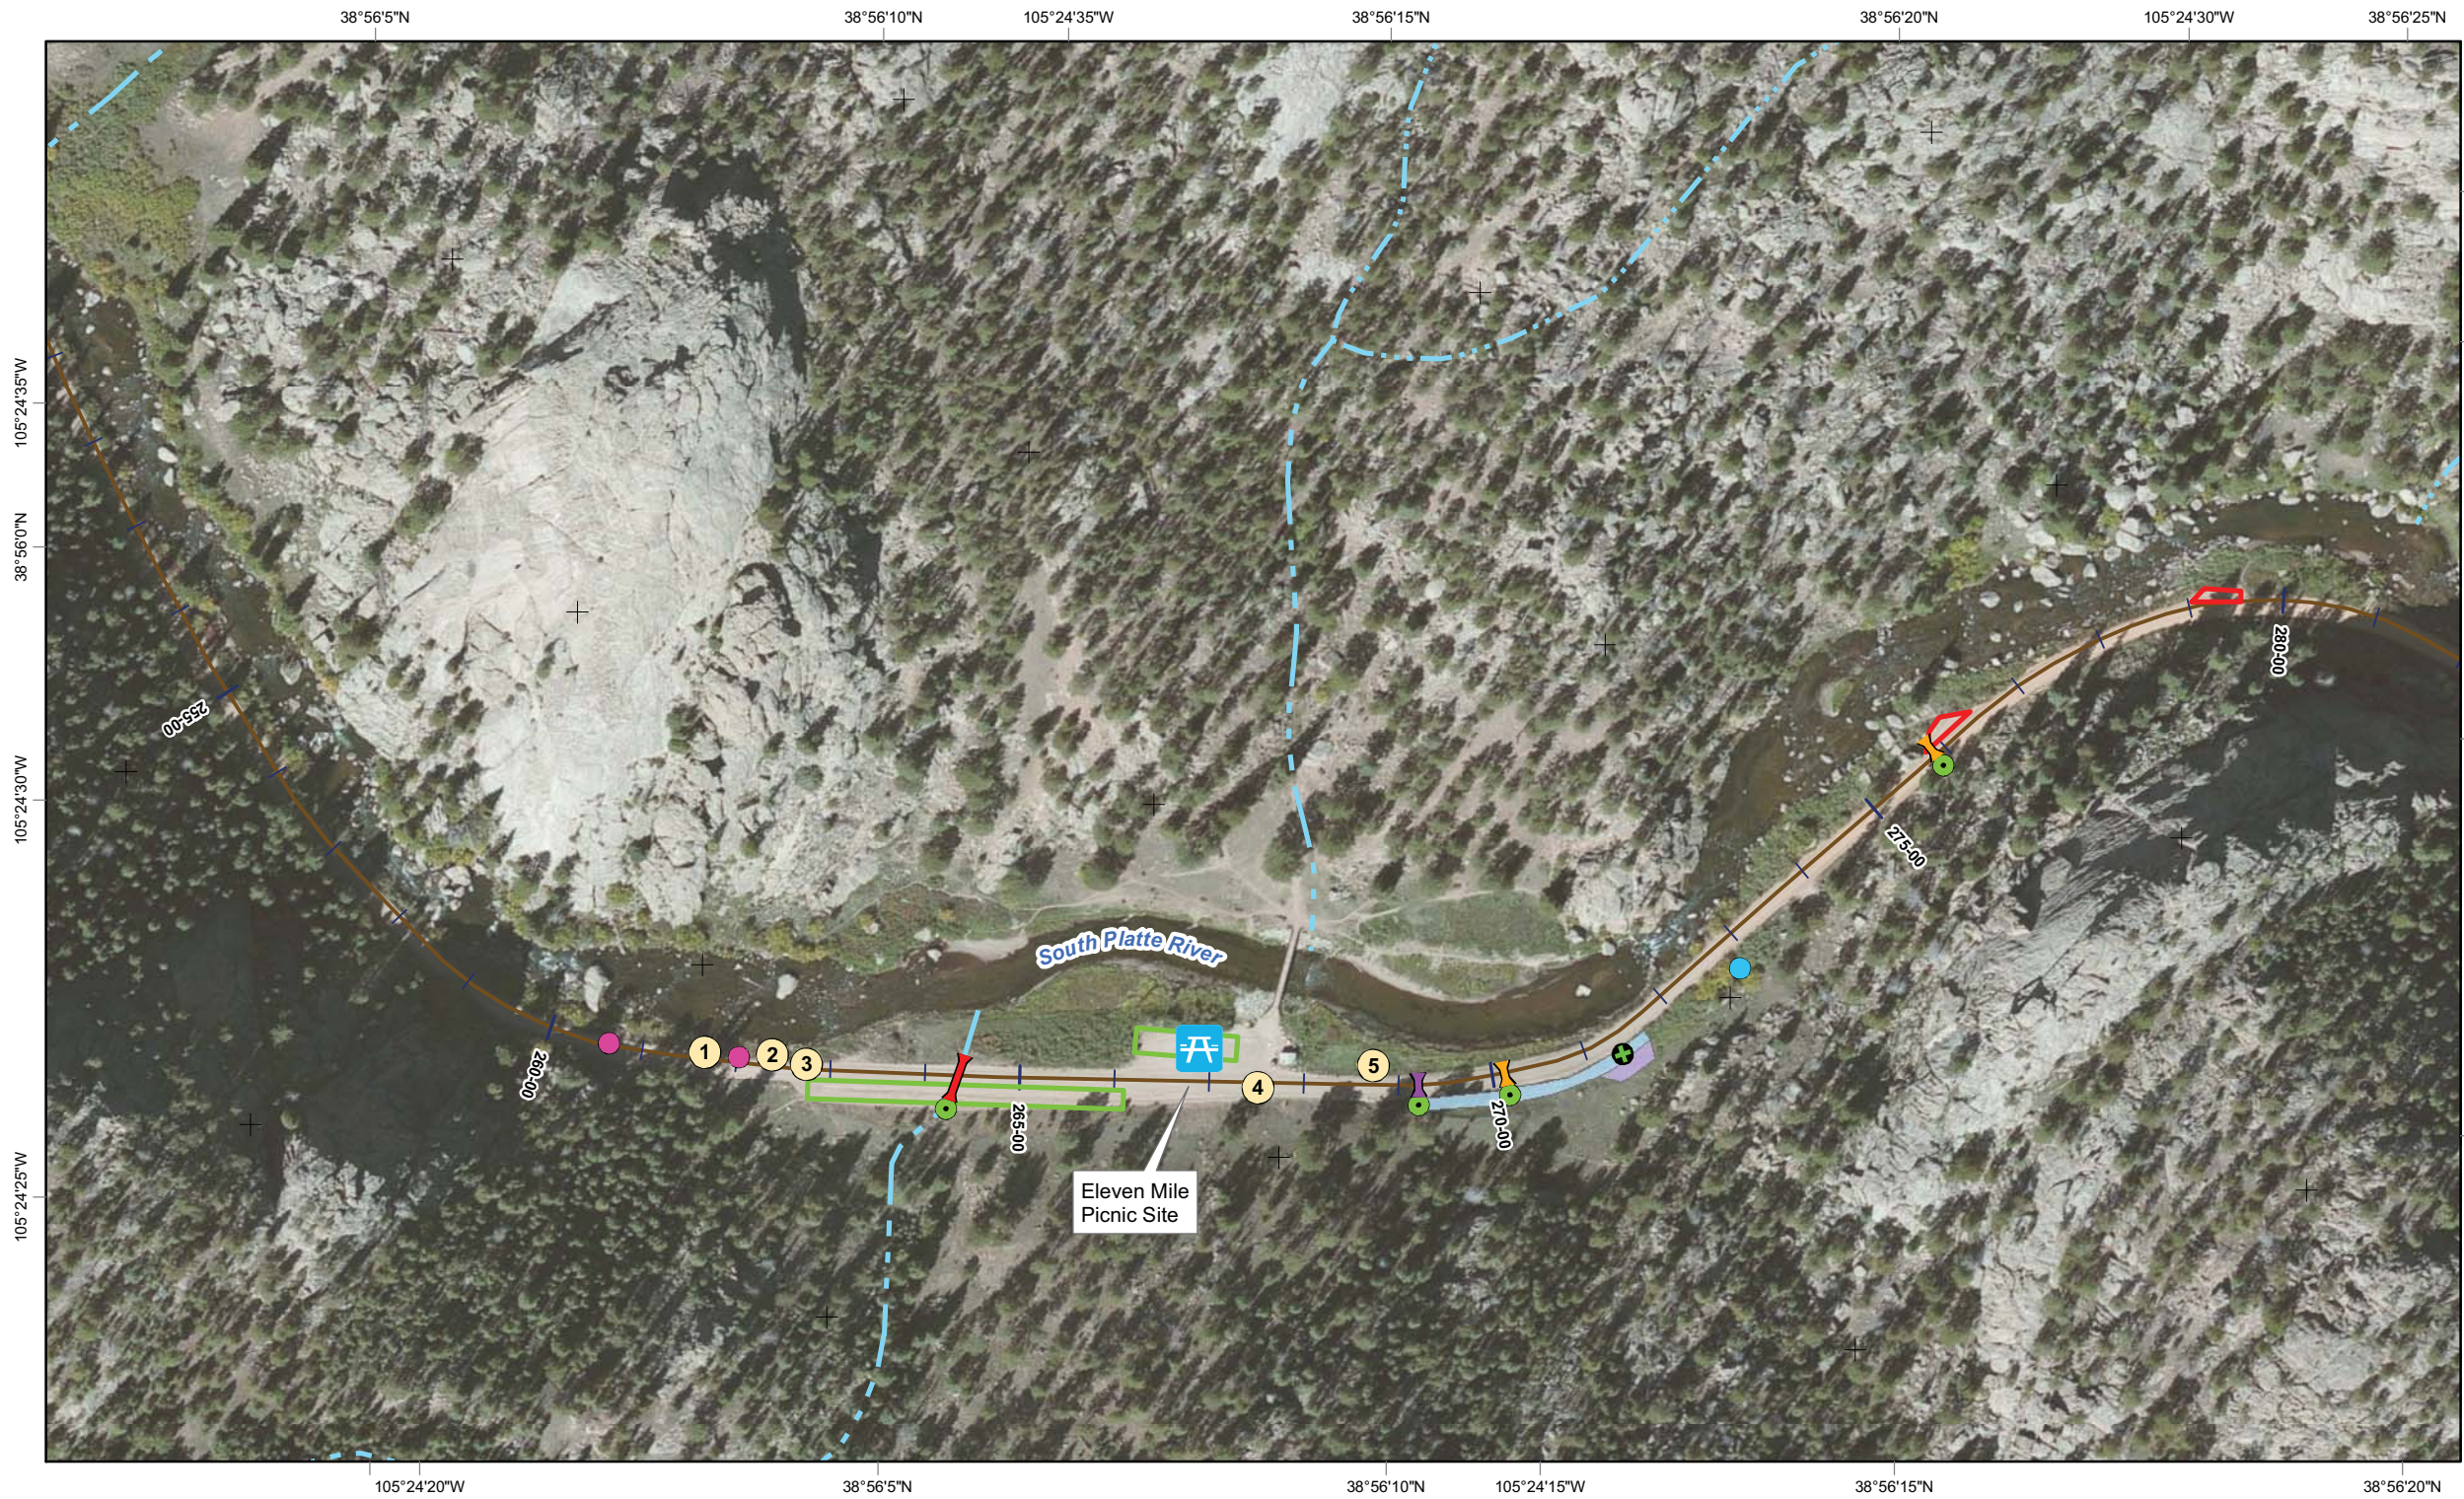
Photo 5
Hillside Erosion

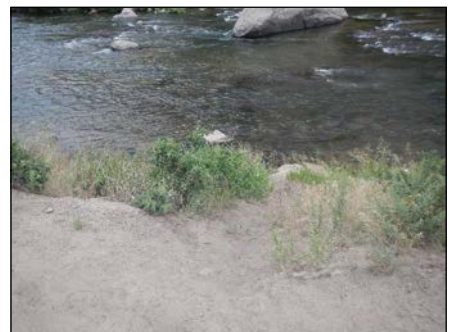
Photo 1
Noxious Weeds - Toadflax/Thistle

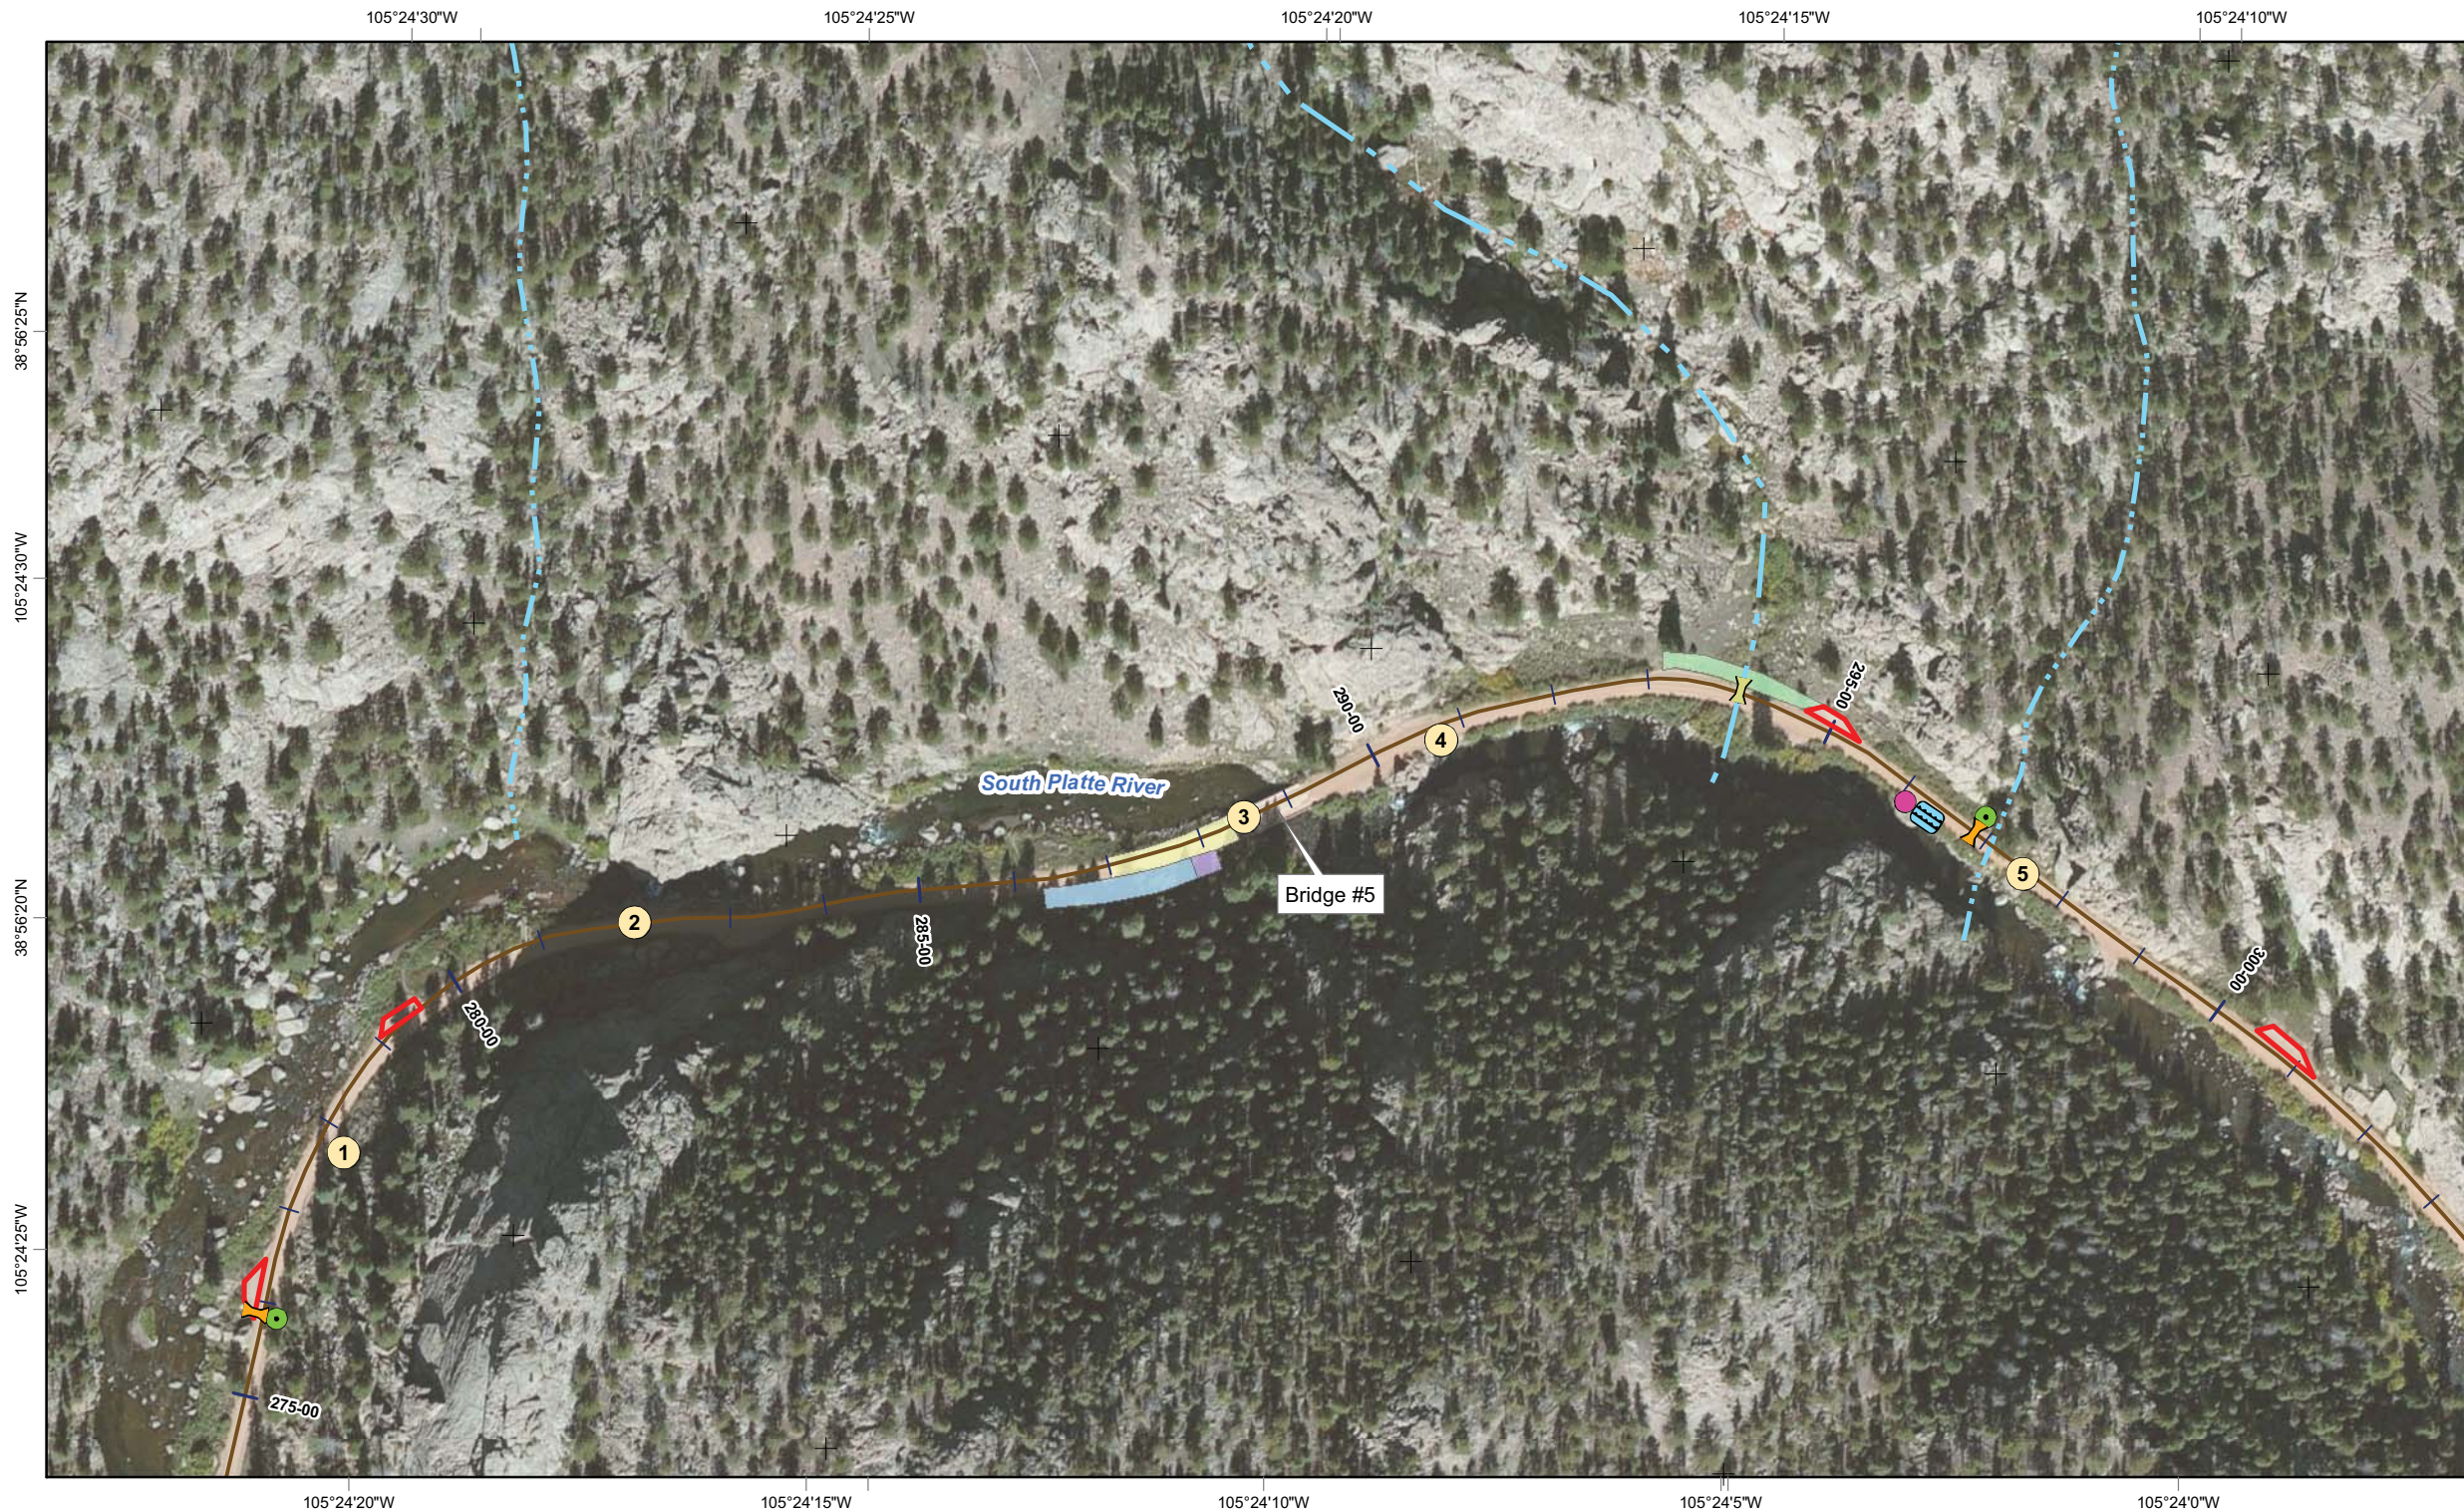
Photo 5
Culvert Blocked with Sediment

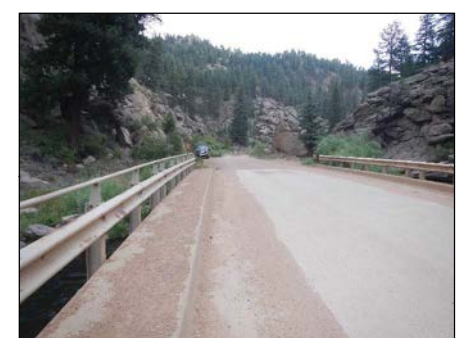
Photo 2
Banks Too Steep to Support Vegetation

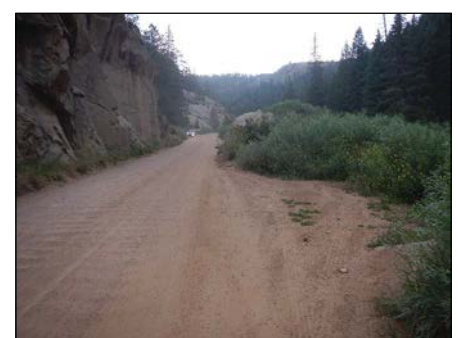
Photo 4
Limited Vegetation on Slope

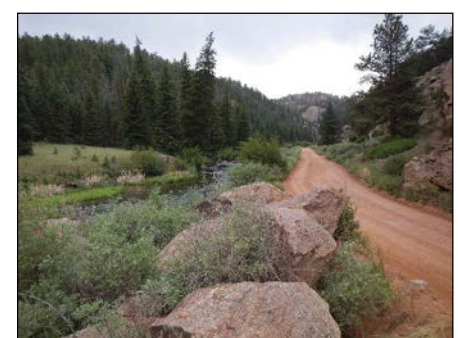
Photo 3
Pedestrian Rundown to River

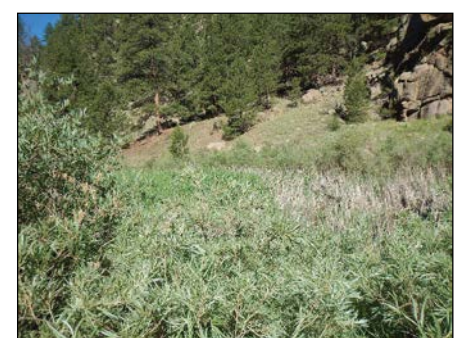
Photo 4
Wetland - Old Oxbow

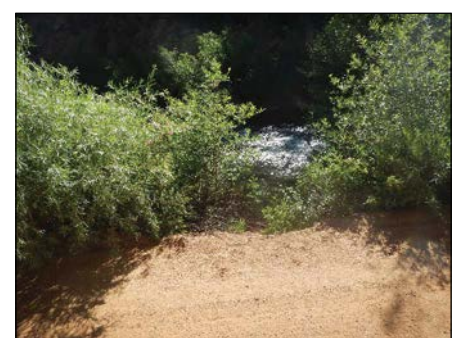
Photo 5
Pedestrian Rundown to River

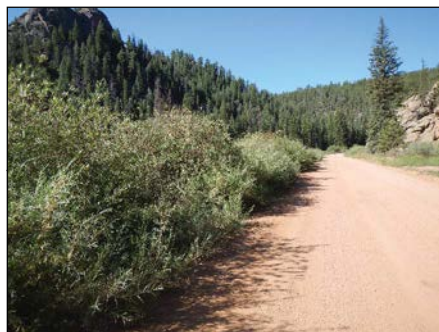
Photo 1
Roadside Buffer

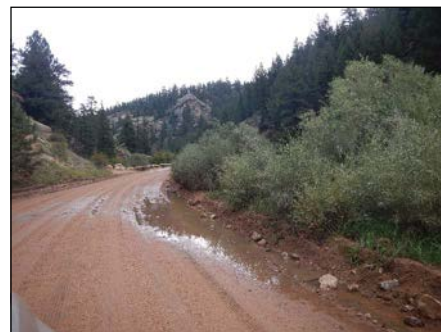
Photo 2
Roadway Drainage

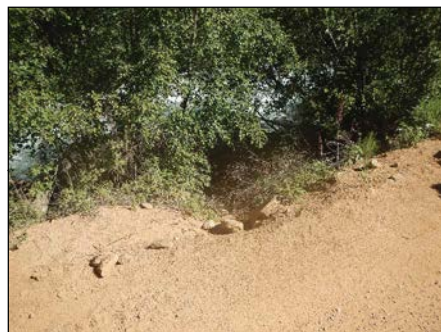
Photo 3
Rundown Location

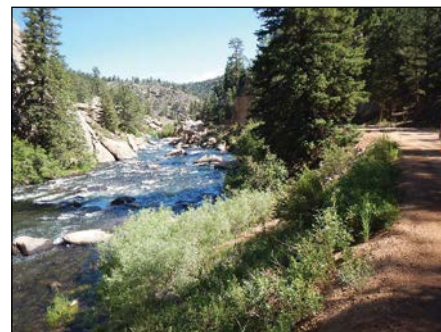
Photo 5
New Willow Growth in Depositional Area

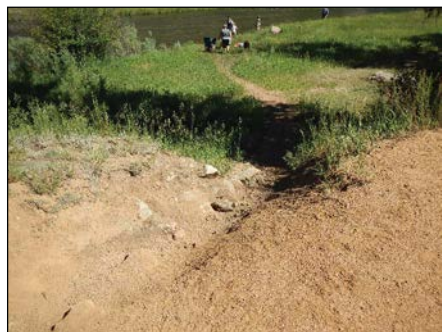
Photo 4
Pedestrian Access Vegetation Impacts

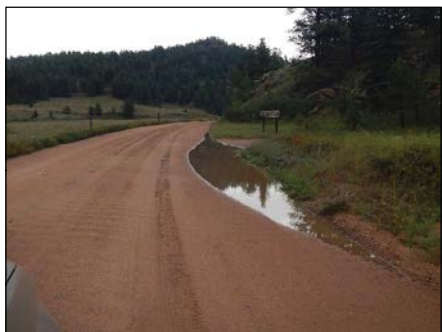
Photo 5
Roadway Drainage

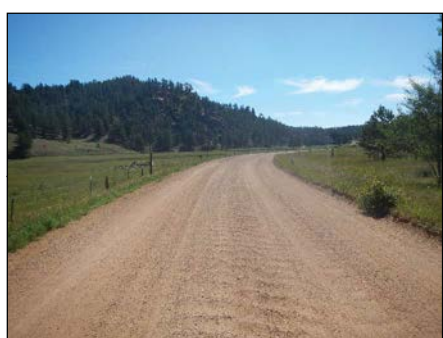
Photo 1
Washboarded Surface

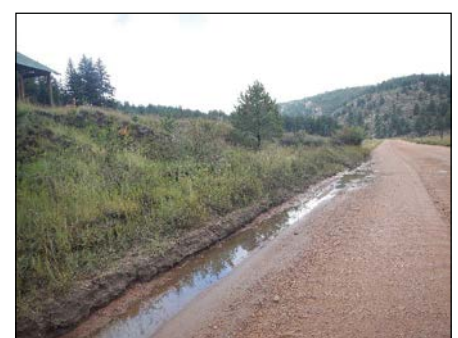
Photo 5
Roadway Drainage

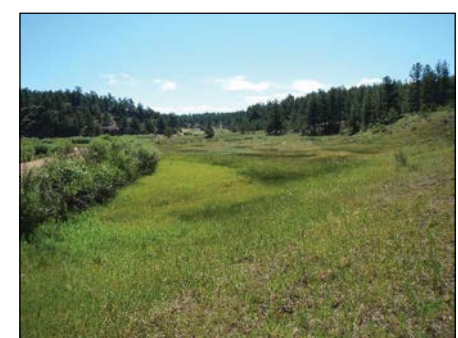
Photo 2
Wetland - Old Oxbow

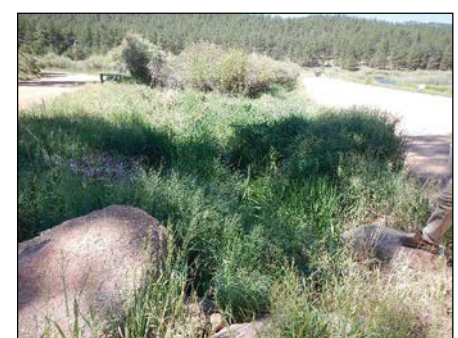
Photo 4
Potential Water of the U.S.

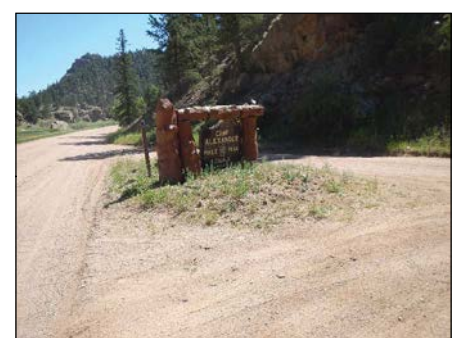
Photo 5
Boy Scout Intersection

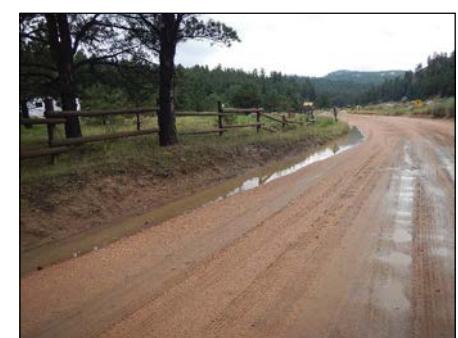
Photo 2
Roadway Drainage

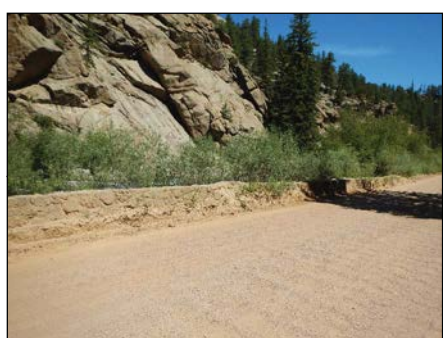
Photo 1
Old Rock Wall - Cultural Resource

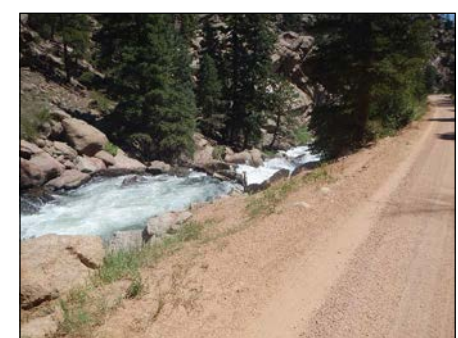
Photo 2
No Buffer Next to River

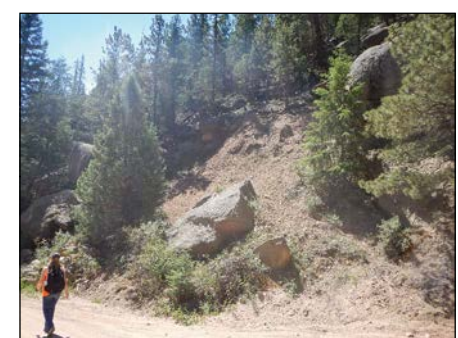
Photo 2
Hillside Erosion

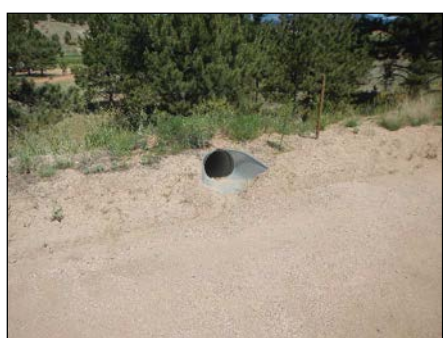
Photo 1
Culvert Rundown

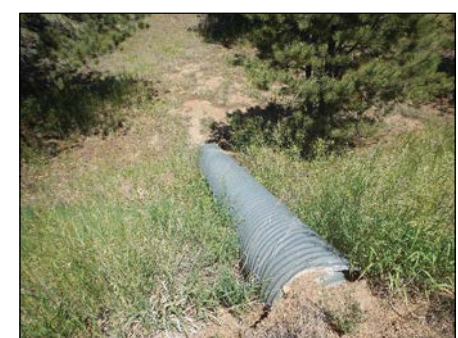
Photo 2
Culvert Rundown

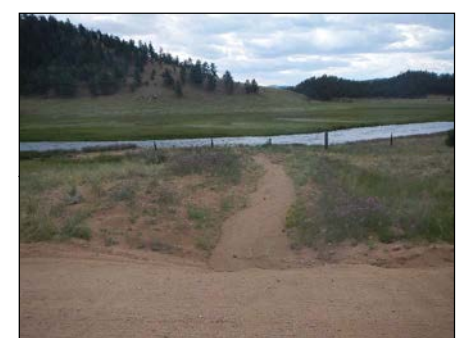
Photo 3
Sediment Deposition

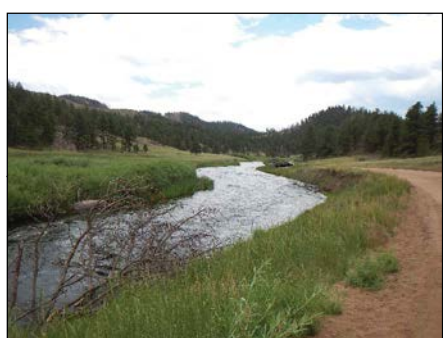
Photo 1
Lack of Woody Riparian Buffer

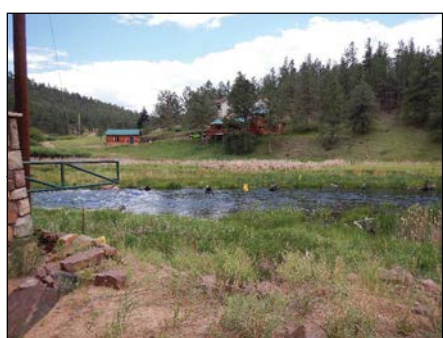
Photo 1
Instream Woody Structures

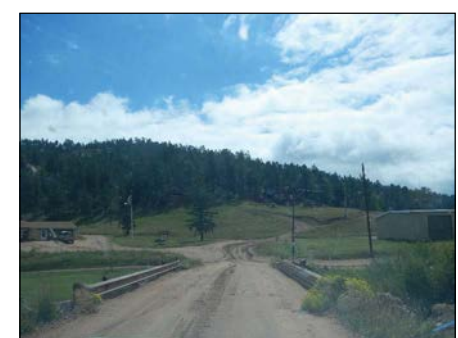
Photo 2
Happy Meadows Community Bridge

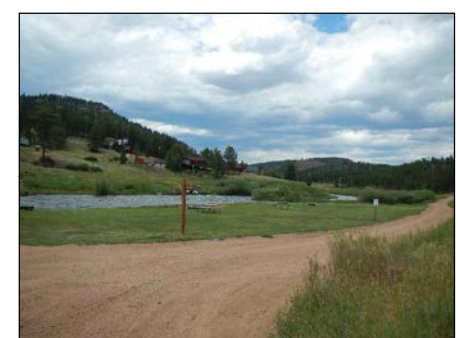
Photo 3
Manicured Lawn

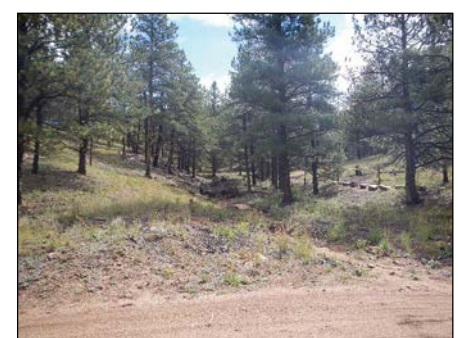
Photo 4
Hillside Drainage

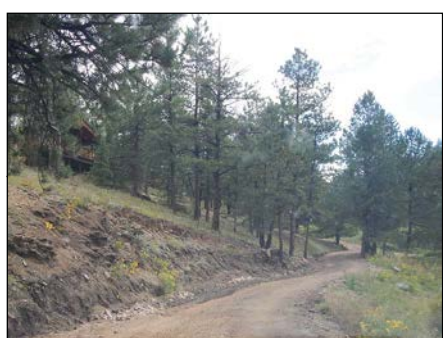
Photo 1
Typical Narrow Roadway Section

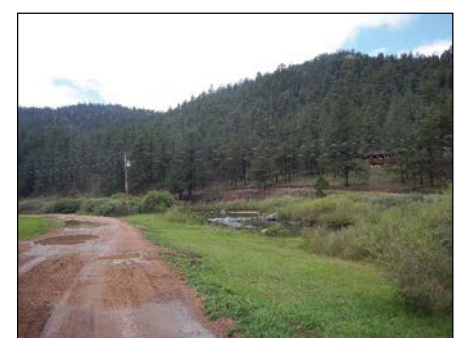
Photo 4
Roadway Drainage

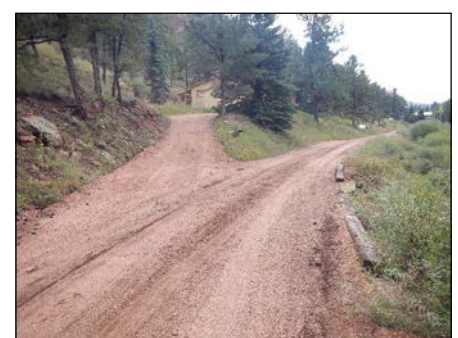
Photo 5
Typical Driveway Intersection
